Bromley Farm

Master Plan

Historic Structures Assessment

Prepared by:
Avenue L Architects
March 18, 2010

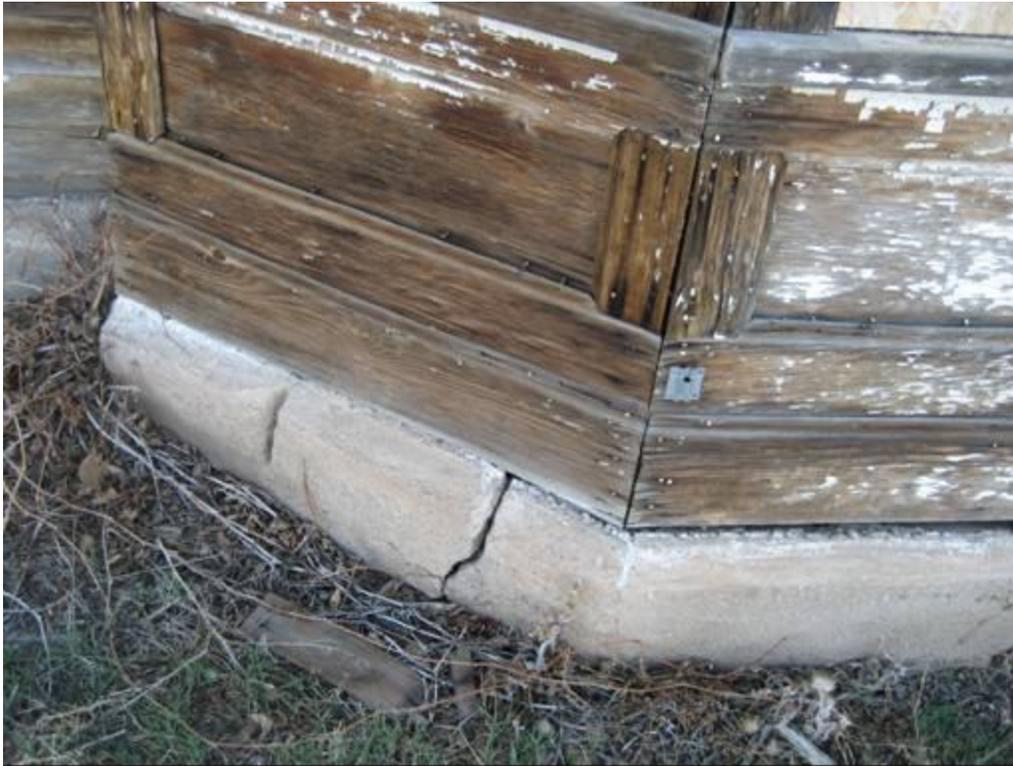
East bay window; typical exterior foundation wall; notice cracking and displacement away from bottom of stud wall

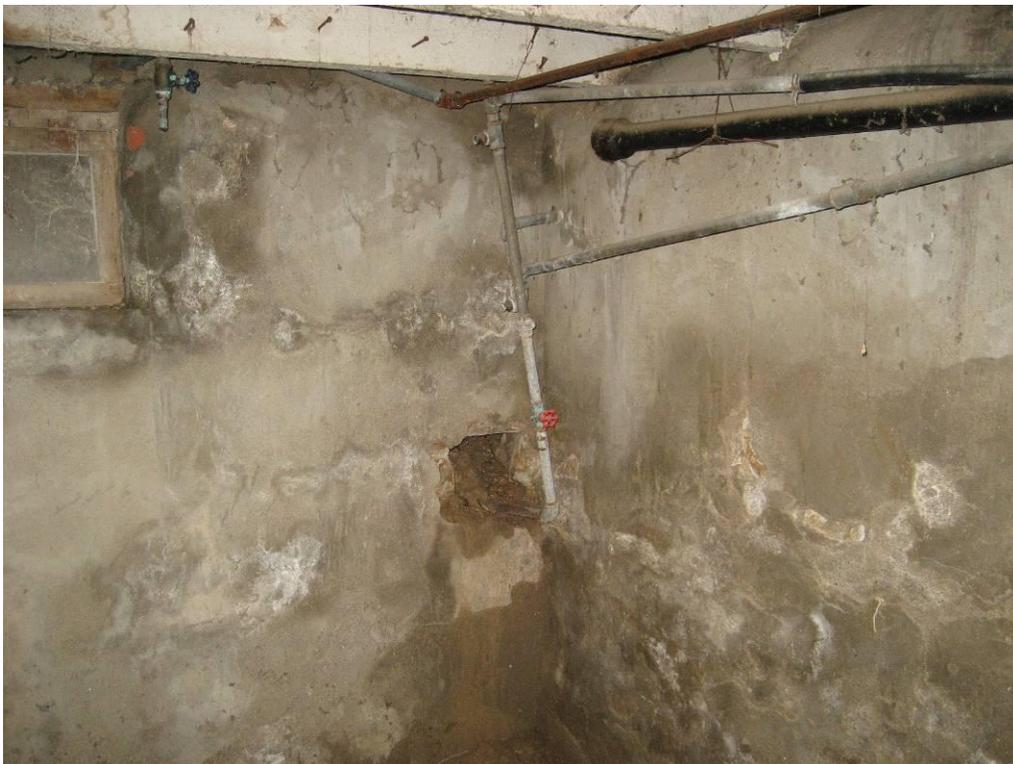
Stone basement walls; water intrusion through west wall opening, failing parging along base of wall, 2009.

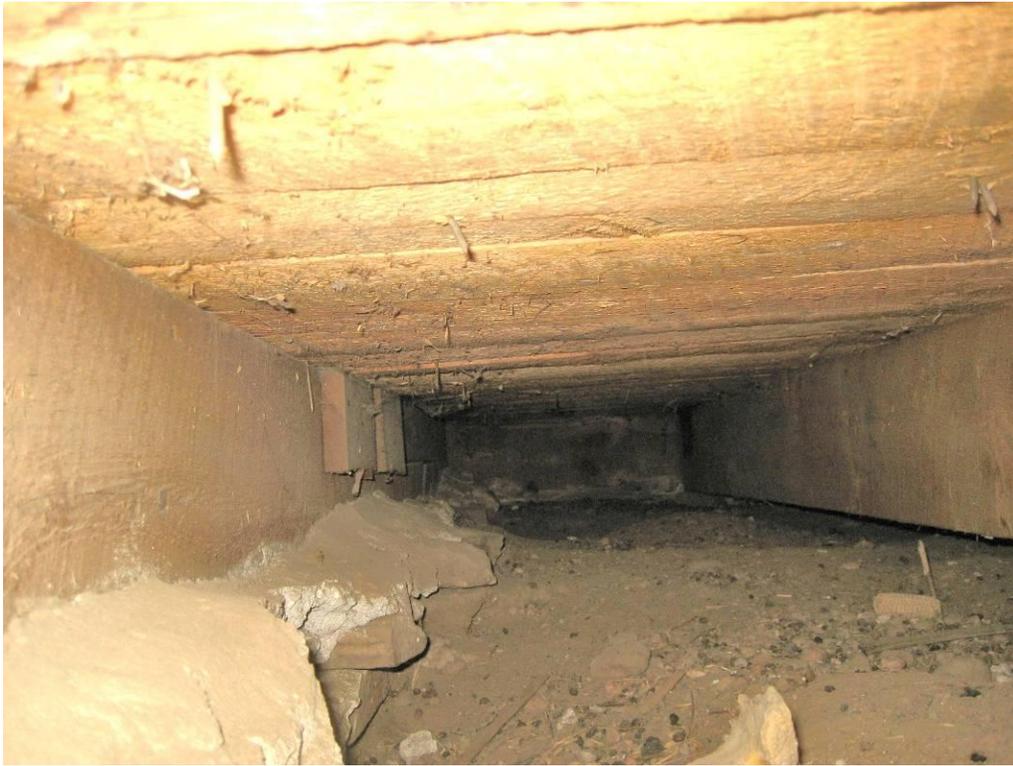
Typical interior foundation of stacked stone and concrete. Looking west under north wall of Dining Room. Note untreated wood in contact with masonry, 2009.

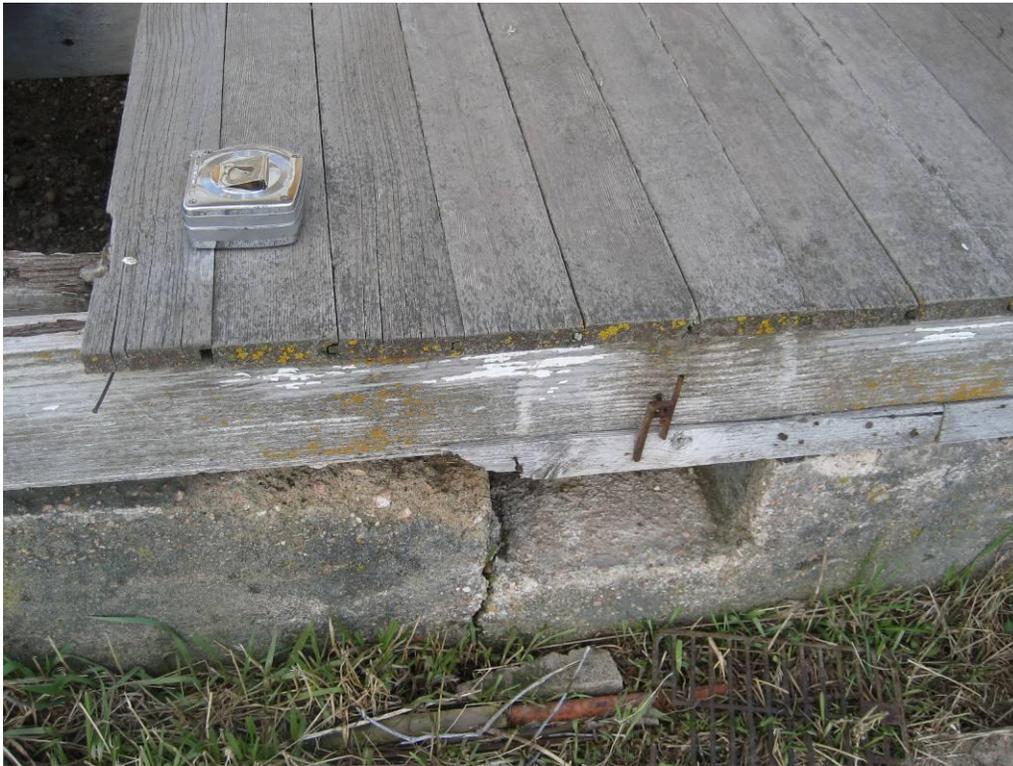
The perimeter foundation around the North Porch has three 1/4" wide cracks in it and has deteriorated due to exposure.

Foundation wall at perimeter of porch; notice cracking, 2009.

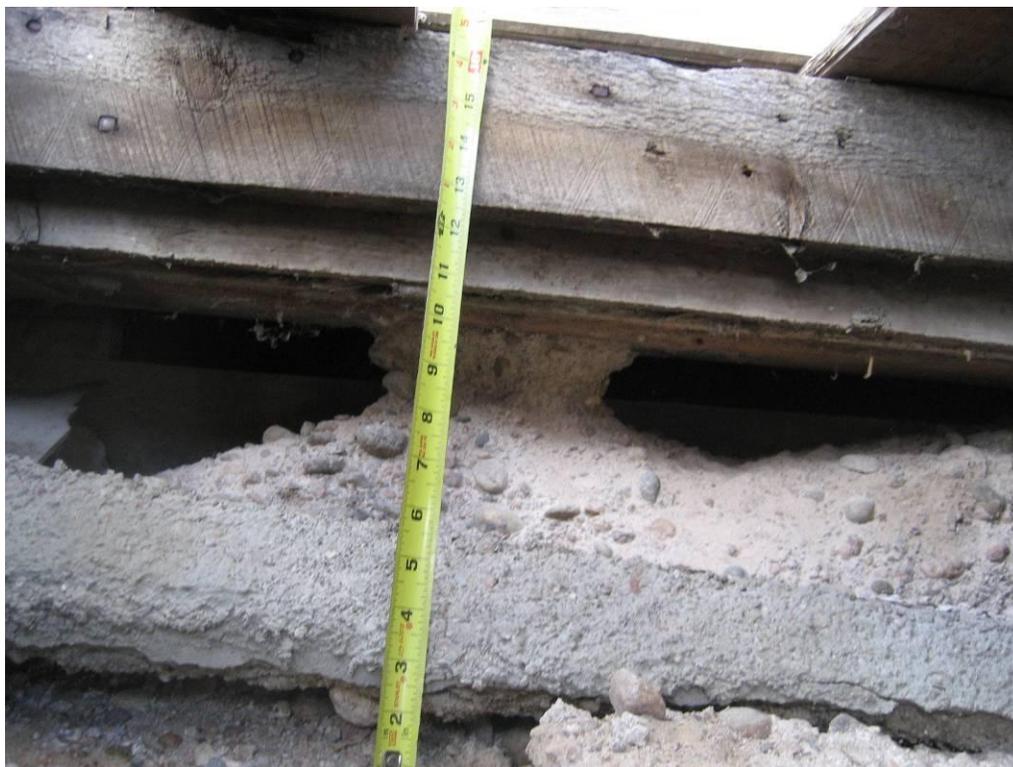
NE wall of house under porch; severe foundation deterioration, 2009.

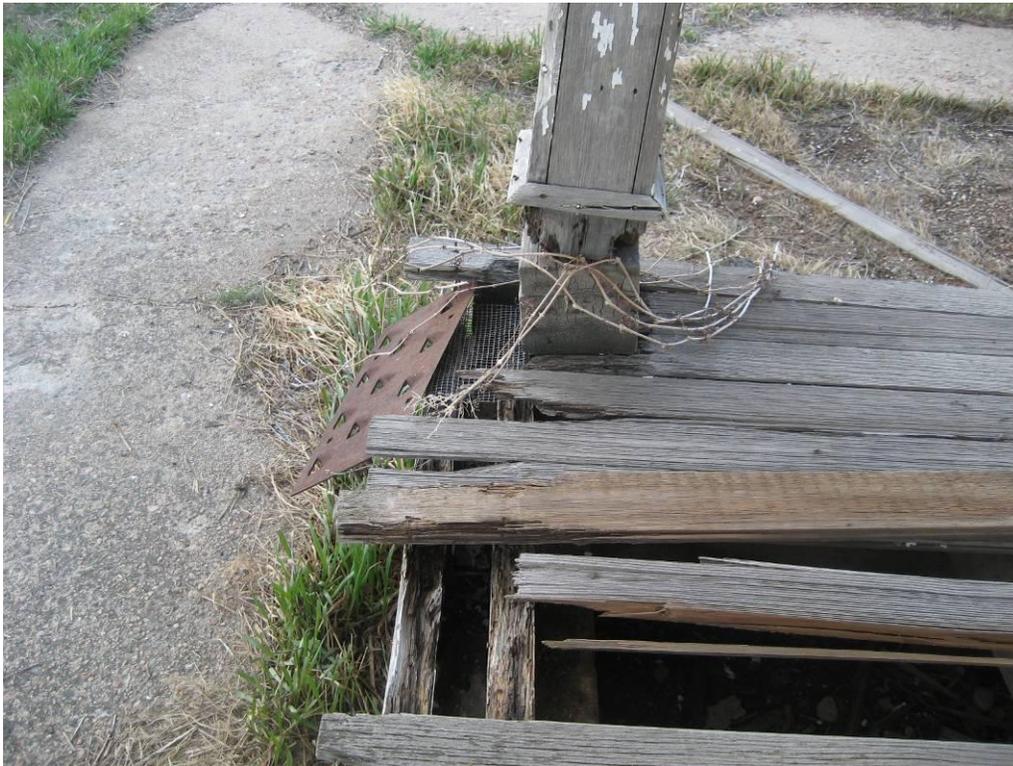
North Porch decking, joist and post deterioration, 2009.

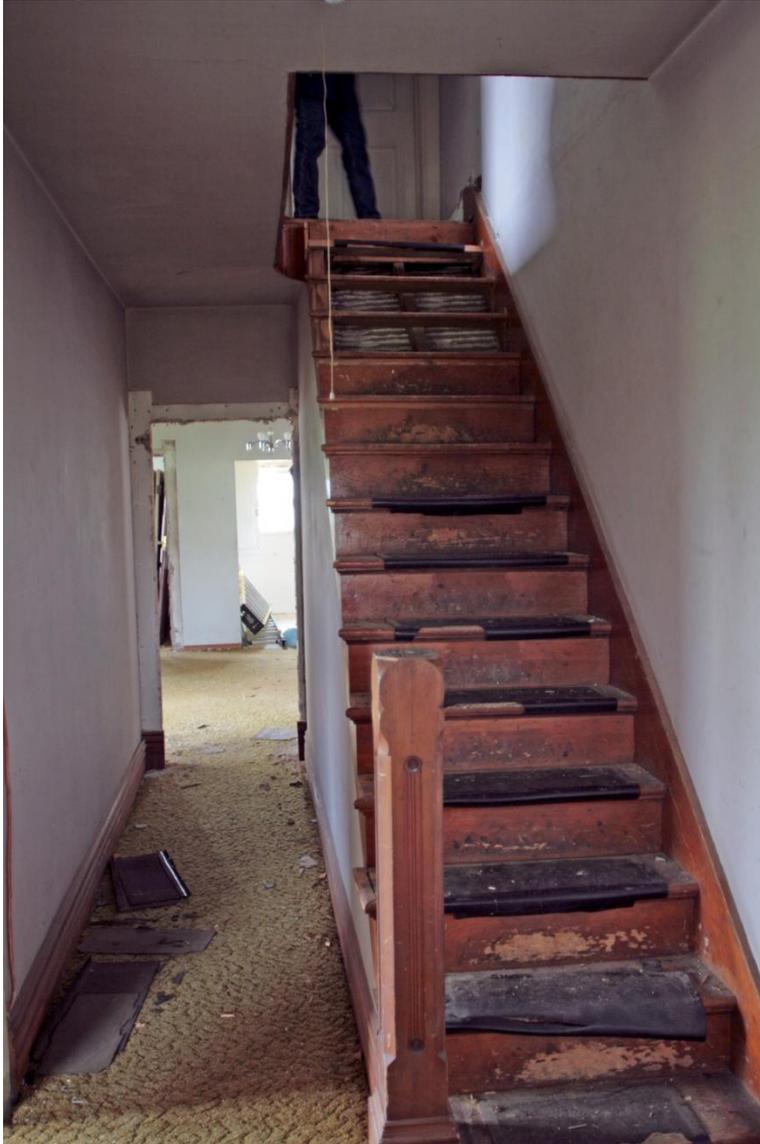
Looking south at Hall and stair from North entry.
2009 photo.

Condition: Historic wallpaper is covered with paint and peeling away from wall at north end of stair. Historic wallpaper on the ceiling is covered with paint, but is in fair condition. The non-historic carpet is extremely soiled and covered with debris. Wood base is in fair condition. The handrail, balusters, wood edge trim, and some of the wood stair risers have been removed. Stair treads have been covered with non-historic rubber mat. Stair finish is in poor condition. Also see Sections 3.1.8, Mechanical Systems, water and wastewater and Section 3.1.9., Electrical systems and lighting.

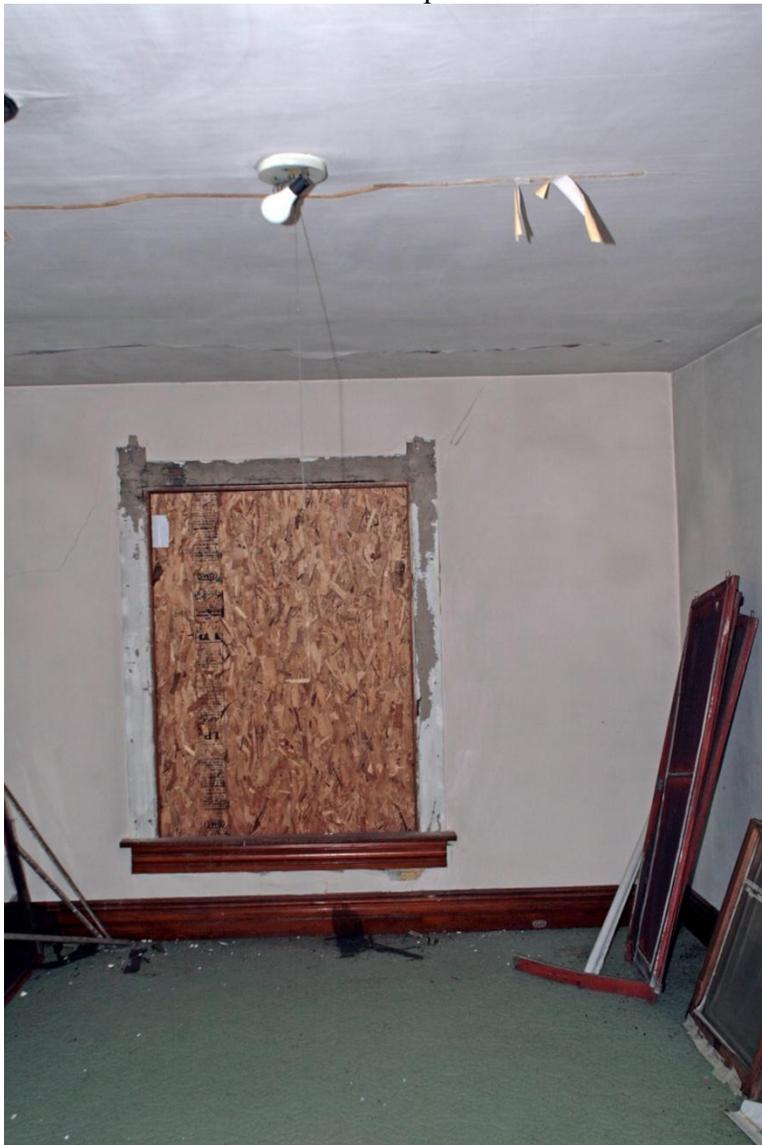
North wall of Great Room. 2009 photo.

Condition: Walls are dusty but in fair condition. No water damage is visible. Painted wallpaper is peeling off the ceiling in several locations. The non-historic carpet is extremely soiled and covered with debris. Wood base is in fair condition and intact. Door trim that has not been

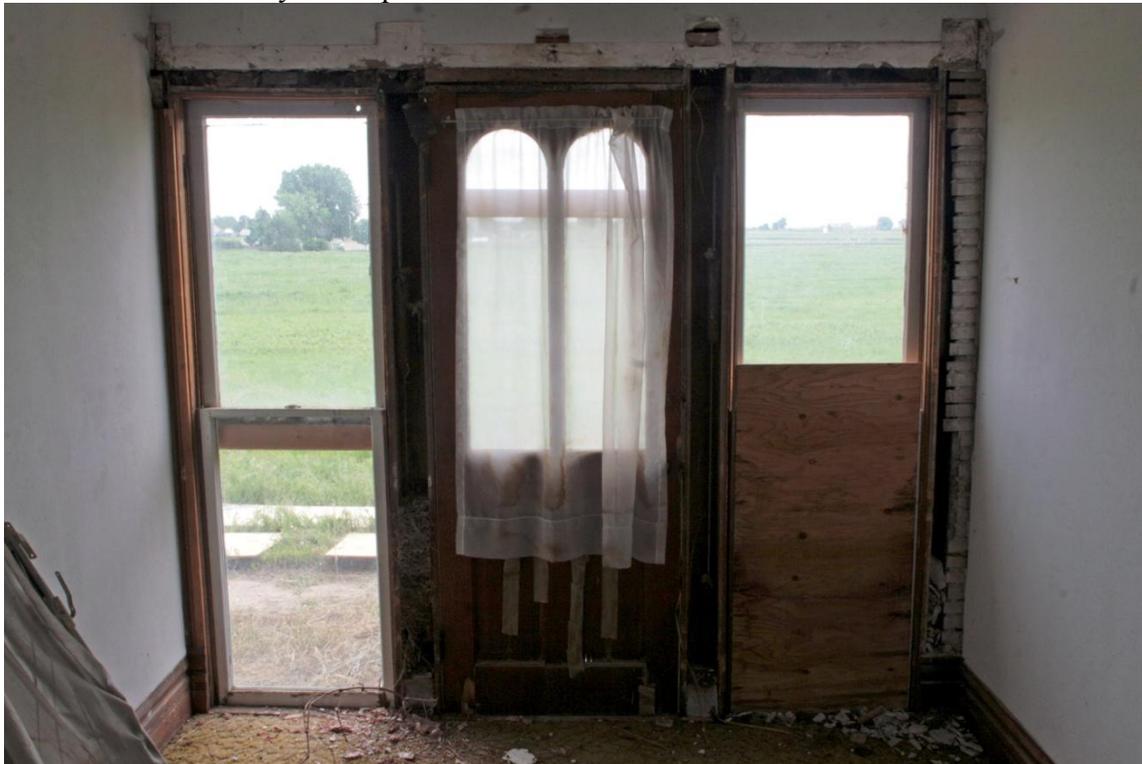
East wall of East Entry. 2009 photo.

Condition: The painted gypsum board walls are damaged where trim has been removed. The painted gypsum wallboard ceiling is in fair condition. The non-historic carpet is extremely soiled and covered with debris and some animal droppings. Wood base is in fair to poor condition. The condition of wood trim could not be assessed, since it has been removed. Also see Sections 3.1.8, Mechanical Systems, water and wastewater and Section 3.1.9., Electrical systems and lighting.

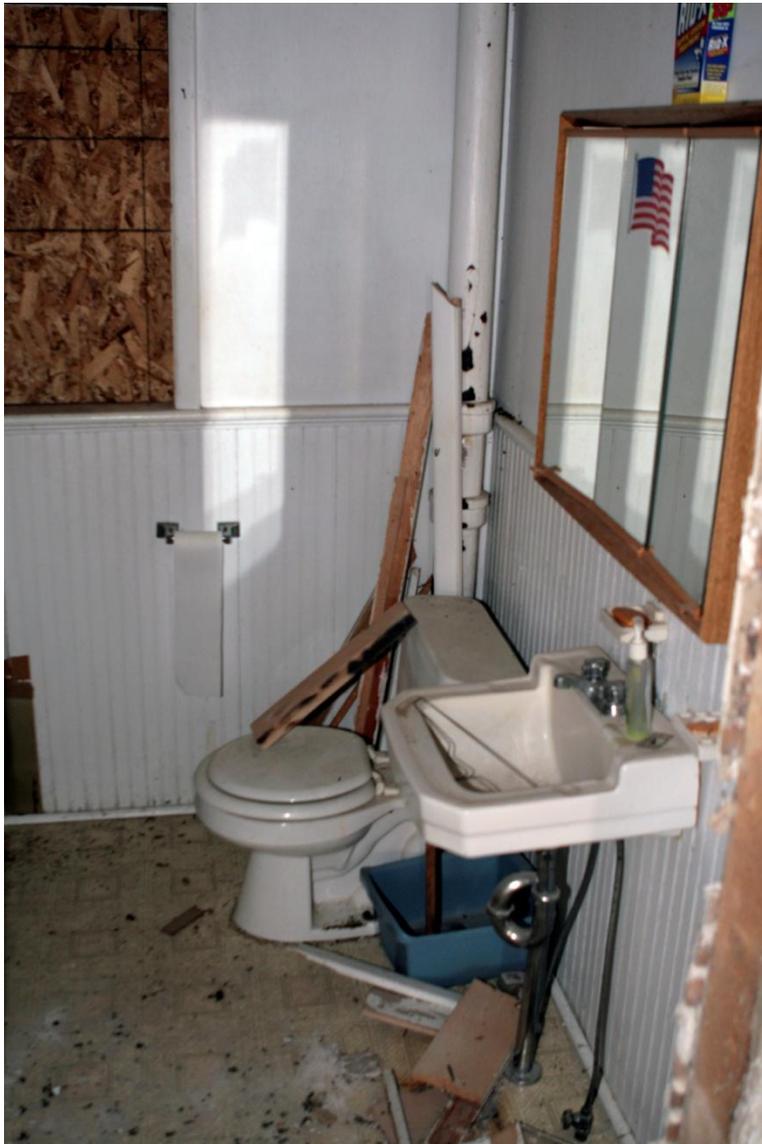
Condition: The painted gypsum board walls are damaged where trim has been removed. Painted beadboard wainscot is chipped and worn. The painted gypsum wallboard ceiling is in fair condition. The linoleum is extremely soiled and in poor condition. The water closet, wash basin, and tub are not damaged. It could not be determined if they are operable. Also see Sections 3.1.8, Mechanical Systems, water and wastewater and Section 3.1.9., Electrical systems and lighting.

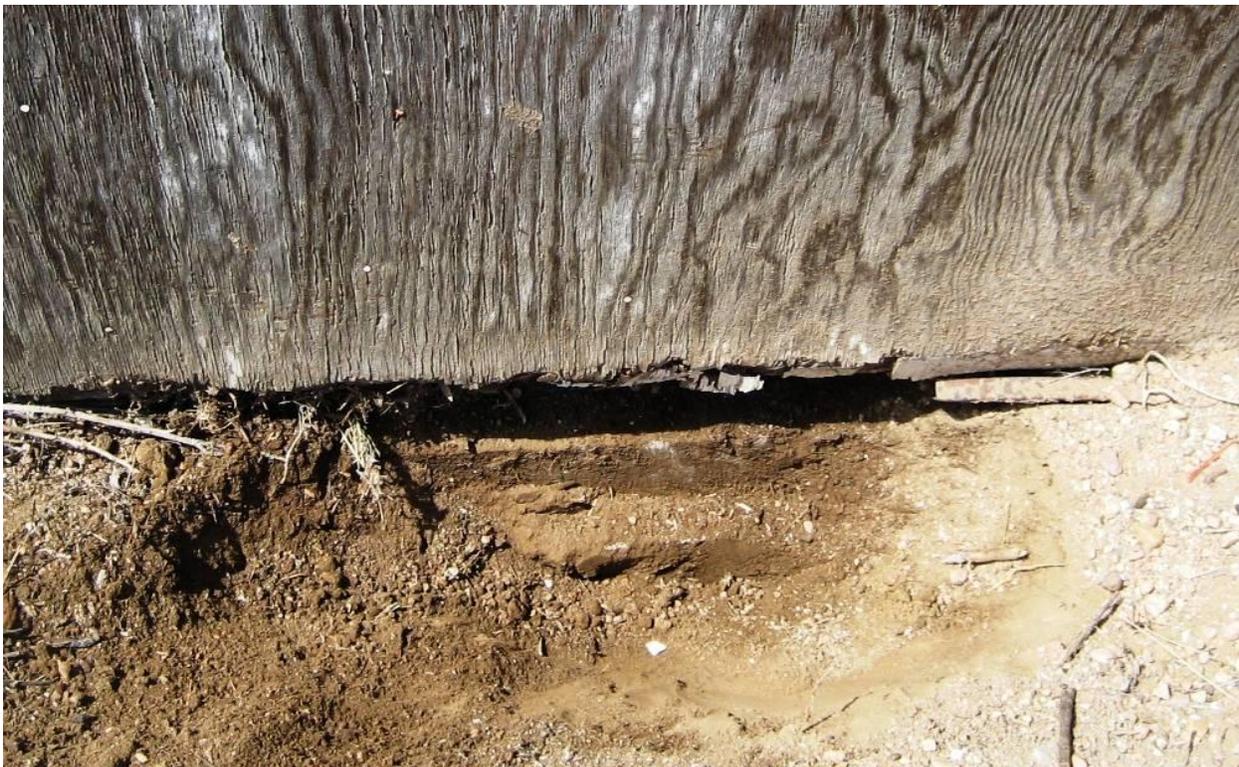
Typical concrete perimeter foundation under east wall of Porch; note soil above top of stem wall, 2009.

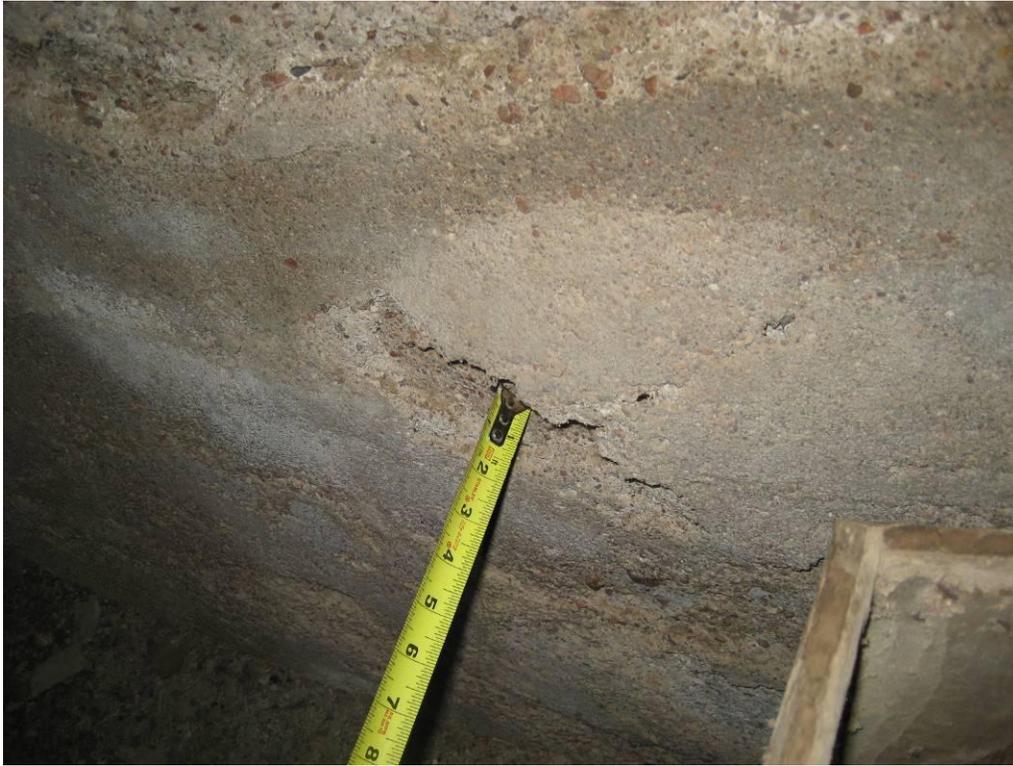
South Cellar wall efflorescence and spalling, 2009.

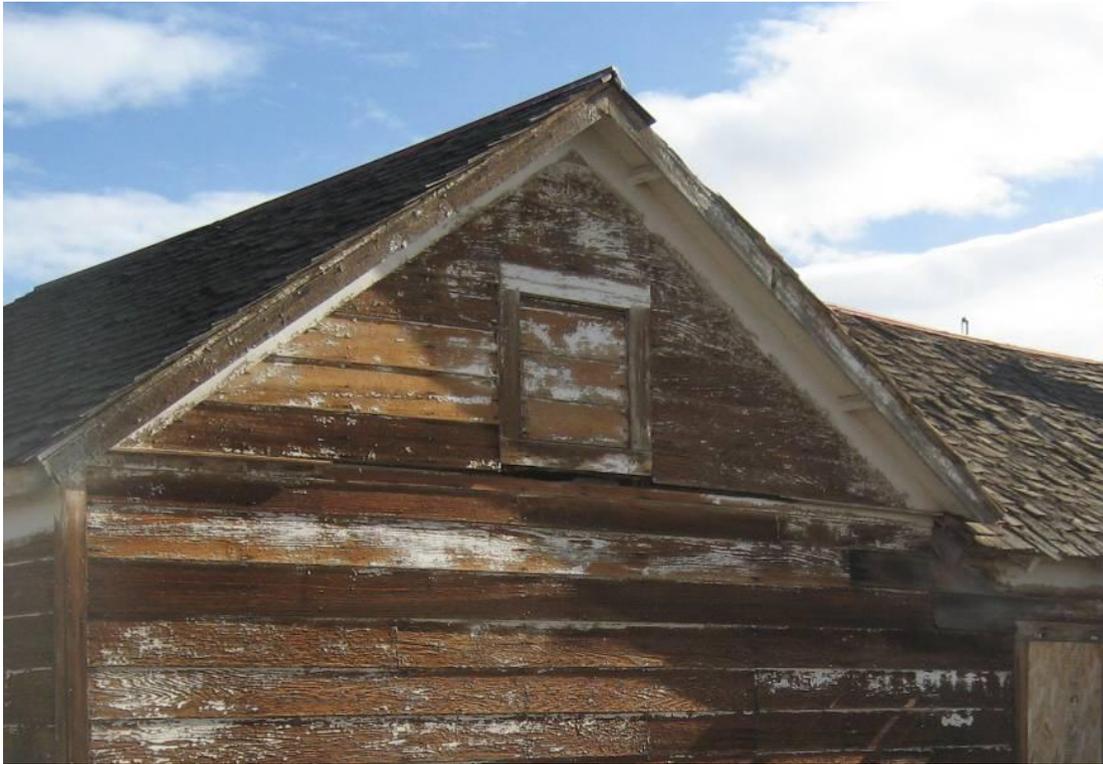
South wall of Bunk Room; notice gap in siding at plate height being used by birds, 2009.

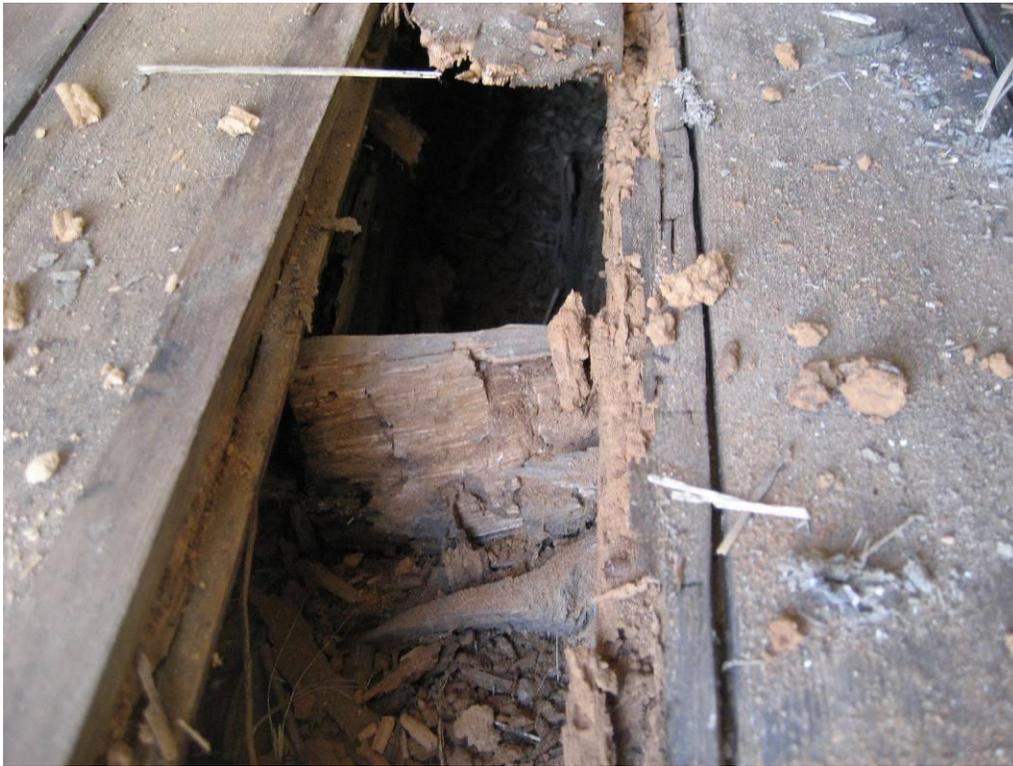
Deteriorated floor framing under Porch, 2009.

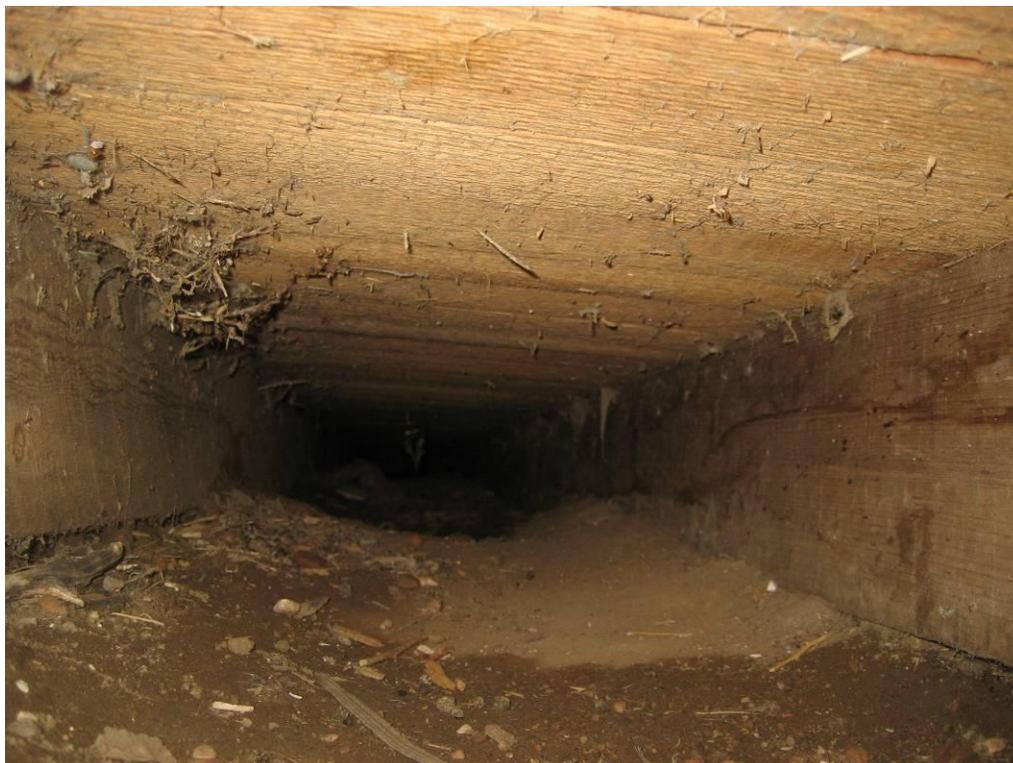
Typical floor framing below Bunk Room; notice joists sitting in dirt and moisture, 2009.

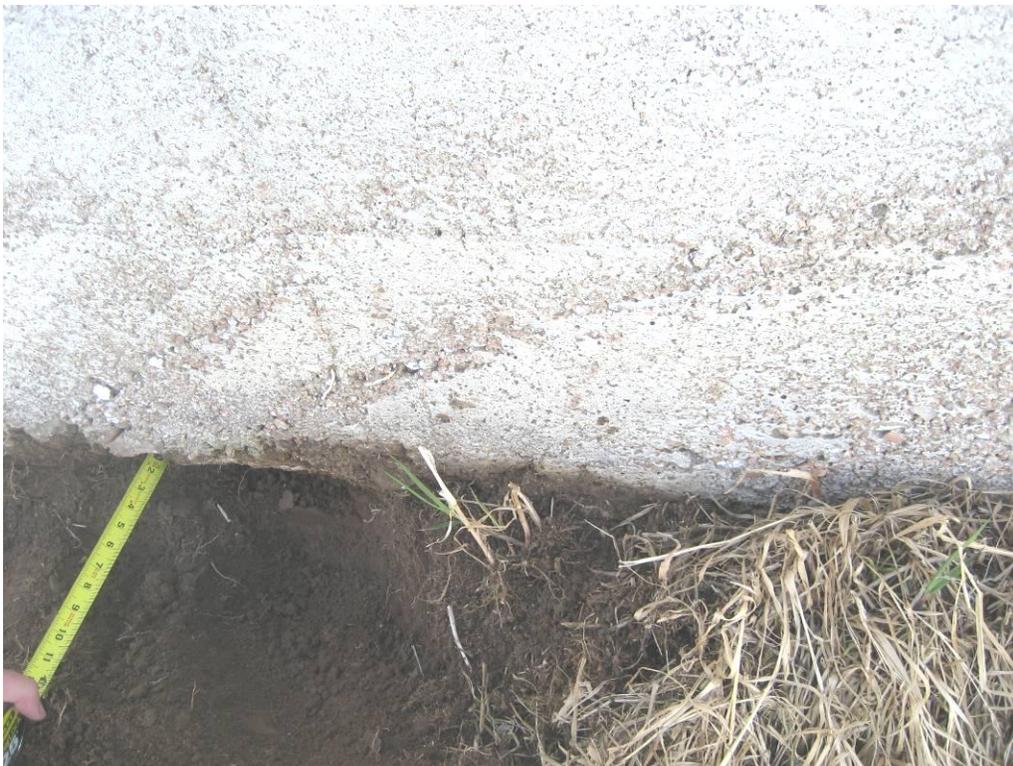
North knee wall at exterior showing lack of foundation under wall, 2009.

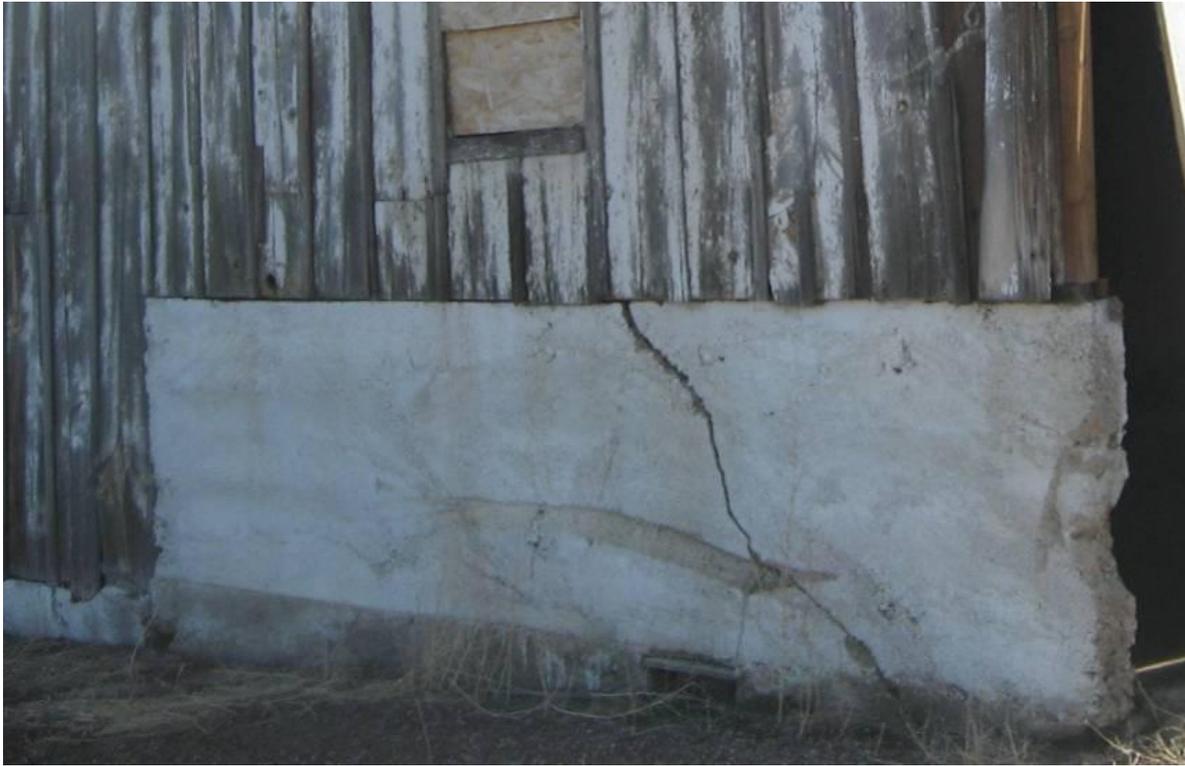
Southwest knee wall cracks, 2009.

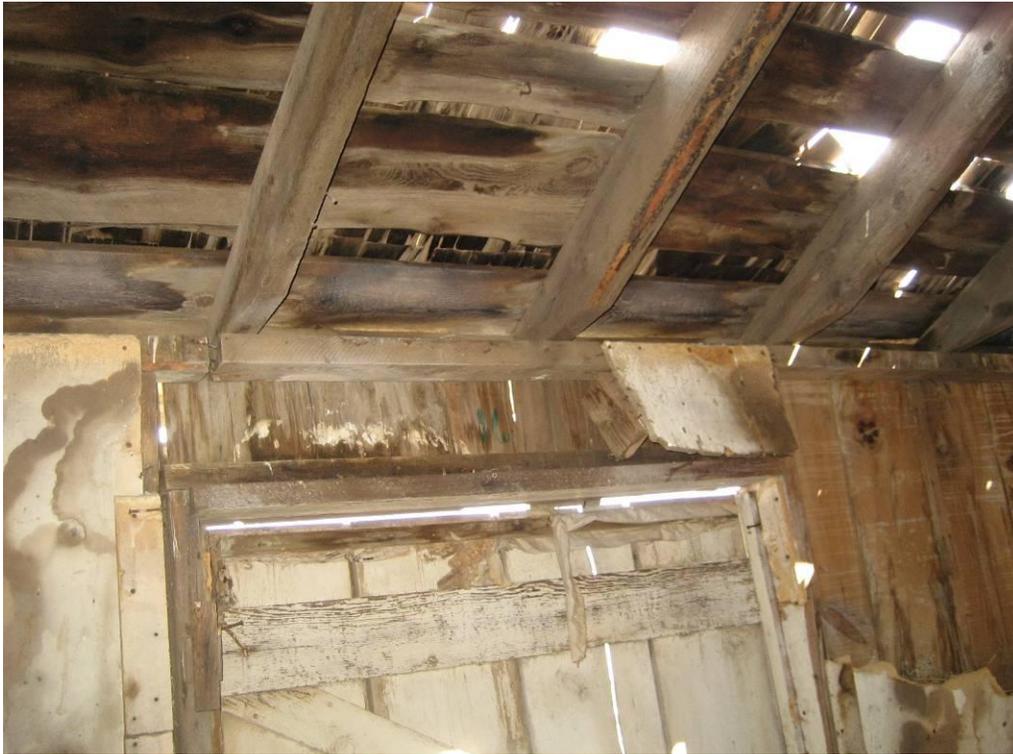
Shed roof framing at north wall; note that plate supporting rafter is not attached to wall framing, 2009.

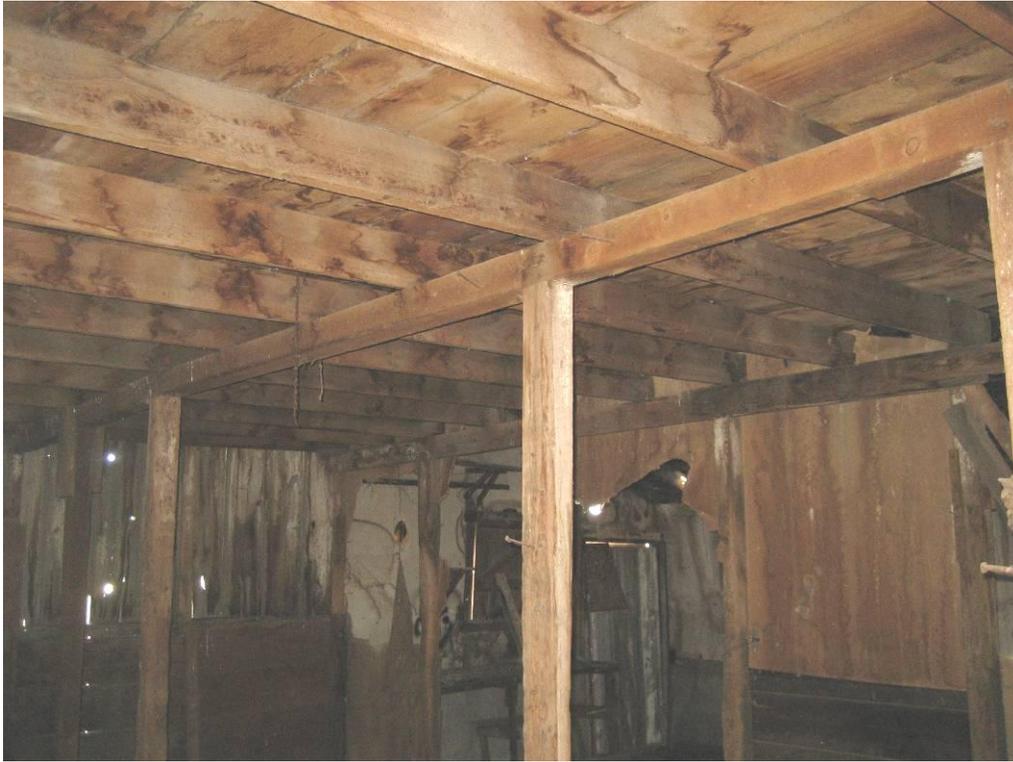
Loft floor framing and intermediate girder; missing posts have been replaced, 2009.

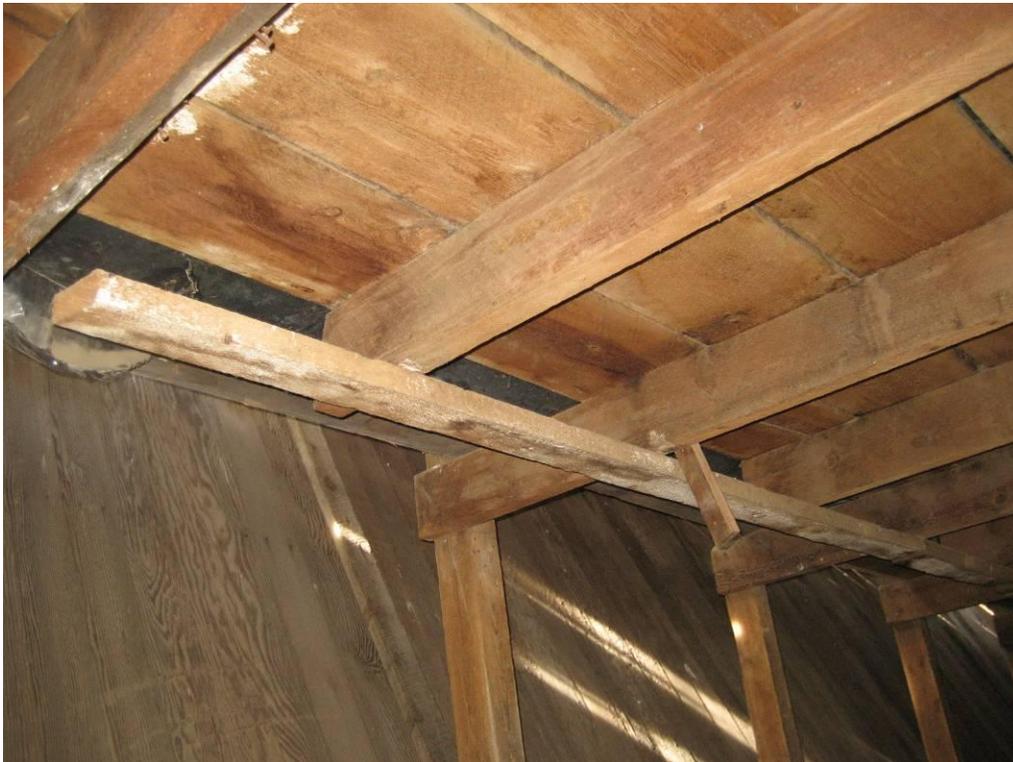
Loft floor framing; south ends inadequately supported by flat 2x4, 2009.

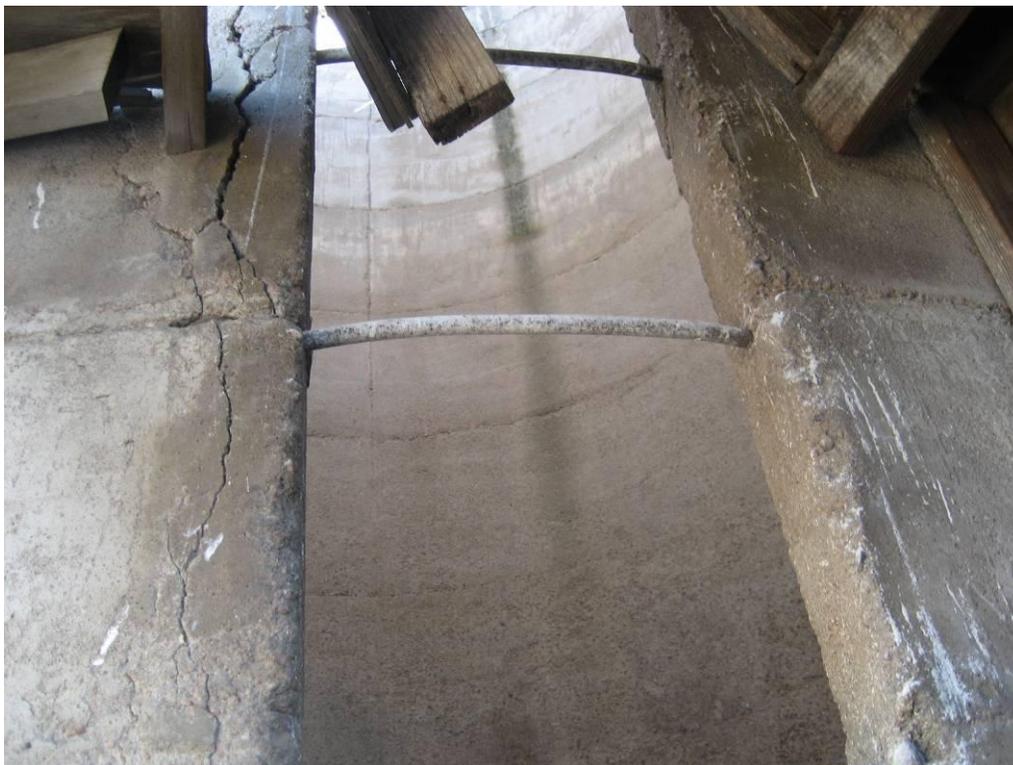
Silo wall cracking inside ladder-way, 2009.

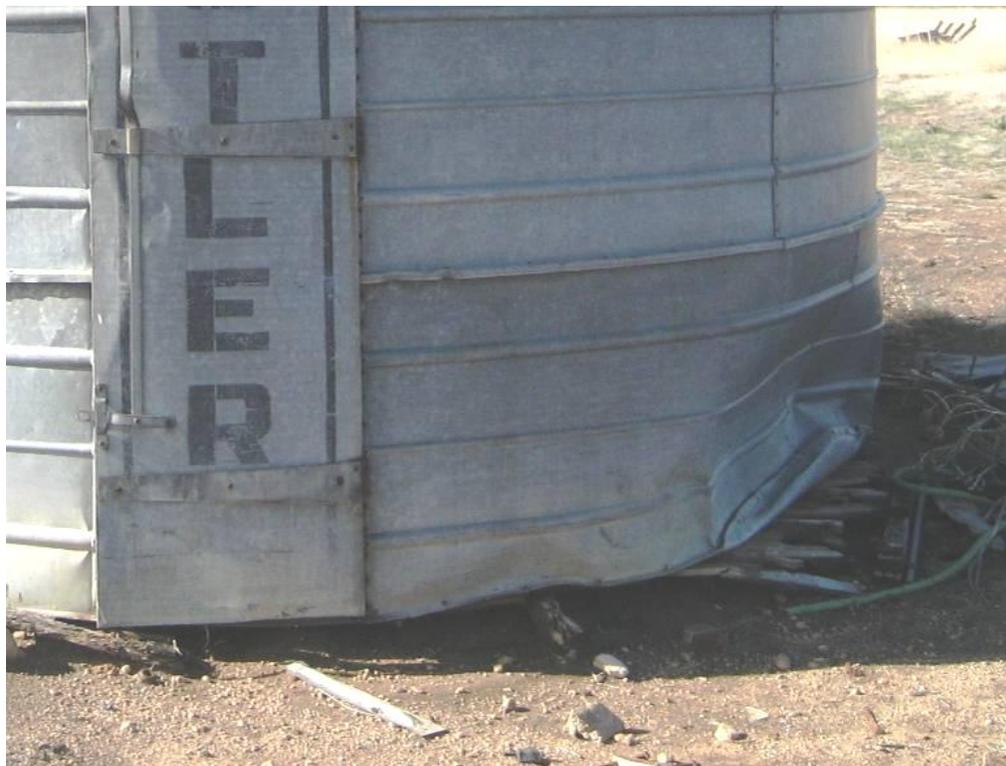
Remnants of wood footing under metal granary at right, 2009.
