Bromley Farm

Master Plan

Historic Structures Assessment

Prepared by:
Avenue L Architects
March 18, 2010

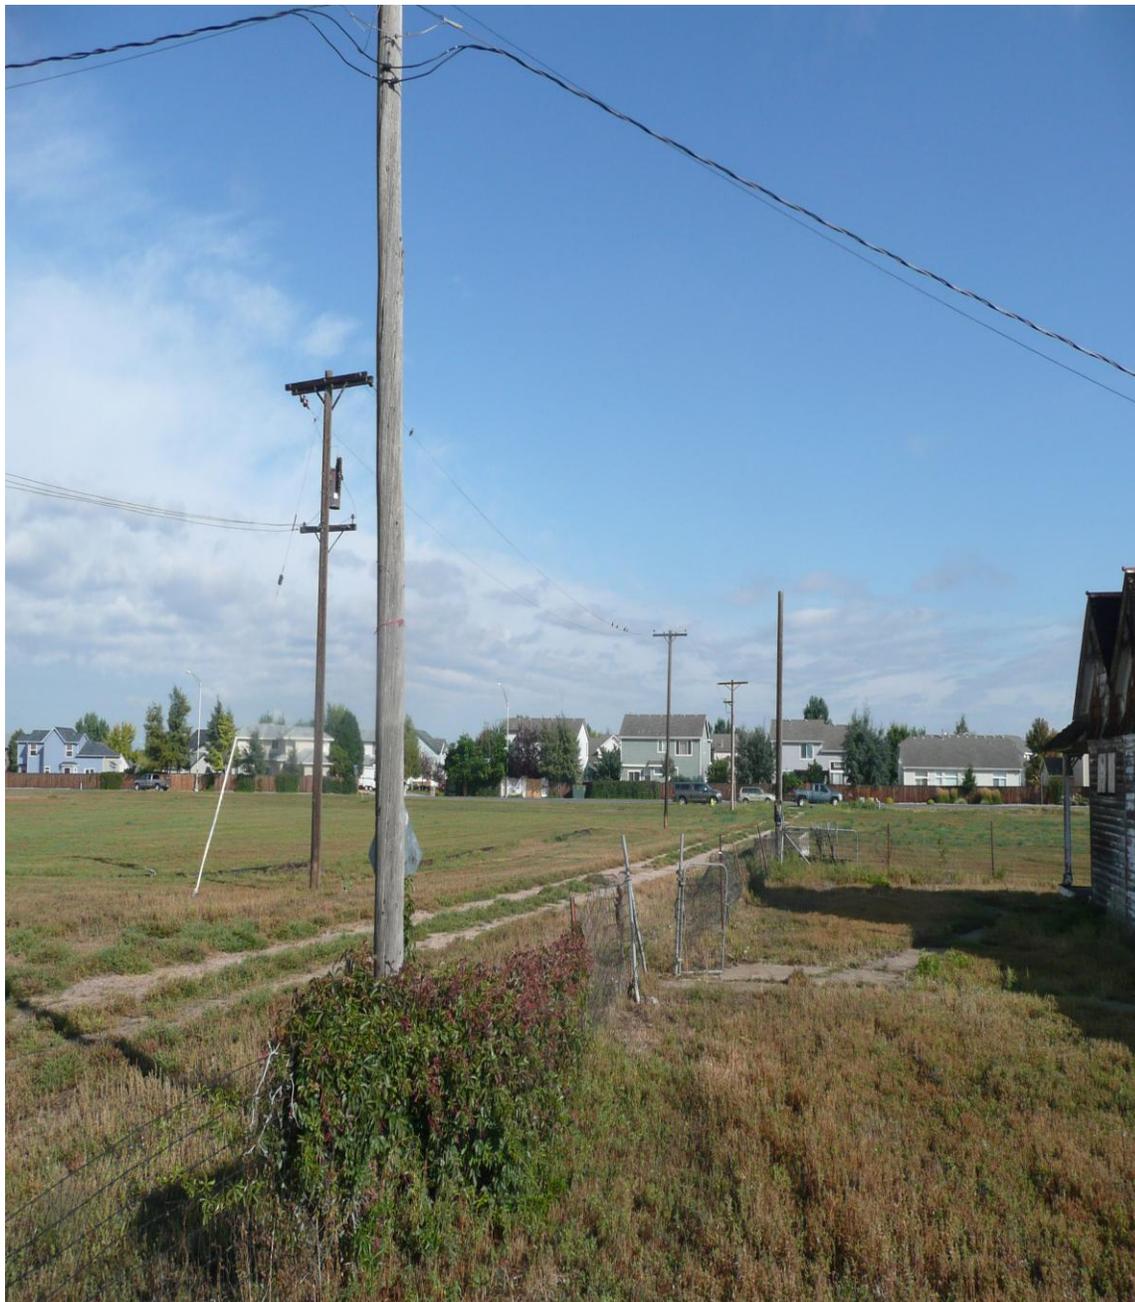
Looking north along gravel entrance drive, 2009

Condition: Poor. The channels and pipe are bent, sagging and rusted. The wire is missing in many locations.

Condition: Fair. The surface is acceptable for minimal use by light vehicles, but it is not acceptable for frequent use. It is not wide enough for Fire Department emergency access. The removal of the cottonwood trees is a loss of a key character-defining feature.

Condition: Poor. The poles are split and leaning. They appear to be in danger of falling down.

Condition: Poor. The wooden enclosure is splitting and nails have popped loose.

- Remove the outdated electrical equipment (see electrical sections).
- Repair, reinforce and stabilize the wooden poles for interpretation.
- Since new electrical systems do not permit the use of similar poles, new electrical distribution should be underground. Above-grade, modern electrical masts would be visually obtrusive.

Recommended Treatment: Reconstruct well housing. Leave well non-functioning.

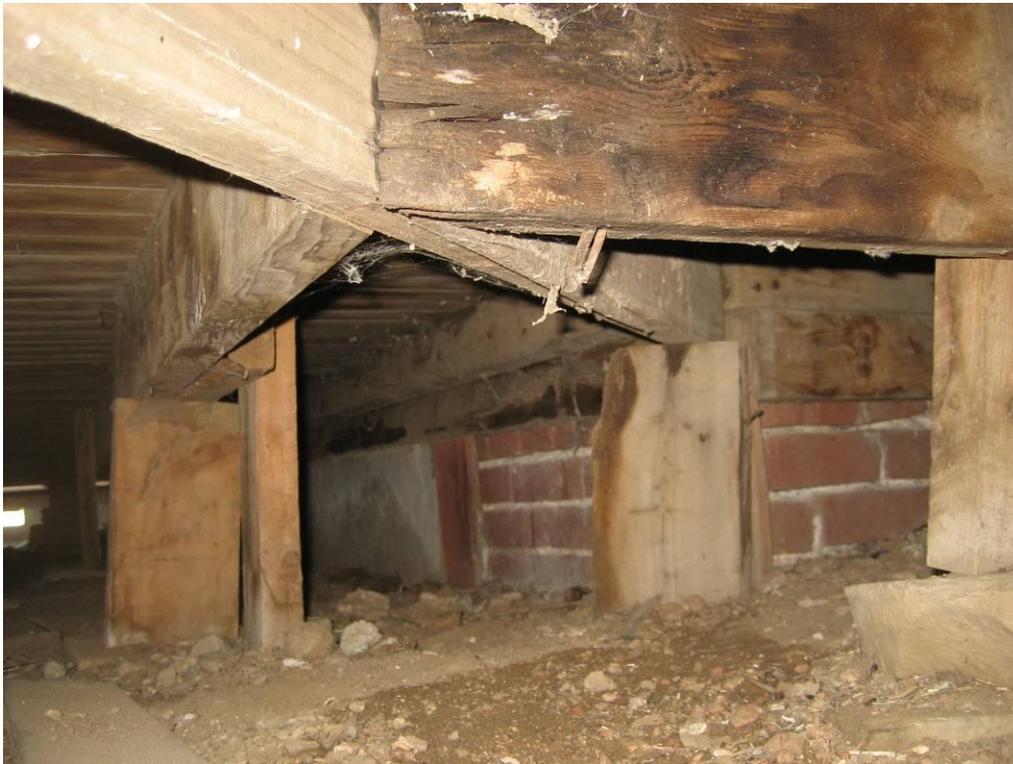
Under NW corner of North Porch; typical brick foundation, concrete foundation beyond, isolated stone footings under posts, 2009.

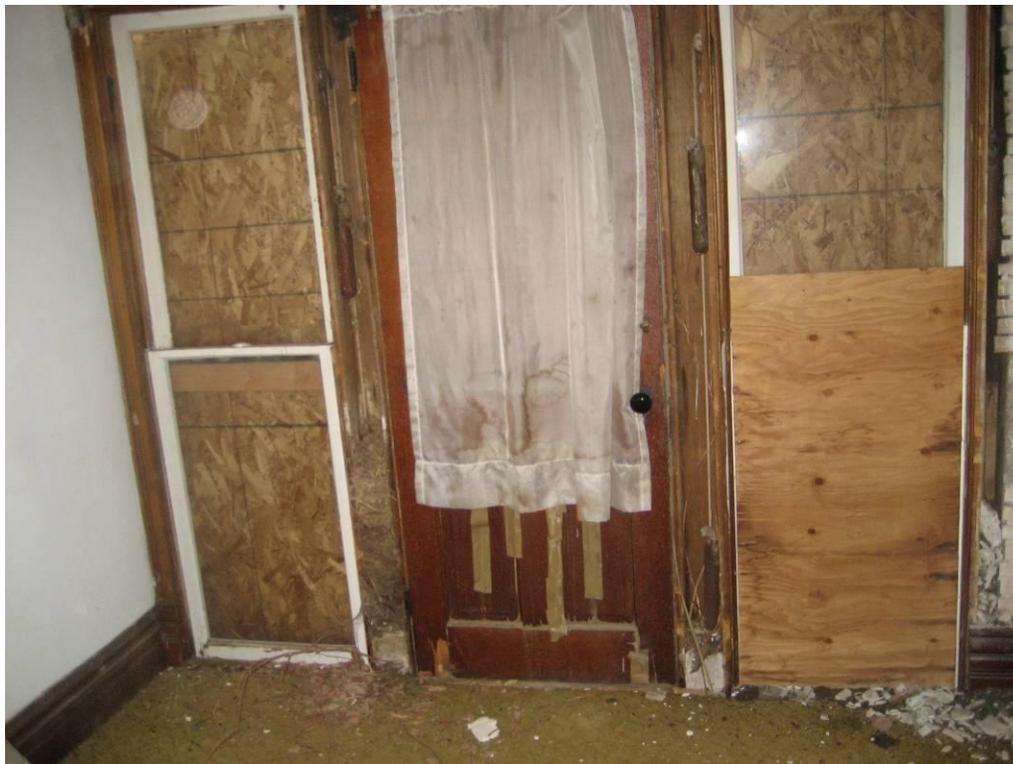
East Entry wall framing; note lack of studs between door and windows, 2009.

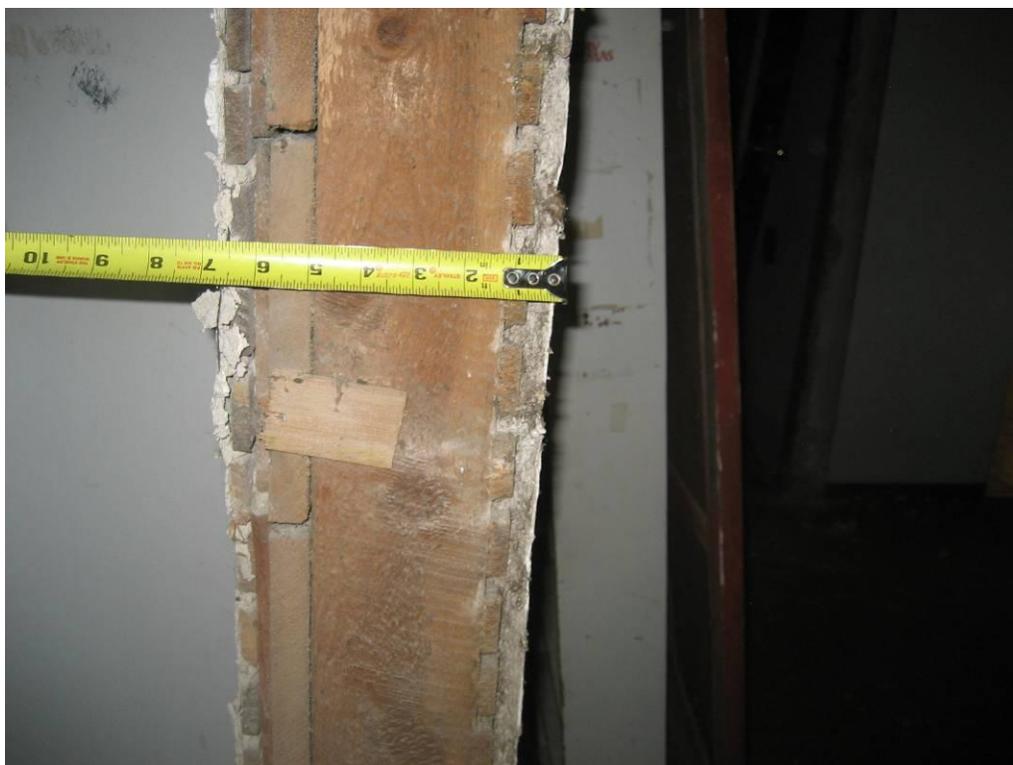
Cross section of typical exterior stud wall. Plaster and lath was added later over 1x horizontal boards at left, 2009.

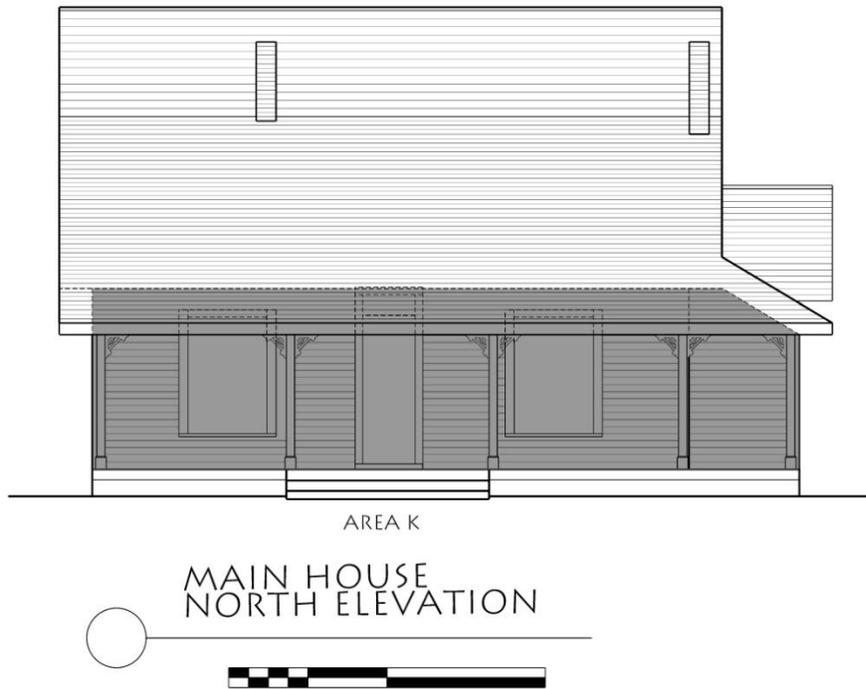
An open, elevated porch projects north from the north wall. The west side of the porch wraps the west face of the north wall. The North Porch deck rests approximately 16” above grade and is covered with 1” x 4” tongue and groove wood over 2” x 6” wood framing at approximately 16” on center. Five 5”x5” wood posts support the projecting roof eave. The four posts to the east are spaced evenly and correspond to the length of the north wall. The fifth post at the west end of the porch has a spacing that corresponds to the projection of the west bays of the Main House. The North Porch soffit is beaded board which coincides with the slope of the roof until it reaches a height of 7’-1” where it becomes horizontal.

Each post has decorative wood brackets set at the top of the post and extending under the roof eave. Many of the 7” high wood trim pieces at the base of each post are missing.

- Rehabilitate porch structure as described in Section 3.1.3, Structural System, Page 3.1.3-3, Sections g and h.
- Reconstruct all missing or damaged wood decking and post base trim. Match the profile and width of existing decking and post base trim
- Remove all loose paint. Paint may contain lead. Sand and prep decking and post base trim.
- Apply primer and two coats high-quality acrylic latex paint. Paint color(s) should be historically accurate.

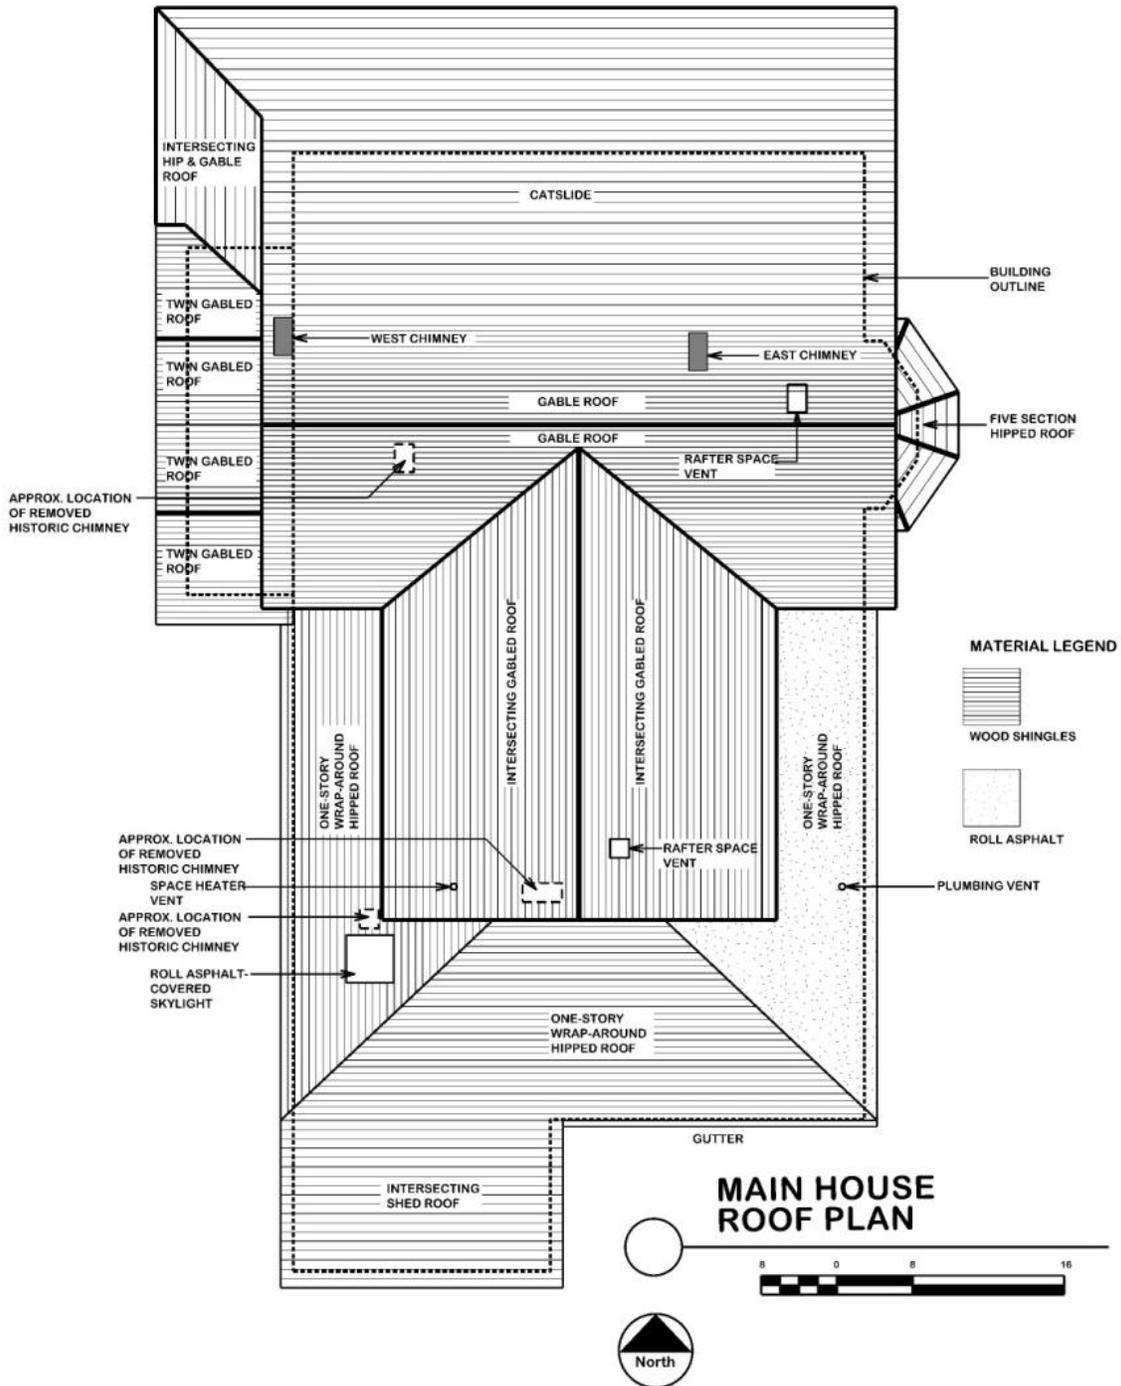
Existing Roof Plan

Gabled main roof. This is the highest and most prominent feature of the Main House. The roof has an east to west orientation and a 12:12 slope. Two layers of wood shingles with approximately 5" exposure cover the roof. The wood shingles rest upon gapped boards. It is assumed that the lower layer of wood shingles is original, because nails on the underside of the gapped board roof sheathing appear original, and there are no other nail holes visible. A painted galvanized metal ridge with ball cap ends divides the north and south faces of the roof. The gable ends project approximately 12" beyond the exterior wall. The gable end is covered with a 1" x 6" painted wood fascia and painted wood gable molding. A painted board soffit is fastened to the underside of the projecting gable. Two brick chimneys project through the north face of the roof. Both chimneys have had their upper courses replaced with a lighter colored, non-matching brick. A painted metal attic ventilator is located on the north face east of the east chimney. There are no gutters or downspouts on this section of roof. There is no visible evidence of the brick chimney located in the closet ceiling of Bedroom #4. An early photograph from the Koizuma-Hishinuma era (Circa 1947) shows this chimney in place. This chimney is not visible in somewhat later photographs (Circa 1950).

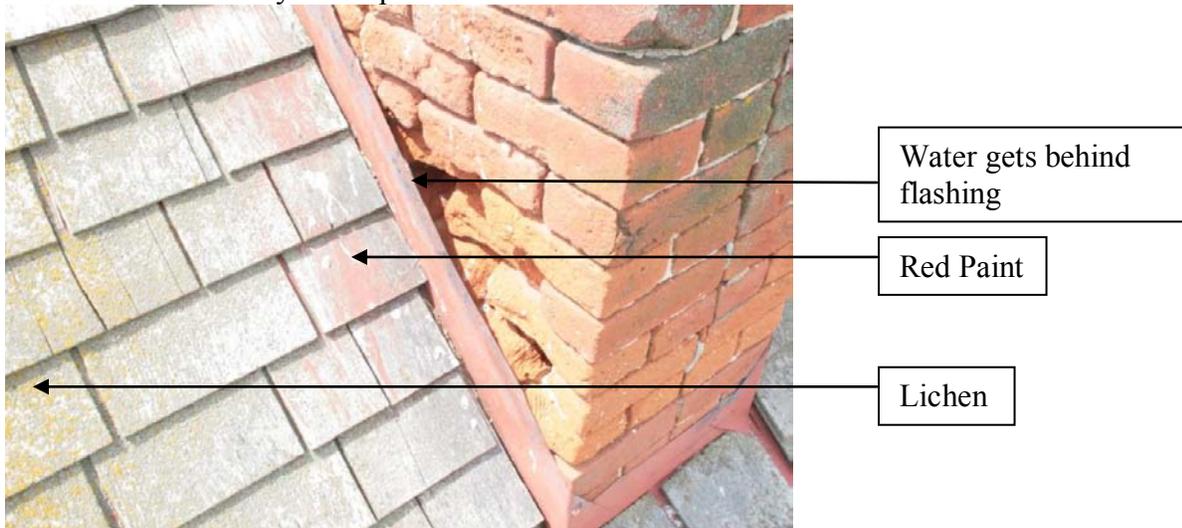
East face east chimney. 2009 photo.

Condition: Roof-fair to poor. Many of the wood shingles are brittle, warped, and/or split. Moss and lichen are also present. These slow down the drying process after rains and accelerate deterioration.

The shingles appear to be near the end of the serviceable life. The attic ventilator is improperly flashed and does not provide enough ventilation to meet current building codes. The gable molding is also very weathered and missing paint.

Chimneys-fair. Masonry joints in both chimneys are deteriorated. This is especially noticeable in the lower, older sections of the chimneys. Chimney caps are concrete or mortar. Testing would be required to determine the exact composition. The east chimney cap is moderately deteriorated. The west chimney cap is almost complete disintegrated. Brick on the lower east face of the east chimney is extremely deteriorated. Because of the deterioration, the flashing which is relatively intact is completely ineffective. There is water damage to the ceiling in the Bedroom #3 closet below this chimney. Flashing on the west chimney at the gabled main roof and north twin gabled roof is not directing water away from the brick. There is extreme water damage to the ceiling in the Bedroom #1 closet adjacent to this chimney.

- Roof -remove all shingles down to gapped board sheathing.
- Install new No. 1 blue label sawn wood shingles. Match size, exposure, nailing pattern, distinctive details, and decorative elements of existing wood shingles. Use a double layer of wood shingles for the starter course.
- Re-flash existing attic vent. Install new vents required to meet code.
- Rehabilitate and reuse the existing galvanized metal ridge with ball cap ends.
- Remove any loose paint from the gable fascia, soffit, and molding. Paint may contain lead. Check them for decay. Consolidate or replace deteriorated areas.
- Sand and prep the fascia, soffit, and molding for new paint.

- Apply primer and two coats high-quality acrylic latex paint. Paint color(s) should be historically accurate.
- Chimney - test mortar and chimney cap material to determine their composition.
- Remove all loose or crumbling mortar in existing joints. Re-point mortar joints using mortar of same composition, color, texture, and strike as the existing historic mortar. Re-pointing should be done by a professional mason specializing in historic masonry. Install new stepped flashing for both chimneys. Install a two-piece cricket above each chimney to facilitate drainage around the chimneys. Replace eroded and loose bricks. Install a new chimney cap for each chimney.

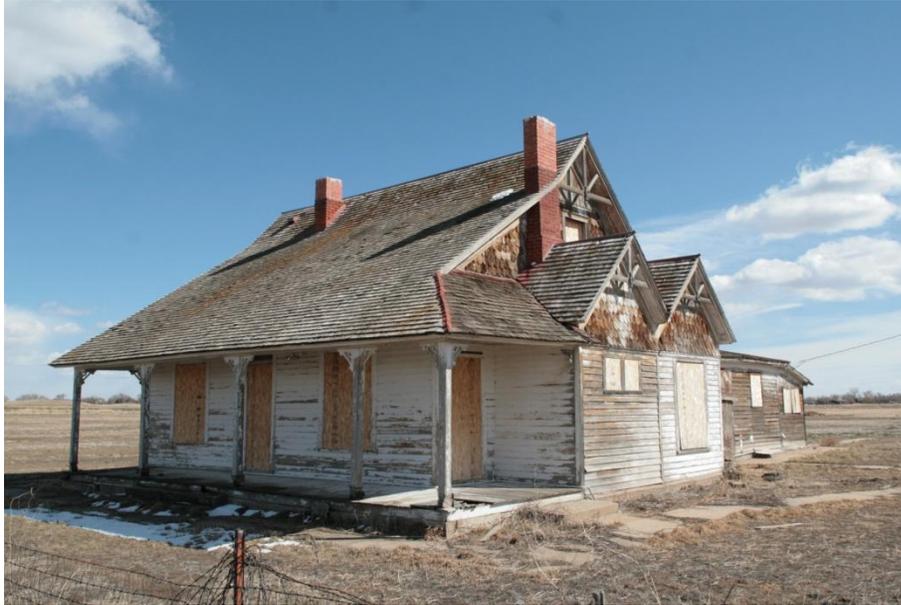
2009 photo.

Catslide. The upper end of the catslide roof begins at the level established by the lower side of the west chimney. At this level the gable roof transitions into the catslide. The slope of the catslide is 8:12. Two layers of wood shingles cover the catslide roof. A hipped roof intersects the catslide at its northwest corner and covers the wrap-around north porch. The south end of this hipped roof then intersects the lower north edge of the north twin gabled roof, which is discussed in the following section. There are no gutters or downspouts on the eaves for the catslide.

Condition: Fair to poor. Many of the wood shingles are brittle, warped, and/or split. While no leaks were visible in the ceiling below, the shingles appear to be near the end of the serviceable life. Moss and lichen are also present. These slow down the drying process after rains and accelerate deterioration. The gable soffit is moderately weathered while the gable fascia is very weathered and missing paint. The gable molding is very weathered and missing paint. The catslide does not have sufficient rafter space ventilation to meet current building code requirements.

- Remove all shingles down to wood deck.
- Install new No. 1 blue label sawn wood shingles. Match size, exposure, nailing pattern, distinctive details, and decorative elements of existing wood shingles. Use a double layer of wood shingles for the starter course.
- Paint may contain lead. Remove any loose paint from the gable fascia, soffit, and molding. Check them for decay. Consolidate or replace deteriorated areas.
- Sand and prep the fascia, soffit, and molding for new paint.
- Apply primer and two coats high-quality acrylic latex paint. Paint color(s) should be historically accurate.
- Install additional rafter ventilation which does not adversely impact the historical appearance and meets current building code requirements. UBC 2006 requires

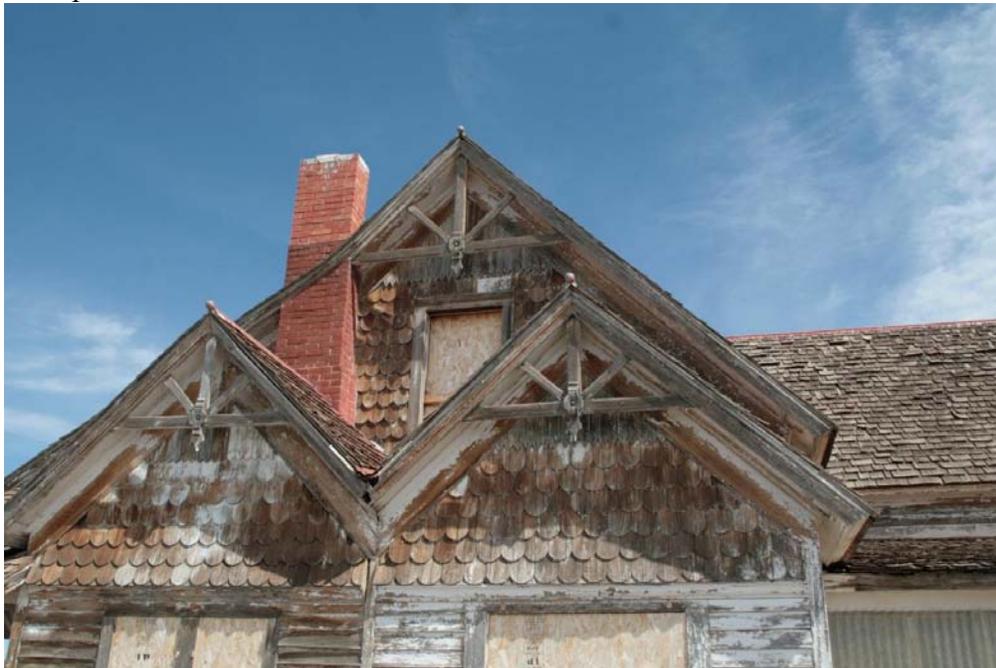
2009 photo.

Twin gabled roof. The symmetry and prominence of the gabled main roof are reinforced by a pair of projecting gabled roofs whose centerline is aligned with the gabled main roof ridge. These are located on the west side of the Main House. Each twin gable roof has a 12:12 slope, galvanized metal ridge with ball capped end, and a proportionally smaller decorative truss with medallion and flat dropped pendant near the gable.

The roofs are covered with a double layer of wood shingles. There are no gutters or downspouts associated with the twin gabled roof.

Condition: Poor. Many of the wood shingles are brittle, warped, and/or split. Moss and lichen are also present. These slow down the drying process after rains and accelerate deterioration. The shingles appear to be near the end of the serviceable life. Water in the valley between the roofs does not drain adequately. This has caused the lower courses of wood shingles in the valley and the intersecting gable ends to deteriorate. Flashing around the chimney is inadequate. This is causing extreme water damage in the ceiling below. (See photographs on page 3.1.5-7.) The gable soffit is moderately weathered while the gable fascia is very weathered and missing paint. The gable molding is also very weathered and missing paint. The twin gable roofs do not have sufficient rafter space ventilation to meet current building code requirements.

- Roof -remove all shingles down to wood deck.
- Install new No. 1 blue label sawn wood shingles. Match size, exposure, nailing pattern, distinctive details, and decorative elements of existing wood shingles. Use a double layer of wood shingles for the starter course.
- Rehabilitate and reuse the existing galvanized metal ridge with ball cap ends.
- Install new valley flashing with a minimum 20" width. The upper end of the valley flashing should be flashed behind the fish-scale shingle rake wall outside Bedroom #3.
- It is recommended that a scupper be installed on the lower end of the valley to conduct water away from the building. A more functional, but also more visually intrusive option would be to install a downspout at this location. This option

- Lead paint may be present. Remove any loose paint from the gable fascia, soffit, and molding. Check them for decay. Consolidate or replace deteriorated areas.
- Sand and prep the fascia, soffit, and molding for new paint.
- Apply primer and two coats high-quality acrylic latex paint. Paint color(s) should be historically accurate.
- Install additional rafter ventilation which does not adversely impact the historical appearance and meets current building code requirements.

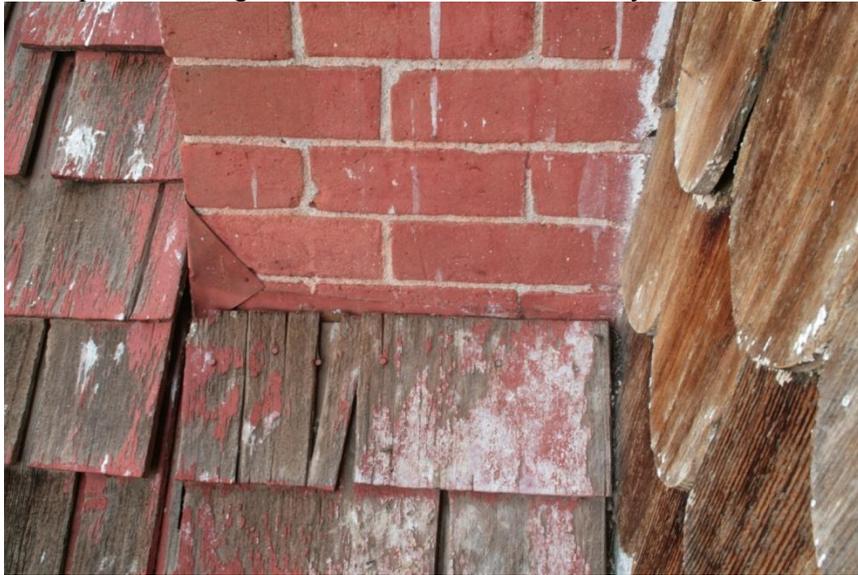
2009 photo.

Inadequate flashing on south face of west chimney at twin gable roof

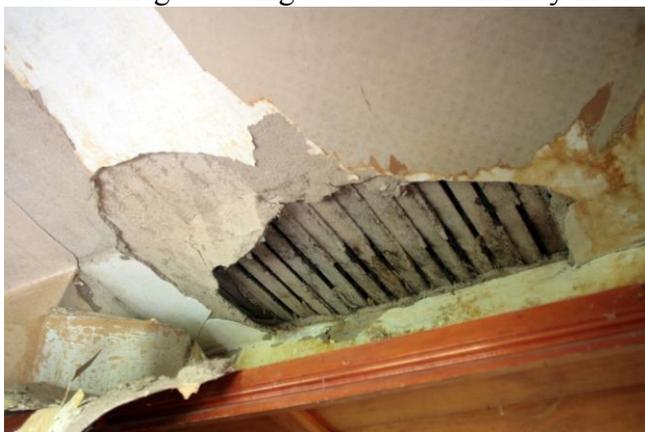
2009 photo.

Water damaged ceiling below west chimney in closet west of Bedroom #1

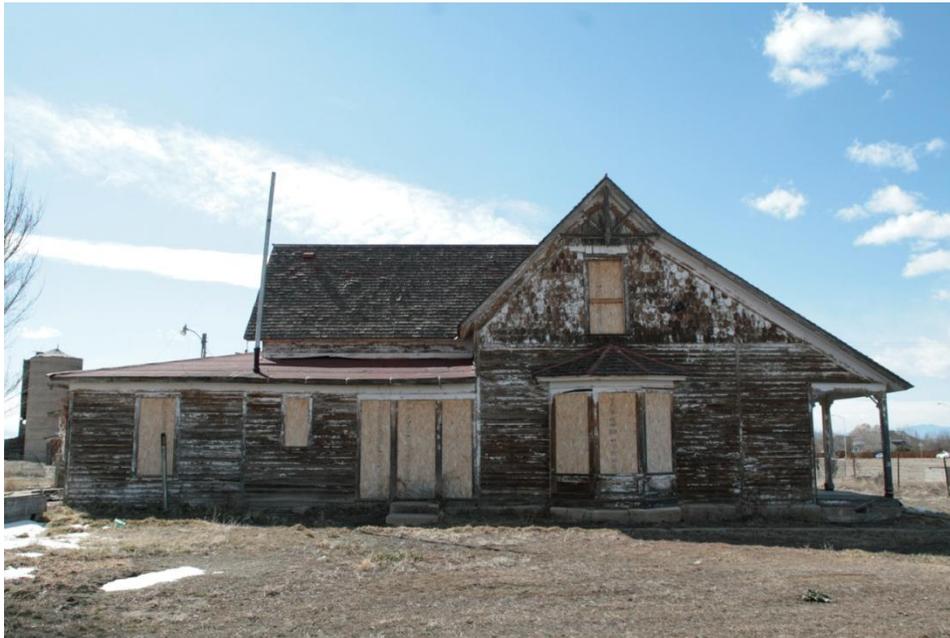
Five section hipped roof.

On the east side of the Main House the roof symmetry is reinforced by a projecting bay window covered with a five section hipped roof. The centerline of the bay window and the peak of its roof are aligned with the ridge of the gabled main roof. The roof is covered with wood shingles with a 5" exposure. A galvanized metal ridge covers the intersection between each roof section. There are no gutters or downspouts associated with this roof.

Condition: Poor. Many of the wood shingles are brittle, warped, and/or split. While no leaks were visible in the ceiling below, the shingles appear to be near the end of their serviceable life. The roof fascia and molding are moderately weathered and missing paint.

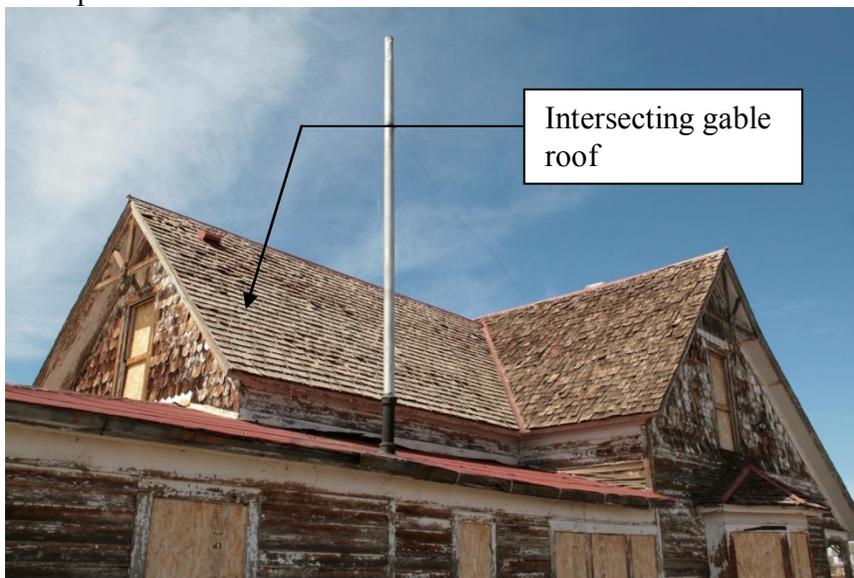
Intersecting gable roof.

An intersecting gabled roof with north to south orientation meets the gabled main roof on its south face. This roof also has a 12:12 slope and a decorative wood truss with medallion and flat dropped pendant at its south gable end. The roof is divided by a galvanized metal ridge with a ball cap at the south end. This roof is slightly lower and less prominent than the gabled main roof, but still dominates the

south façade of the Main House. It is covered with two layers of wood shingles with a 5” exposure. There are no gutters or downspouts associated with the intersecting gable roof.

Condition: Poor. Many of the wood shingles are brittle, warped, and/or split. Moss and lichen are also present. These slow down the drying process after rains and accelerate deterioration. Roof leakage was visible in the ceiling below Bedroom #5. The shingles appear to be near the end of their serviceable life. The existing attic vent does not provide enough ventilation to meet current building codes. The gable soffit is moderately weathered while the gable fascia is very weathered and missing paint. The gable molding is very weathered and missing paint.

- Rehabilitate and reuse the existing galvanized metal ridge with ball cap ends.
- Lead paint may be present. Remove any loose paint from the gable fascia, soffit, and molding. Check them for decay. Consolidate or replace deteriorated areas.
- Sand and prep the fascia, soffit, and molding for new paint. Apply primer and two coats high-quality acrylic latex paint. Paint color(s) should be historically accurate.

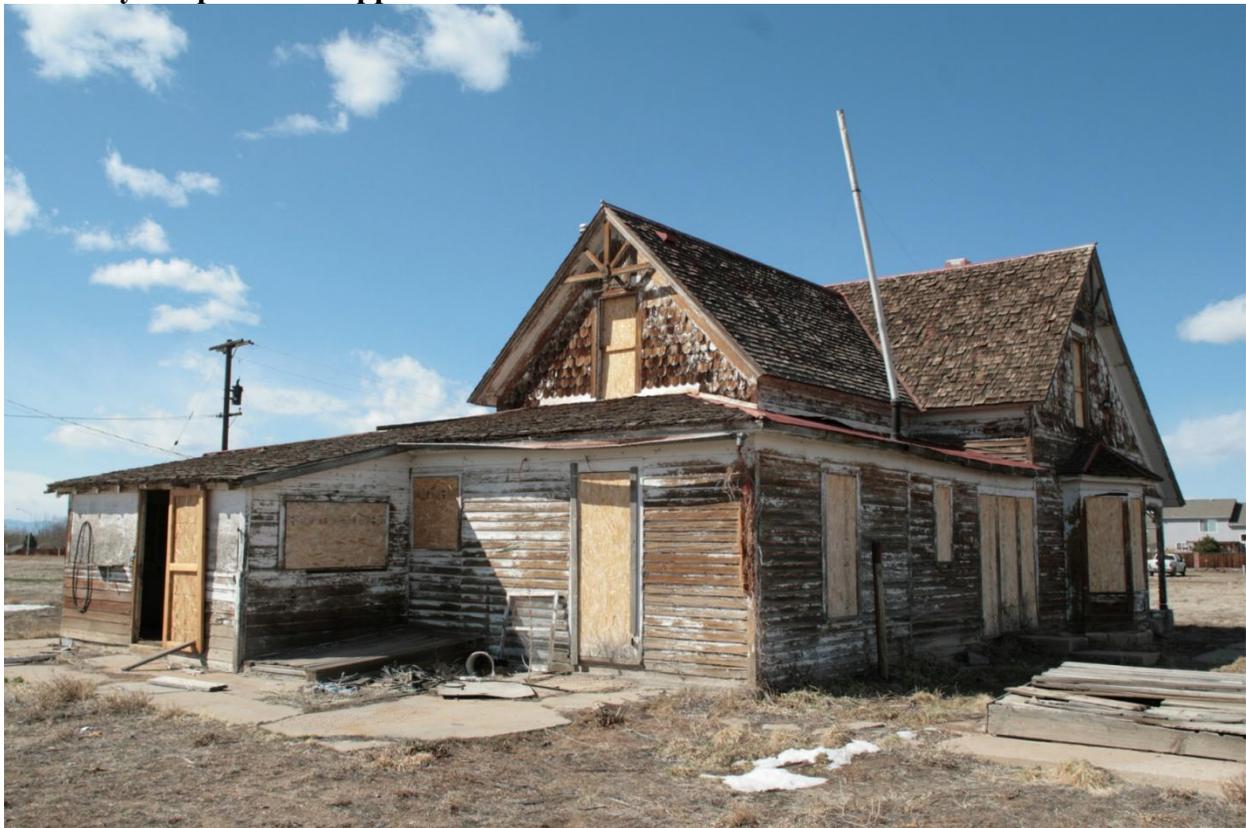
One-story wrap around hipped roof.

Below the intersecting gable roof on the east, south, and west sides is a one-story, wrap around hipped roof. The slope of the hipped roof is approximately 3.5:12. The east side of this roof is covered with asphalt roll roofing. The south and west sides of the roof are covered with two layers of wood shingles. The attic space below the roof was not accessible, therefore the nail ends penetrating the roof sheathing could not be observed. It could not be determined if the asphalt roll roofing on the east roof or the wood shingles on the south and west roofs are the original roof coverings. The west and south sides of the wrap around hipped roof display the

Condition: Poor. Many of the wood shingles are brittle, warped, and/or split. Moss and lichen are also present. These slow drying after rains and accelerate deterioration. While no leaks were visible in the ceilings below, the shingles appear to be near the end of the serviceable life. The metal roof ridge trim on the southwest side of the roof is detached and bent. (See photograph on the next page.) The asphalt roll roofing on the east side is extremely weathered and in poor condition. It may also be a departure from the historic appearance of the Main House. The wood fascia and soffit are extremely weathered and in very poor condition on all three sides of the roof. This is due to the shallow slope of the roof and the lack of an adequate drip edge to conduct the water away from the fascia and soffit. The gutter is in very bad condition and does not serve

its purpose. The one-story wrap around hipped roof does not have sufficient rafter space ventilation to meet current building code requirements.

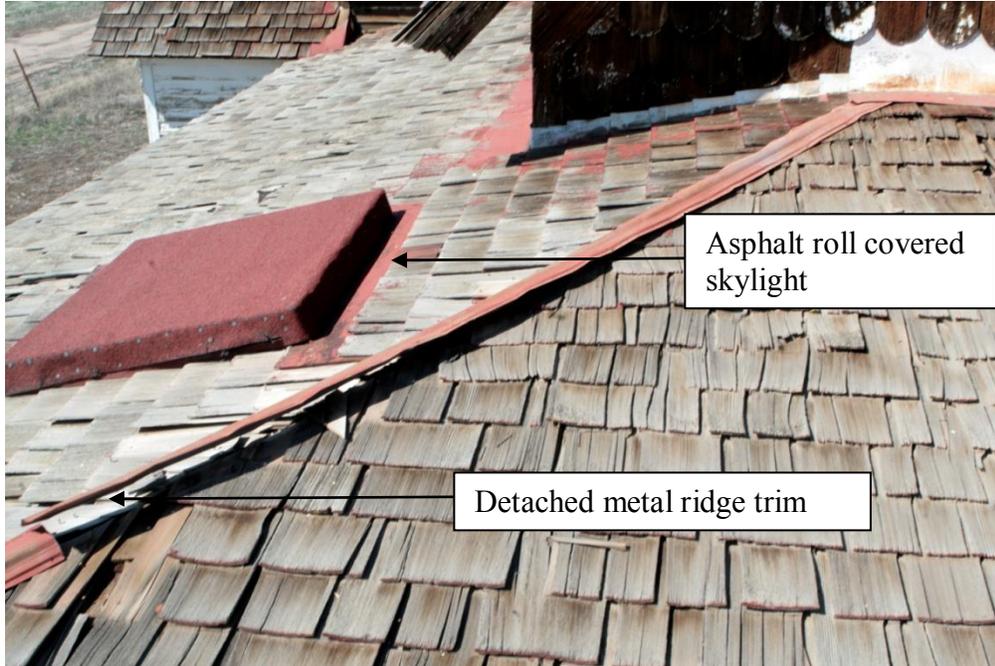
Detached metal roof trim on southwest side of roof.

Recommended treatment:

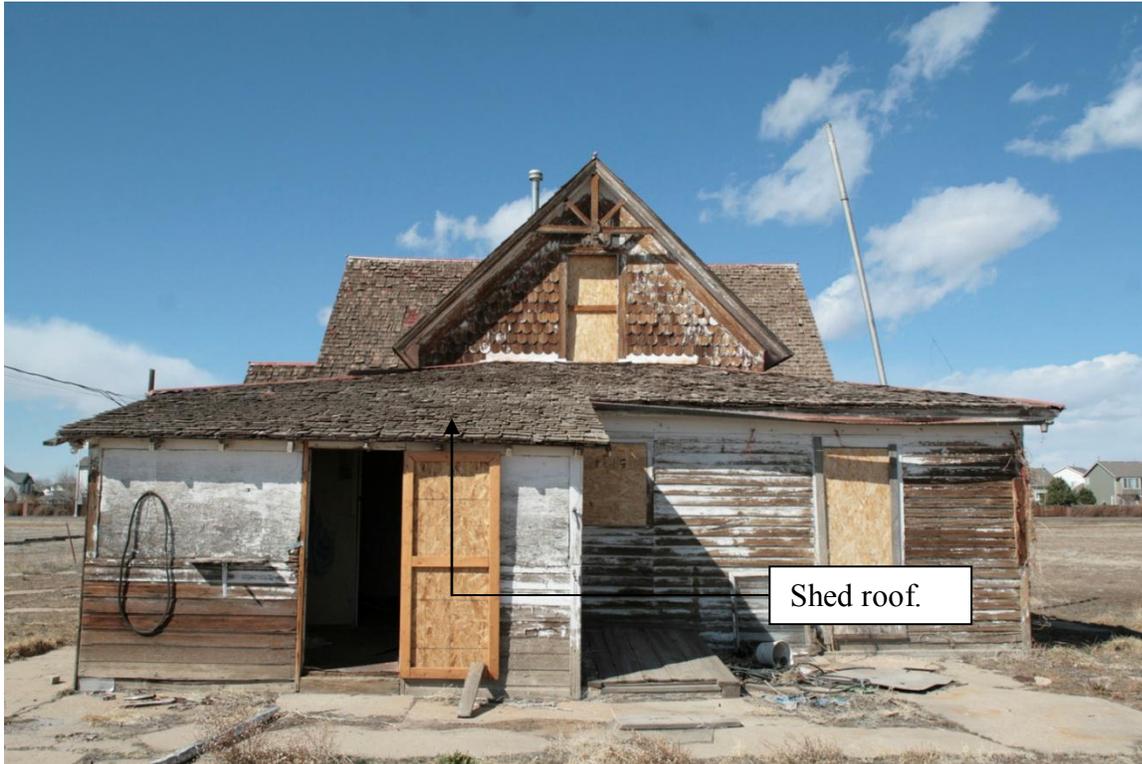
Shed roof.

A shed roof intersects the one-story, wrap around hipped roof at its southwest corner. This roof covers the South Porch. It has a very shallow 1.7:12 slope. This roof is covered with wood shingles with a 5" exposure. There are exposed rafter ends on the south side and a shallow wood fascia board below the roof on the east and west sides of the porch. Roof sheathing for this roof area was not visible and could not be determined. In historic photos circa 1947 the shed roof material appears to match the wood shingle roof of the wrap around hipped roof. There are no known earlier photographs which show the shed roof.

Condition: Poor. Many of the wood shingles are brittle, warped, and/or split. Moss and lichen are also present. These slow down the drying process after rains and accelerate deterioration. While no leaks were visible in the ceiling below, the shingles appear to be near the end of their serviceable life. The fascia boards are very weathered and missing paint. The exposed rafter ends are also in poor condition.

- Due to the shallow slope of the roof it is recommended that new wood shingles be installed over new cedar breather over new 30# felt over new ice and water guard over new solid wood sheathing. This would be a much more durable roof than the current roof.
- Replace the wood fascia boards on the east, south, and west sides. Metal eave flashing with a drip edge should be installed below the new roof material to help direct water away from the new fascia boards.

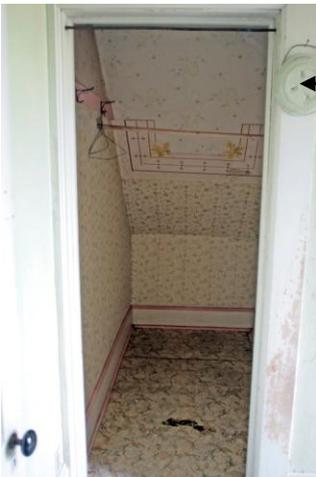
A chimney stack is located in the northwest corner of the closet in Bedroom #4 on the second floor. There is an opening for an exhaust vent to this chimney on the northwest face of the outside wall for this closet. At an early time there was probably a coal fired or woodstove located in this bedroom. There are no chimneys or vent openings visible currently in the Kitchen. Based upon the historic photograph the exhaust vent appears to be near the north wall.

Opening in Bedroom #4 Closet wall for exhaust vent from removed heater.

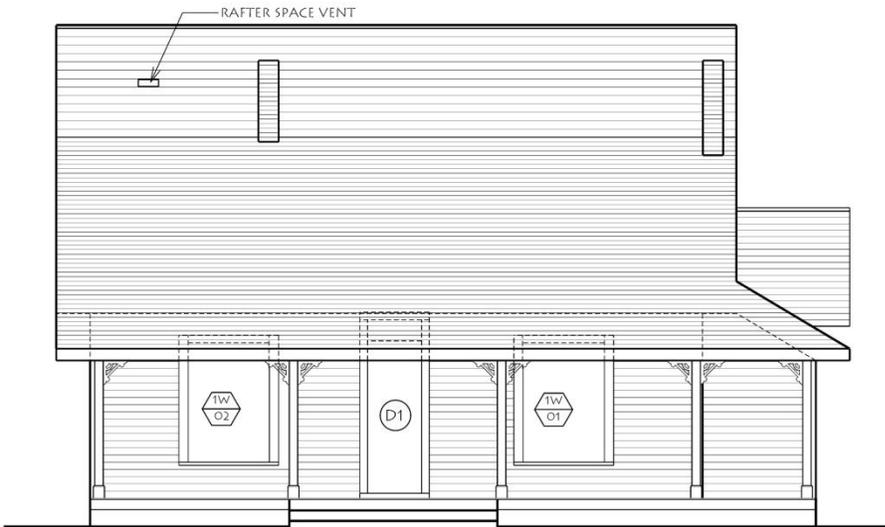
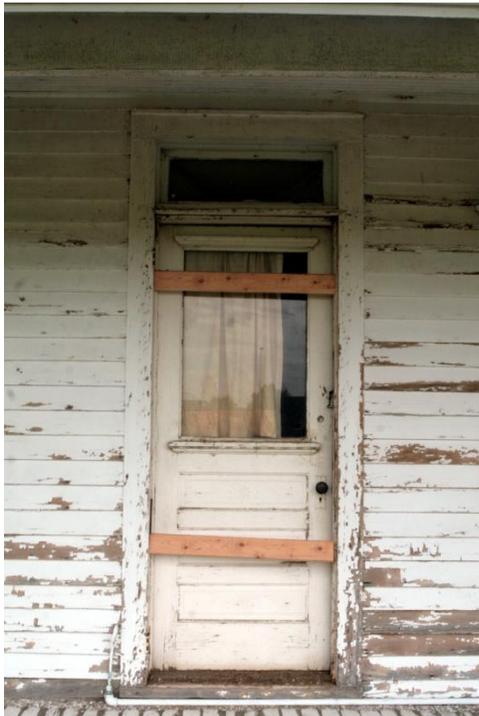
Door D1. 2009 Photo.

Condition: The exterior finish of the door and frame is moderately weathered. The interior finish is slightly worn. Exterior wood trim is moderately weathered, but sound. This opening is currently protected with a particle board inset on the exterior side. Interior trim is slightly worn.

Thick, non-historic carpet prevents the door from completely opening. The historic latch set is operable, but the door is missing its thumb turn.

Recommended treatment: Inventory the historic screen doors stored in the Main House to determine if the screen door for door D1 still exists. (If it cannot be located, a new, historically accurate screen door based upon historic photographs should be fabricated and installed.) Paint may contain lead. Remove all loose paint on the exterior face of the door, frame, and the exterior trim. Sand and prep. Repaint with two coats high quality acrylic latex paint. On the interior sand and prep the door, frame, and trim. Refinish with new clear finish. If possible, install weather strip at head, jamps, and sill. Rehabilitate the latch set. Install a new historically accurate thumb turn. Remove carpet and underlayment to make the door operable.

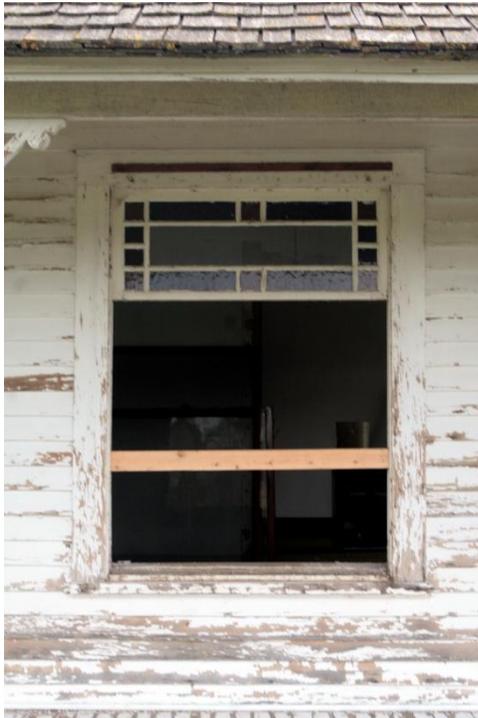
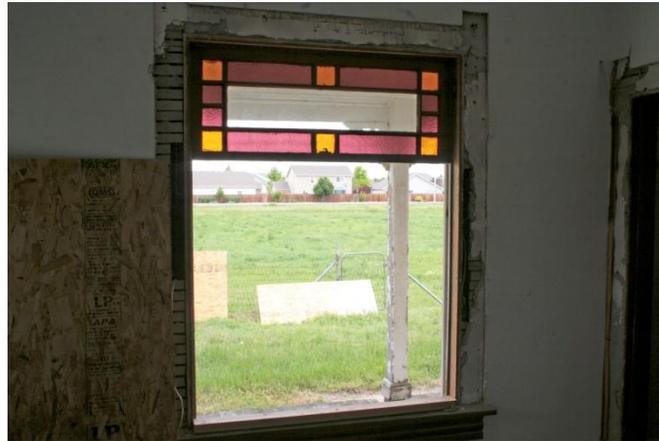
Exterior and interior photos window 1W-01. - 2009.

Condition: The exterior finish of the window and frame is moderately weathered, but the wood is sound. The interior finish is slightly worn. Exterior wood trim is moderately weathered, but sound. Interior trim is slightly worn. The window is not operable and not water tight because the lower sash is removed. This opening is currently protected with a particle board inset on the exterior side.

Recommended treatment: Inventory the windows stored on site. If this historic window and screen can be located, they should be repainted and installed. (If they cannot be located, a new, historically accurate window and screen should be fabricated and installed.) Paint may contain lead. Remove all loose paint on the exterior face of the sash, frame, and the exterior trim. Sand and prep. Install new glazing putty for all lights. If possible, install weather strip at head, jambs, and sill. Repaint with two coats high quality acrylic latex paint. On the interior sand and prep the sash, frame, and trim. Refinish with new clear finish. Reinstall the removed trim and lower sash. Replace sash cords and counter weights. Restore and reinstall all stops. Restore window and hardware to operable and functional condition.

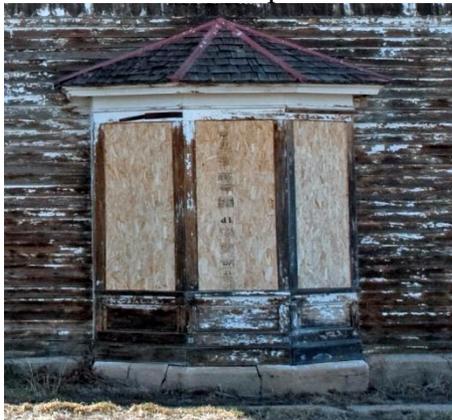
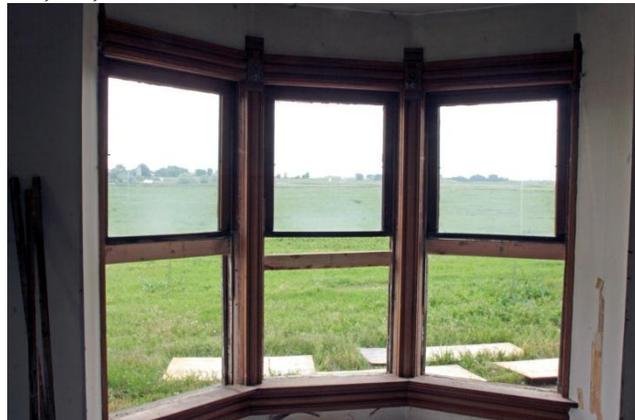
Exterior and interior photos of Windows 1W-03, 04, 05.- 2009 Photos.

Condition: The exterior finish of the window and frame are moderately weathered, but the wood is sound. The interior finish is slightly worn. Exterior wood trim is extremely weathered. Interior trim is slightly worn. The window is not operable and not water tight because the lower sash is removed. This opening is currently protected with a particle board inset on the exterior side.

Window 1W-04. This window is identical to 1W-03 except that the upper sash glazing is cracked and should be replaced. Refer to the section above for 1W-03.

Recommended treatment: Inventory the windows stored on site. If these historic windows and screens can be located, they should be repainted and installed. (If they cannot be located, a new, historically accurate window and screen should be fabricated and installed.) Paint may contain lead. Remove all loose paint on the exterior face of the sash, frame, and the exterior trim. Consolidate or splice in new wood where the existing trim and sash are rotted or damaged. Sand and prep. Install new glazing putty for all lights. Repaint with two coats high quality acrylic latex paint. On the interior sand and prep the sash, frame, and trim. Restore with new clear finish. Restore the removed lower sash. Replace sash cords and counter weights. Refinish and reinstall all stops. If possible, install weather strip at head, jambs, and sill. Restore windows and hardware to operable and functional condition. Inventory all windows stored on the site. If these historic wood screens can be located, they should be protected and installed. If they cannot be located, new, historically accurate wood screens should be fabricated and installed.

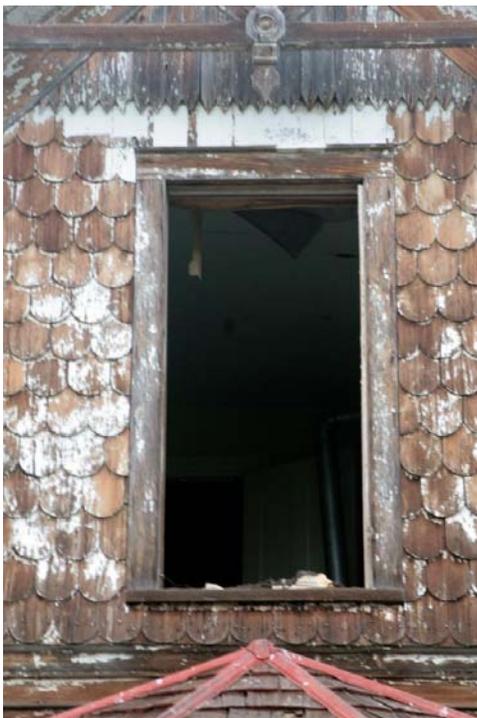
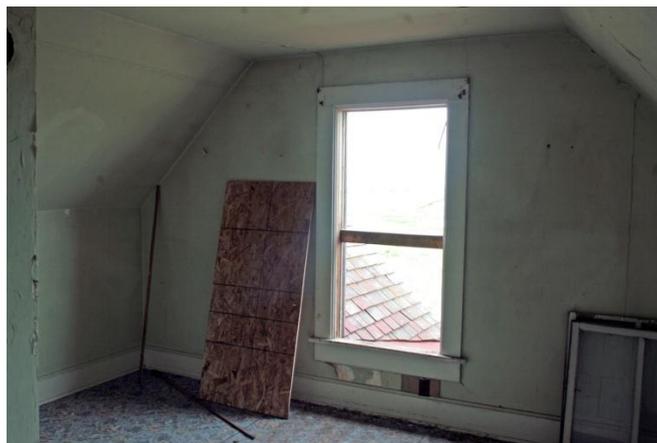
Windows 2W-01, 2W-02, and 2W-03. 2009 Photos.

Condition: The exterior finish of the window and frame is moderately weathered, but the wood is sound. The interior finish is slightly worn. Exterior wood trim is extremely weathered. Interior trim is slightly worn. The window is not operable and not water tight because both sash have been removed. These openings are currently protected with a particle board inset on the exterior side.

Recommended treatment: Inventory the windows stored on site. If these historic windows and screens can be located, they should be repainted and installed. (If they cannot be located, a new, historically accurate window and screen should be fabricated and installed.) Paint may contain lead. Remove all loose paint on the exterior face of the sash, frame, and the exterior trim. Consolidate or splice in new wood where the existing trim and sash are rotted or damaged. Sand and prep. Install new glazing putty for all lights. Repaint with two coats high quality acrylic latex paint. On the interior sand and prep the sash, frame, and trim. Paint. Reinstall the removed upper and lower sash. Replace sash cords and counter weights. Restore and reinstall all stops. Restore windows and hardware to operable and functional condition.
