Bromley Farm

Master Plan

Historic Structures Assessment

Prepared by:
Avenue L Architects
March 18, 2010

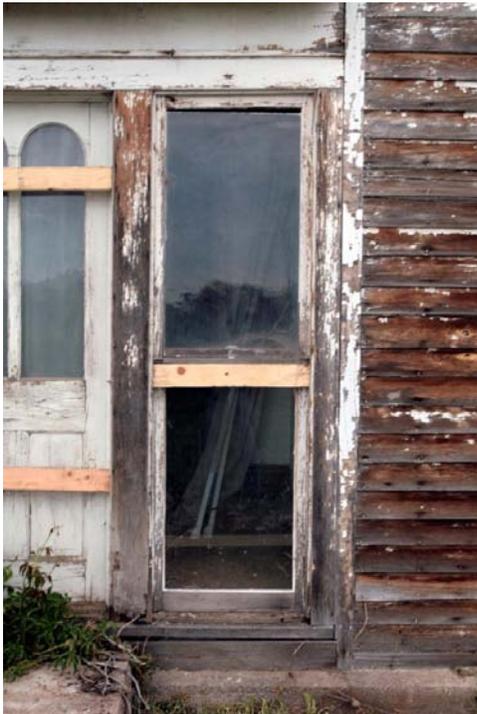
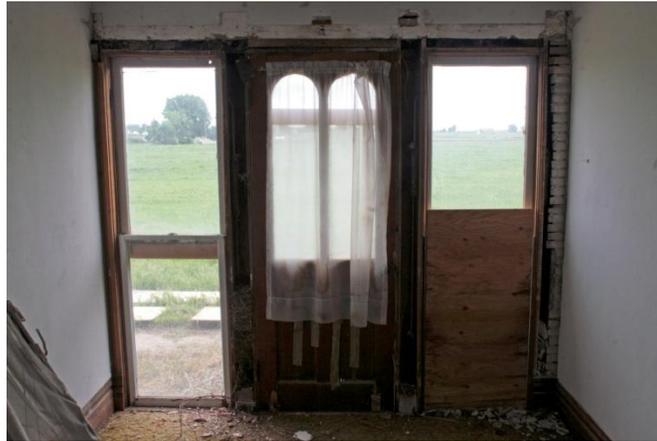
Windows 1W-06 and 1W-07 and door D2. . 2009 Photos

Condition: The exterior finish of the window and frame is moderately weathered, but the wood is sound. The interior finish is slightly worn. Exterior wood trim is also moderately weathered. The lower ends of two vertical pieces of exterior wood trim are rotted. The windows are not operable and not water tight because stops and the lower sash of 1W-07 have been removed. These openings are currently protected with particle board insets on the exterior side.

Condition: The exterior of the door, frame, and the exterior trim are extremely weathered. The wood bottom rail, locking rail, and the lower ends of both stiles are rotted and loose. Some of the exterior wood trim is rotted in places. Daylight is visible through the south panel at its base from the inside. The interior finish on the door is in poor condition. Interior trim could not be evaluated, because it has been removed. The thick, non-historic carpet inside the door would prevent it from opening completely. The historic latch set, thumb turn, and hinges are in place. It could not be determined if the latch set and dead bolt were operable.

Recommended treatment: Inventory the windows and interior trim stored on site. If the missing historic sash, interior trim, and screens can be located, they should be refinished and installed. (If they cannot be located, a new, historically accurate sash, interior trim, and screens should be fabricated and installed.) Paint may contain lead. Remove all loose paint on the exterior face of the sash, frame, and the exterior trim. Splice new wood on to the vertical trim with rotted bottom ends. Sand and prep. Install new glazing putty for all lights. Repaint with two coats high quality acrylic latex paint. On the interior sand and prep the sash, frame, and trim. Refinish with new clear finish. Reinstall the removed trim and lower sash. Replace sash cords and counter weights. Restore and reinstall all stops. If possible, install weather strip at head, jambs, and sill. Restore window and hardware to operable and functional condition.

Recommended treatment: Inventory the screen doors stored on site. If this historic screen door can be located, it should be repainted and installed. (If it cannot be located, a new, historically accurate

screen door should be fabricated and installed.) Paint may contain lead. Remove all loose paint on the exterior face of the door, frame, and the exterior trim. Splice new wood or consolidate rotted trim. Consolidate and/or reconstruct door bottom rail, locking rail, stiles, and panels. Sand and prep. Repaint exterior face with two coats high quality acrylic latex paint. Sand, prep, and stain the interior face of the door. Apply clear finish. Locate interior trim and sand, prep, and refinish with new clear finish. Reinstall the removed trim. Refinish and reinstall all stops. If possible, install weather strip at head, jambs, and sill. Remove carpet so that door does not bind when it is opened. Restore so that the door is operable and that its locking hardware is functional.

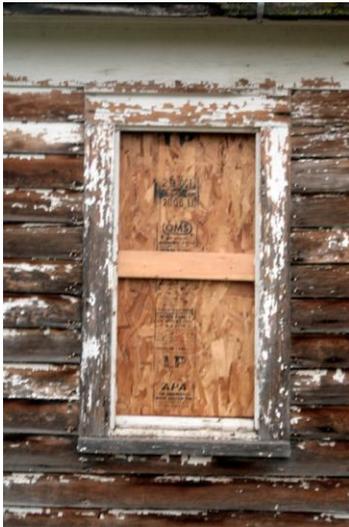
Window 1W-08.

Condition: The exterior frame and trim are extremely weathered. The head trim piece is warped and split at the north edge. Interior wood frame and trim are only slightly worn. The window is not operational or weather tight, since the upper and lower sash are missing.

Recommended treatment: Inventory the windows stored on site. If the historic window sash can be located, it should be refinished and installed. (If it cannot be located, a new, historically accurate upper and lower sash should be fabricated and installed.) Assuming they are found remove all loose paint on the exterior face of the frame and the exterior trim. Consolidate or splice in new wood at the damaged areas of the exterior head trim piece. Paint may contain lead. Sand and prep. Install new glazing putty for all lights. If possible, install weather strip at head, jambs, and sill. Paint the upper and lower sash, frame, and wood trim with two coats high quality acrylic latex paint. On the interior sand and prep the sash, frame, and trim. Paint. Reinstall the upper and lower sash. Replace sash cords and counter weights. Refinish and reinstall all stops. Restore window and hardware to operable and functional condition.

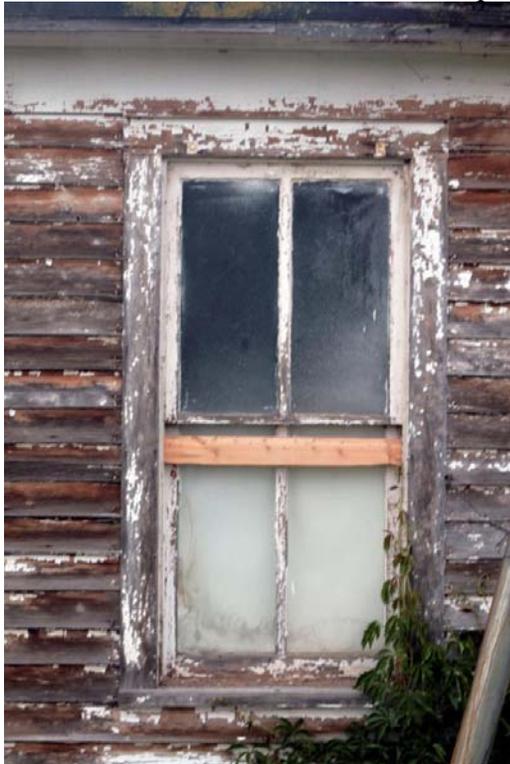
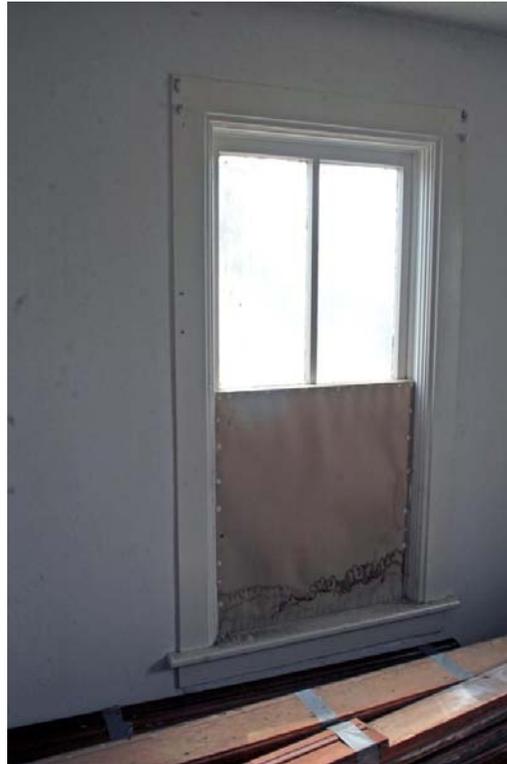
Window 1W-09 exterior and interior photos. 2009

Condition: The exterior finish of the sash, frame, and trim is extremely weathered, but the wood is sound. The interior finish is slightly worn. The lower, south-side light is broken. The window is not currently operable.

Recommended treatment: Inventory the windows stored on site. If this historic screen can be located, it should be repainted and installed. (If it cannot be located, a new, historically accurate screen should be fabricated and installed.) Paint may contain lead. Remove all loose paint on the exterior face of the sash, frame, and the exterior trim. Sand and prep. Replace broken glass pane. Install new glazing putty for all lights. Repaint with two coats high quality acrylic latex paint. On the interior sand and prep the sash, frame, and trim. Paint. Remove, rehabilitate, and reinstall all stops. If possible, install weather strip at head, jambs, and sill. Restore windows and hardware to operable and functional condition.

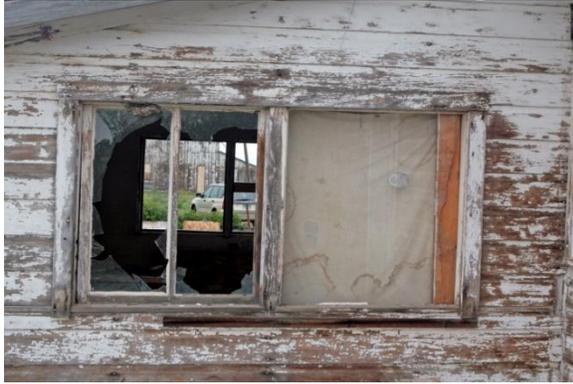
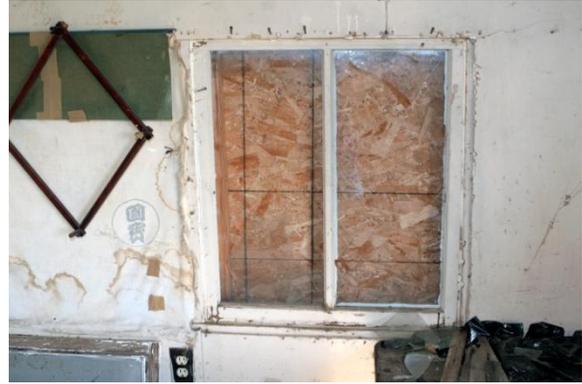
Window 1W-11 exterior and interior photos. 2009

Condition: The exterior finish of the sash, frame, and trim is extremely weathered. The interior finish is slightly worn. The north sash has been removed and rests inside the South Porch. Both lights of the south pane are broken. Exterior vertical and sill trim displays much deterioration. Part of the sill trim is missing.

Recommended treatment: Paint may contain lead. Remove all loose paint on the exterior face of the window, frame, and the exterior trim. Consolidate and/or replace deteriorated exterior trim. Sand and prep. Replace broken glazing in south sash. Install new glazing putty for all lights. Refinish and reinstall north sash. Repaint with two coats high quality acrylic latex paint. On the interior sand and prep the sash, frame, and trim. Paint. Remove, refinish, and reinstall all stops. If possible, install weather strip at head, jambs, and sill.

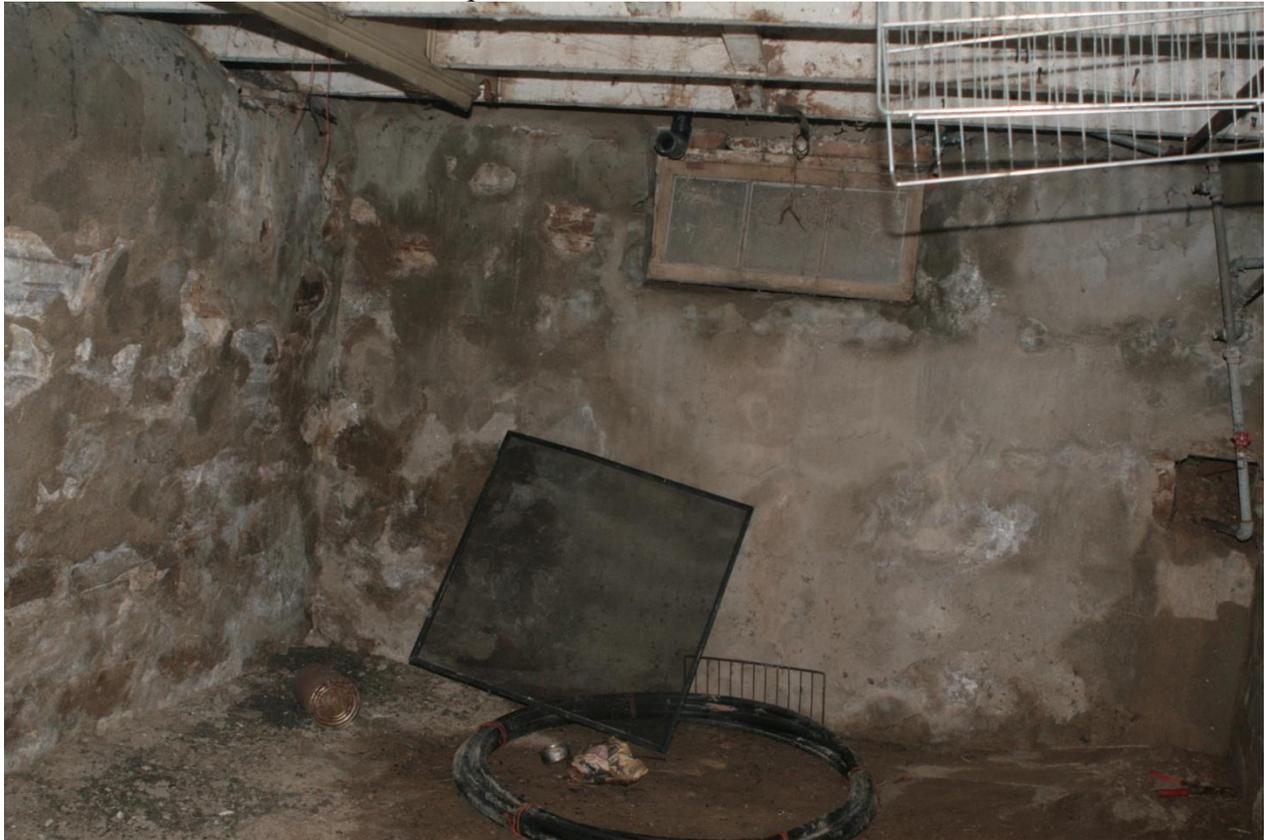
Windows BW-01 and BW-02. 2009 photo.

Condition: The sash and frame for both windows have minor weathering. The glazing for both windows is intact. Paint finish on window trim around BW-01 is deteriorated.

Recommended treatment: The windows and frames will hold up much better, if they are painted. Install new glazing putty for all lights. Remove loose paint from interior trim around BW-01. Clean and sand the existing windows, trim, and frames. Paint may contain lead. Repaint with two coats high quality acrylic latex paint.

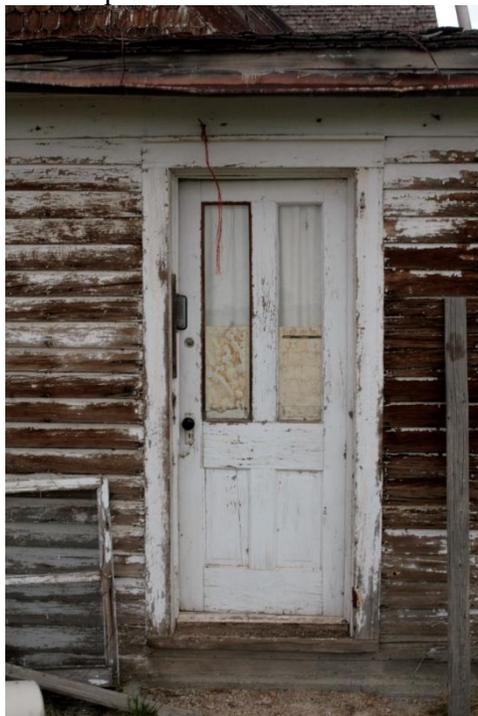
Door D3, 2'-6" x 6'-7".

Condition: The exterior of the door, frame, and the exterior trim are extremely weathered.

On the exterior the frame has been cut and partially removed adjacent to the keypad lock. Directly below this location the stop is broken and the west stile of the door is split. The wood stop at the head of the door is separating from the door frame. The west exterior vertical wood trim is rotted at its base. The west door panel has a long vertical split. The interior finish on the door, frame, and trim is in fair condition. The historic latch set, thumb turn, and hinges are in place. It could not be determined if the latch set and thumb turn were operable.

Recommended treatment: Inventory the historic screen doors stored in the Main House to determine if the screen door for door D3 still exists. (If it cannot be located, a new, historically accurate screen door based upon historic photographs should be fabricated and installed.) Paint may contain lead. Remove all loose paint on the exterior face of the door, frame, and the exterior trim. Splice new wood where exterior stops are missing or broken. Splice new wood or consolidate rotted trim. Consolidate and/or reconstruct the damaged door stile. Rehabilitate split west door panel. Rehabilitate the separated head stop. Install new glazing putty for all lights. Sand and prep. Repaint exterior with two coats high quality acrylic latex paint. Paint may contain lead. Sand and prep the interior face of the door and, frame, and trim. Apply new paint. Refinish, repair, and reinstall all stops. If possible, install weather strip at head, jambs, and sill. Restore so that the door is operable and that its locking hardware is functional. Install missing strike for historic thumb turn.

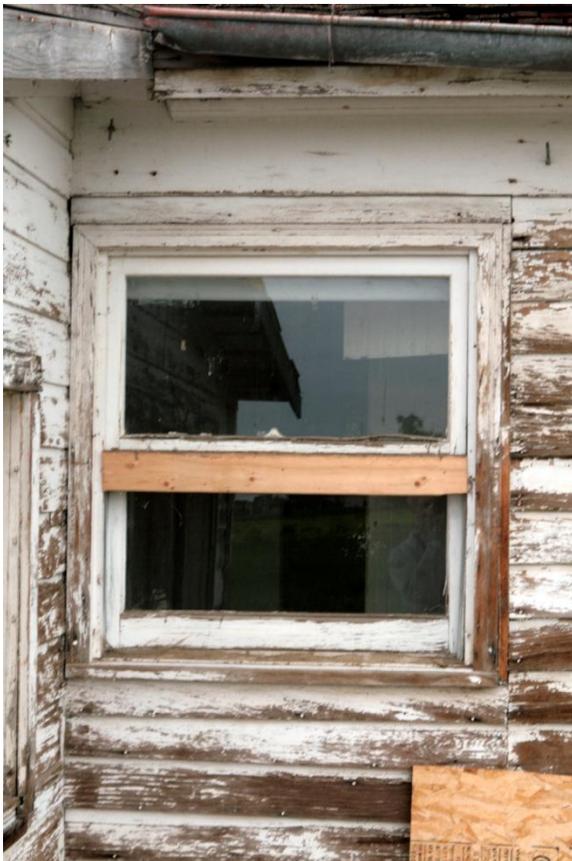
Window 1W-10. 2'-8" x 2'-11".

Condition: The exterior frame and trim are extremely weathered. The frame is in very poor condition. The lower rail of the upper sash is in very poor condition. The interior wood frame and trim are only slightly worn. The window is not operational.

Recommended treatment: Paint may contain lead. Remove all loose paint on the exterior face of the sash, frame, and the exterior trim. Replace the lower rail of the upper sash. Sand and prep. Install new glazing putty for all lights. Repaint the exterior with two coats high quality acrylic latex paint. On

the interior sand and prep the sash, frame, and trim. Paint. Remove, refinish, and reinstall all stops. If possible, install weather strip at head, jambs, and sill. Restore window and hardware to operable and functional condition.

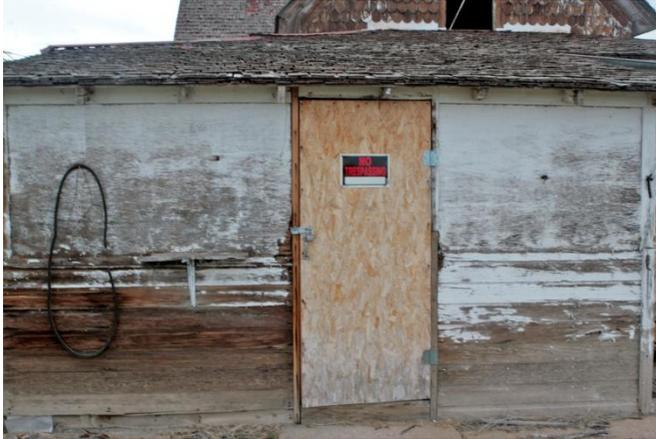
Openings 1W-12 and 1W-13. 2009 photo

Condition: The exterior plywood panels are extremely weathered and starting to deteriorate. The interior particle board panels are in good condition.

Recommended treatment: Remove protective wood panels. If original wood screens cannot be found or salvaged, new historically accurate wood screens should be fabricated. Fabricate new removable exterior protective panels which can cover the screens when the building is not in use or secured.

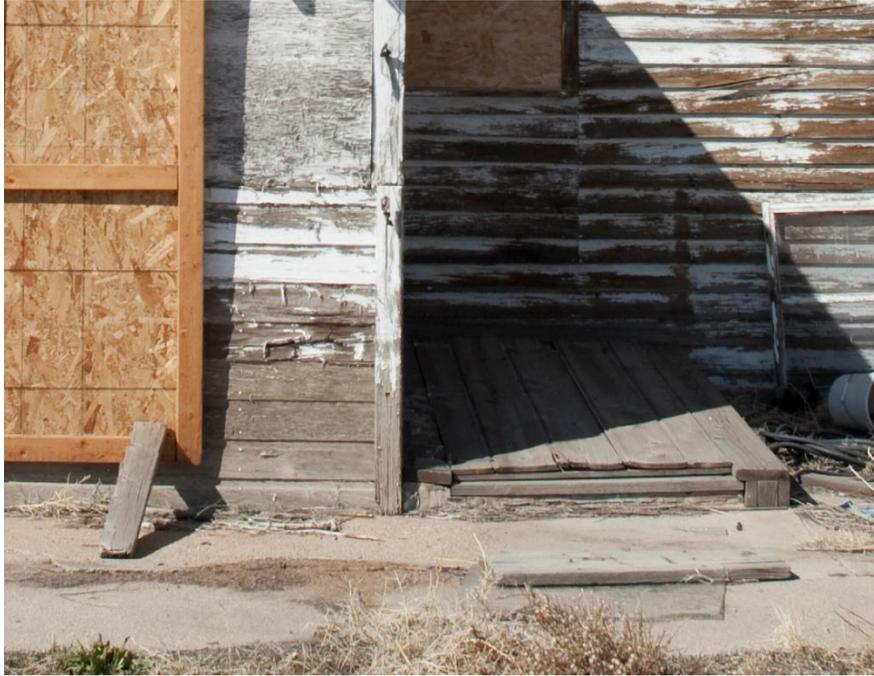
Door D5. 2009 photo.

Condition: The vertical boards and trim are moderately weathered and starting to warp. The door's operation is satisfactory. The door's hinges are still fastened securely to the frame.

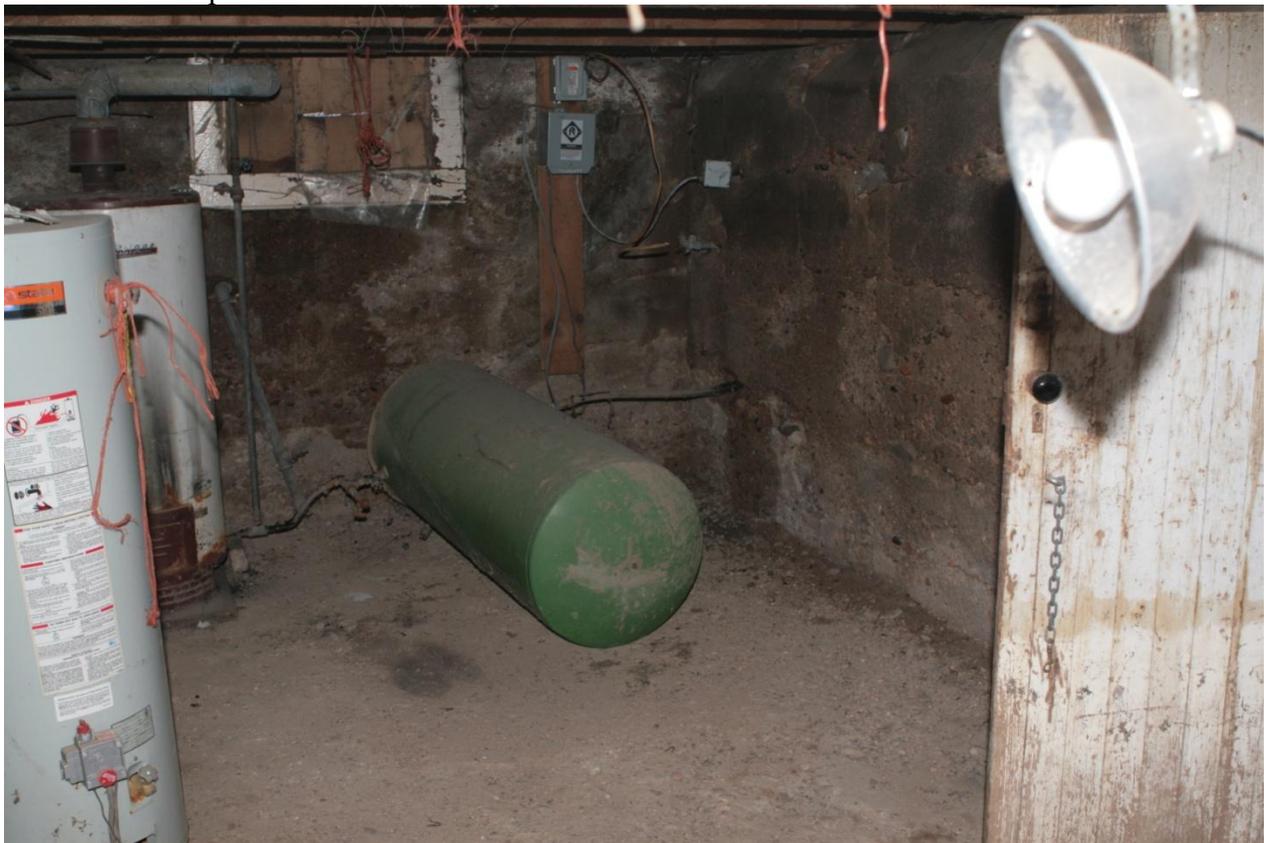
Door D8. 2009 photo.

Description: This door is located at the entrance to the Cellar. It is approximately 3'-0" wide by 6'-6" high. It is built from vertical wood members painted white. The door has a historic keyed latch and non-historic padlock and hasp. There is no evidence that this opening ever had a screen door.

Condition: The door binds on the dirt floor of the Cellar. The door does not close tightly into its frame because the frame is not square or the hinges are slightly sprung. The paint finish on both sides of the door and frame is moderately weathered.

Priority: Serious.

Recommended treatment: Remove excess dirt from the cellar floor so that the door does not bind when opened. Repair frame and/or hinges so that door fits squarely into its frame when shut. Attempt to rehabilitate the historic keyed lock and its strike so that the lock is functional. Paint may contain lead. Remove loose paint from the door and frame. Sand and prep. Repaint with two coats high quality acrylic latex paint.

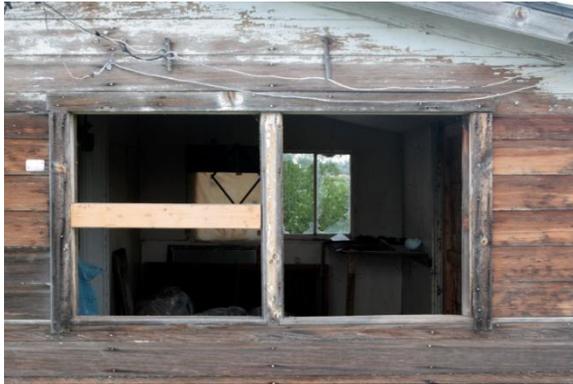
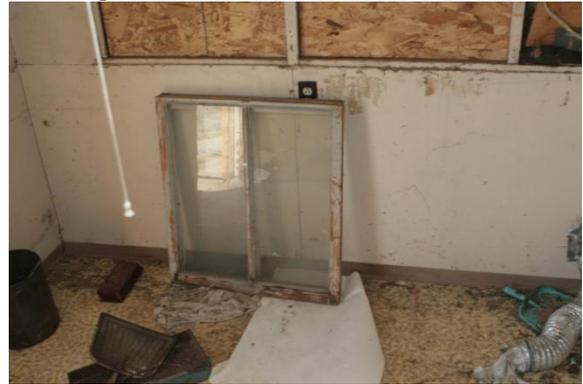
Window 1W-14 exterior and interior photos. 2009.

Description: Window 1W-14 is located on the west side of the South Porch. The opening is 4'-10" wide x 3'-0" high. It is divided in half horizontally by a piece of vertical wood trim. All sash have been removed. A historic photograph shows the window with two vertically divided two light sash. The frame and wood trim are painted white on the exterior. The interior face of the frame is also painted white. There is no interior trim. There are no window screens. No screen attachments were visible.

Condition: The exterior finish of the frame and trim is extremely weathered. The interior finish is slightly worn. Exterior vertical and sill trim displays much deterioration. All of the sill trim is missing or deteriorated.

Priority: Serious.

Recommended treatment: Paint may contain lead. Remove all loose paint on the exterior face of the frame and the exterior trim. Consolidate and/or replace deteriorated exterior trim. Sand and prep. Replace the missing north and south sash. One sash is located inside the South Porch.

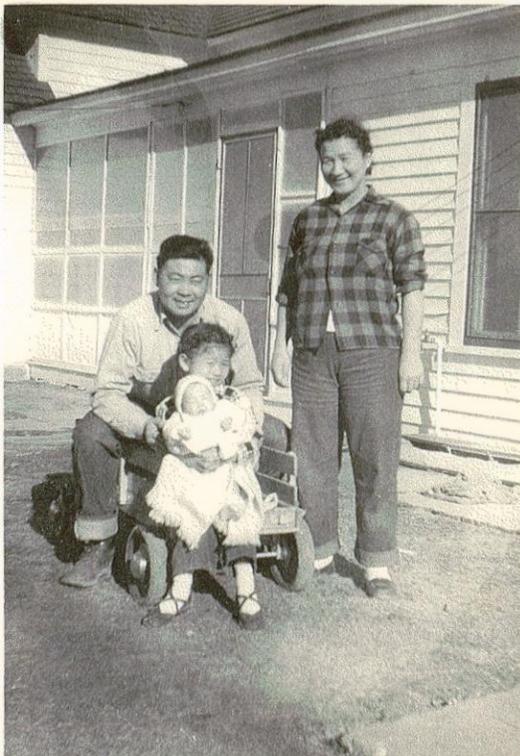
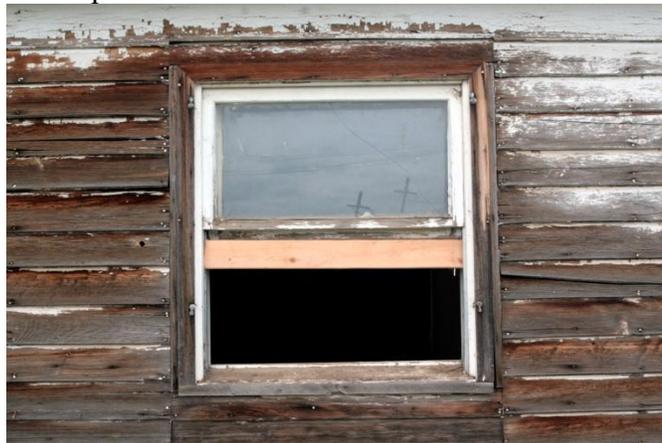
Window 1W-15. Circa 1947 photo. 2009 photo.

Description: This window is located on the west wall of the Kitchen. It is a single pane, double hung window that measures 2'-9" wide x 3'-1" high. The historic photograph shows that this window was once much taller. The inset wood siding below the window in the current photograph is also suggestive of this modification. An exact change for this modification cannot be determined. The window modification was after 1947 based on the photos above. The upper sash

and window frame are painted white. The lower sash has been removed. The window jamb has aluminum slides. The exterior trim is unpainted. The interior trim is painted white. There is clip hardware on the exterior face of the frame for a screen, but the screen has been removed.

Condition: The exterior frame, sash, and trim are extremely weathered. Interior wood frame, sash, and trim are moderately worn. The window is not operational or weather tight, since the lower sash is missing.

Priority: Serious.

Recommended treatment: Paint may contain lead. Remove all loose paint on the exterior face of the sash, frame, and the exterior trim. Sand and prep. Replace the missing lower sash. Install new glazing putty for all lights. Repaint with two coats high quality acrylic latex paint. On the interior sand and prep the sash, frame, and trim. Paint. Remove, rehabilitate, and reinstall all stops. If possible, install weather strip at head, jambs, and sill. Rehabilitate so that the window is operable and that its locking hardware is fully functional. Restoring this window to its original size should

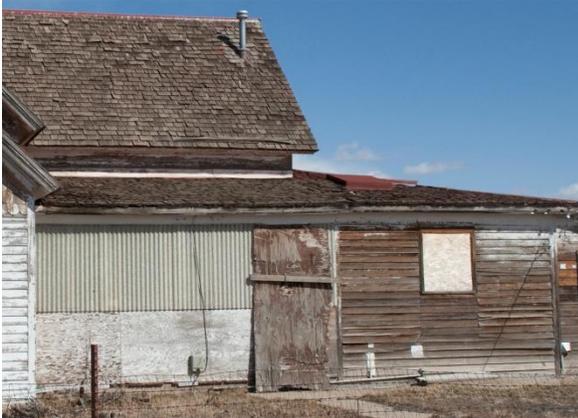
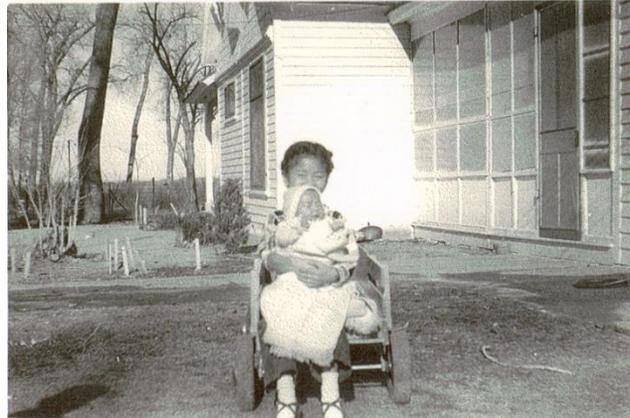
Door D6. 2009 photo

Description: This door is 2'-6" wide x 6'-7" high and exits the West Porch. Currently a non-historic aluminum screen door is installed in this opening. It is covered with an unpainted plywood security panel that is secured by a padlock and chain. The historic photograph shows a painted wood screen door.

Condition: The aluminum screen door was covered with plywood security panels on both sides and could not be evaluated.

Recommended treatment: Remove security panels, non-historic aluminum screen door and its frame. Enlarge the door opening so that it is handicap accessible. Replace with new painted, historically accurate wood screen door and hardware. The new screen door should be constructed using the above historic photograph as a guide.

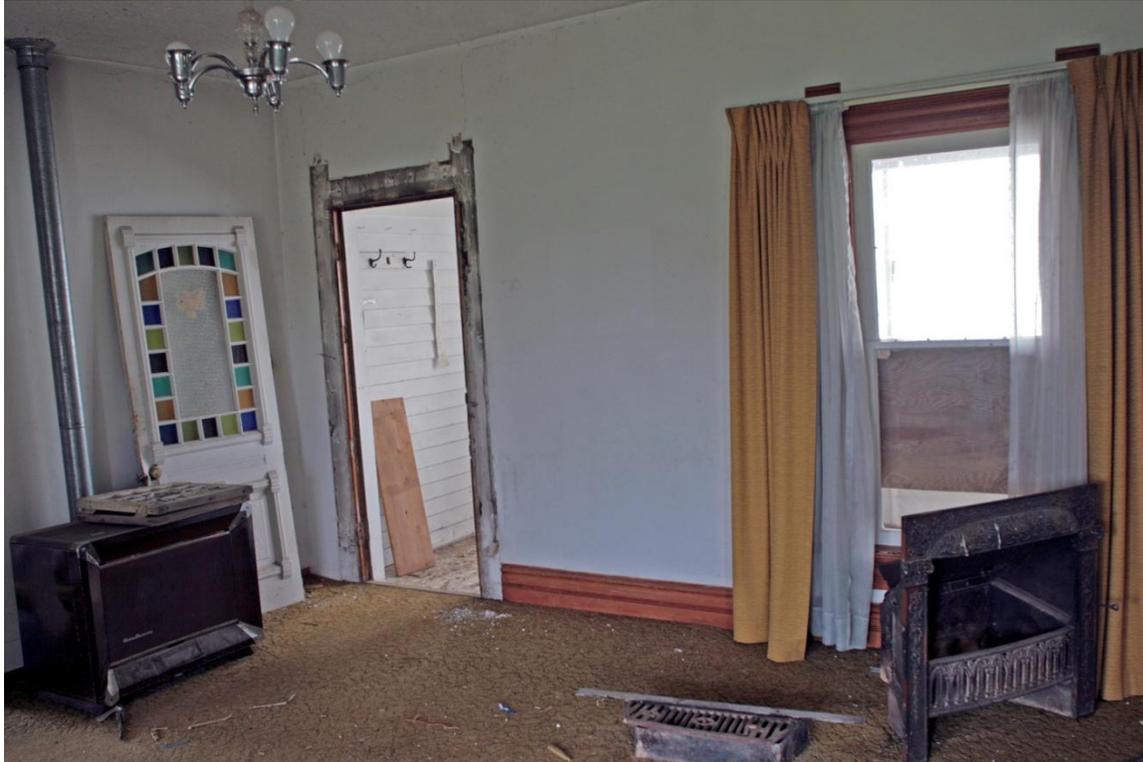
Window 1W-17. 2009 photo.

Description: This window is located on the west wall of the Dining Room looking out to the West Porch. The window is double hung with single pane glazing. The upper sash, lower sash, and frame are painted white on both the interior and exterior sides. Exterior trim is painted 1" x 4" wood. The interior trim is composed of a stained, fluted architrave, corner rosette, and sill with a clear finish. An unpainted plywood security panel has been fastened to the exterior of the lower sash. Non-historic drapes and curtains cover the interior wood trim.

Condition: The sash, frame, and trim are in fair to good condition. The plywood security panel prevents the window from being operational.

Recommended treatment: Remove the security panel. Rehabilitate the sash, frame, exterior trim, and interior trim when other windows are being rehabilitated. Remove non-historic drapes and curtains. Restore so that the window is operable and that its locking hardware is fully functional.

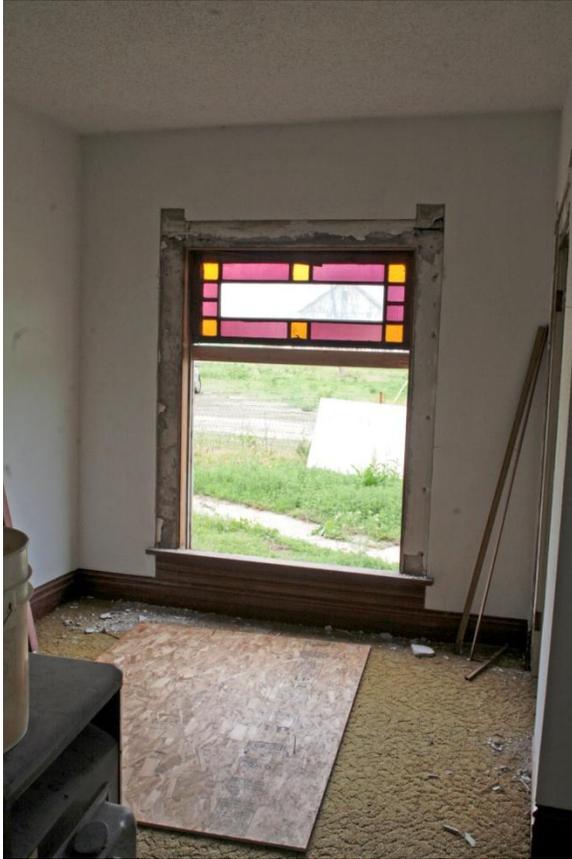
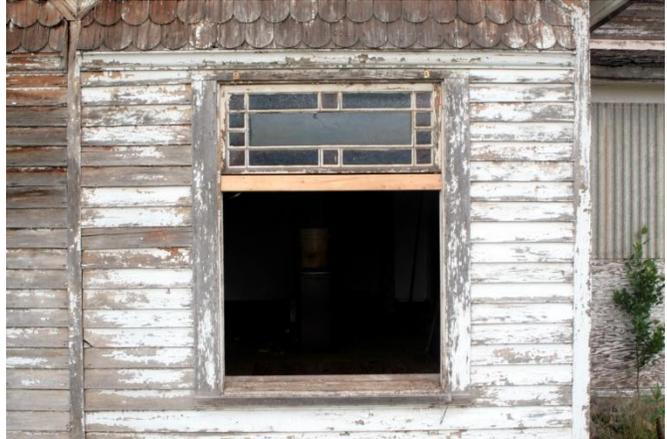
Window 1W-18.

Description: This window is located on the west wall of Bedroom #1. It is 4'-0" wide x 5'-7" high. This is a historic wood single hung window with a decorative glass transom panel above. The transom panel is divided into twelve decorative lights with various colored glasses. The lower sash and wood screen have been removed and presumed to be stored inside the Main House. There are hooks at the top of the exterior frame to suspend a screened window. The window and frame exterior are painted white. The window and frame interior are

stained with a clear finish. Exterior trim is painted 1" x 4" wood. The interior trim, which is composed of a stained, fluted architrave, corner rosette, and sill, all with clear finish, has been removed. It is again presumed that the interior trim is stored in the Main House.

Condition: The exterior finish of the window and frame are moderately weathered. The interior finish is slightly worn. Exterior wood trim is extremely weathered, but sound. Interior trim is slightly worn. The window is not operable and not water tight because the lower sash has been removed. This opening is currently protected with a particle board inset on the exterior side.

Priority: Serious.

Recommended treatment: Inventory the windows stored on site. If this historic window and screen can be located, they should be refinished and installed. (If they cannot be located, a new, historically accurate window and screen should be fabricated and installed.) Paint may contain lead. Remove all loose paint on the exterior face of the sash, frame, and the exterior trim. Sand and prep. Install new glazing putty for all lights. Repaint with two coats high quality acrylic latex paint. On the interior sand and prep the sash, frame, and trim. Refinish with new clear finish. Reinstall the removed trim and lower sash. Replace sash cords and counter weights. Refinish and reinstall all stops. If possible, install weather strip at head, jambs, and sill. Restore window and hardware to operable and functional condition.

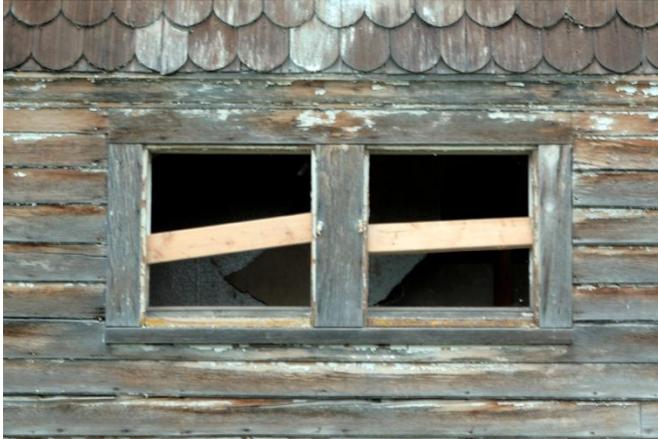
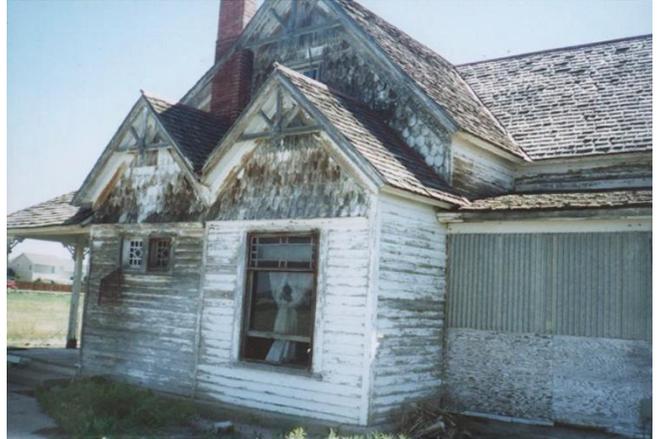
Windows 1W-19 and 1W-20. 2009 photo.

Description: These windows are located on the west wall of the Walk-in Closet in Bedroom #1. They are each 1'-9" wide x 1'-9" high. These are historic casement windows with a decorative divided lights composed of various colored glasses. The casement sash and wood screen have been removed and are stored inside the Main House. There are hooks at the top of the exterior frame to suspend a screened window. The window and frame exterior are painted white. The window and frame interior are stained with a clear finish. Exterior trim is painted 1" x 4" wood. The interior trim is composed of a stained, fluted architrave and sill with clear finish.

Condition: The exterior of the window frame is extremely weathered. The interior finish of the frame is slightly worn. Exterior wood trim is extremely weathered. Interior trim is slightly worn. The window is not operable and not water tight because sash has been removed. This opening is currently protected with a particle board inset on the exterior side.

Priority: Serious.

Recommended treatment: The removed sash are stored within the Main House. Remove all loose paint on the exterior face of the sash, frame, and the exterior trim. Sand and prep. Install new glazing putty for all lights. Repaint with two coats high quality acrylic latex paint. On the interior sand and prep the sash, frame, and trim. Refinish with new clear finish. Reinstall the removed casement sash for both windows. Restore and reinstall all stops. If possible, install weather strip at head, jambs, and sill. Restore window and hardware to operable and functional condition.

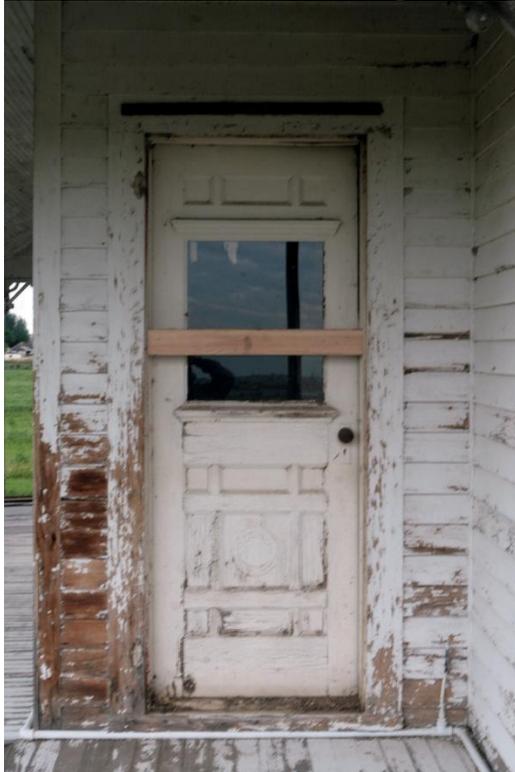
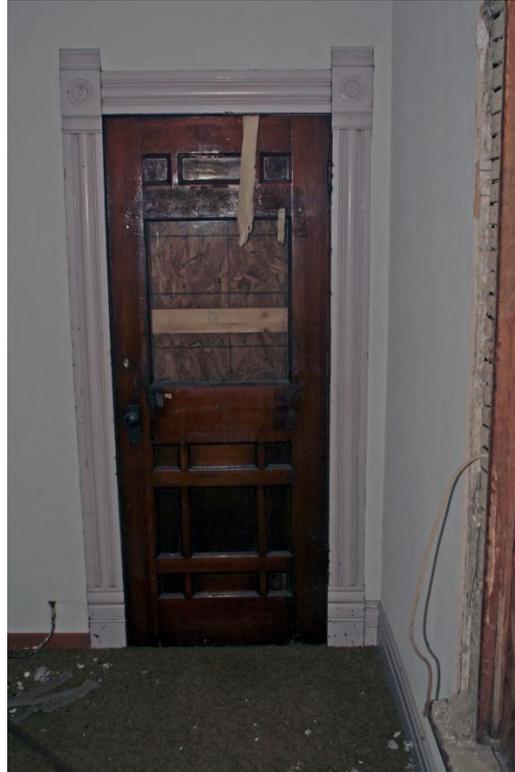
Door D7. Exterior and interior photos. 2009.

Description: Door D7 is 2'-6" wide and 6'-7" high. This door is a four panel, one light wood stile and rail door. Three panels are located below the light and one panel above. Each panel is divided horizontally into three sections. Glazing is single pane. The exterior of the door, frame, and wood trim is painted white. The screen door has been removed. Hinges for the screen door are still present on the frame. The interior of the door has a dark reddish stain with clear finish. Interior trim, which is composed of an architrave, corner rosettes, and plinths, is painted white. It is likely that this trim was originally stained with a clear finish like the trim around other openings in this part of the Main House. Further analysis could determine if this is the case. Hardware consists of a historic thumb turn and latch set with keyed lock. The opening is currently protected with an unpainted plywood panel screwed to the frame.

Condition: The exterior of the door and frame are very weathered. Exterior trim is also very weathered. The wood sill is starting to rot. The interior of the door and the interior trim are slightly worn. Non-historic carpet with a deep pile prevents the door from opening. The hardware could not be tested for its functionality.

Recommended treatment: Install new glazing putty for all lights. Sand and prep. Repaint exterior with two coats high quality acrylic latex paint. Paint may contain lead. Sand and prep the interior face of the door and, frame, and trim. Apply new clear, stained finish. Refinish, repair, and reinstall all stops. If possible, install weather strip at head, jambs, and sill. Restore so that the door is operable and that its locking hardware is functional.

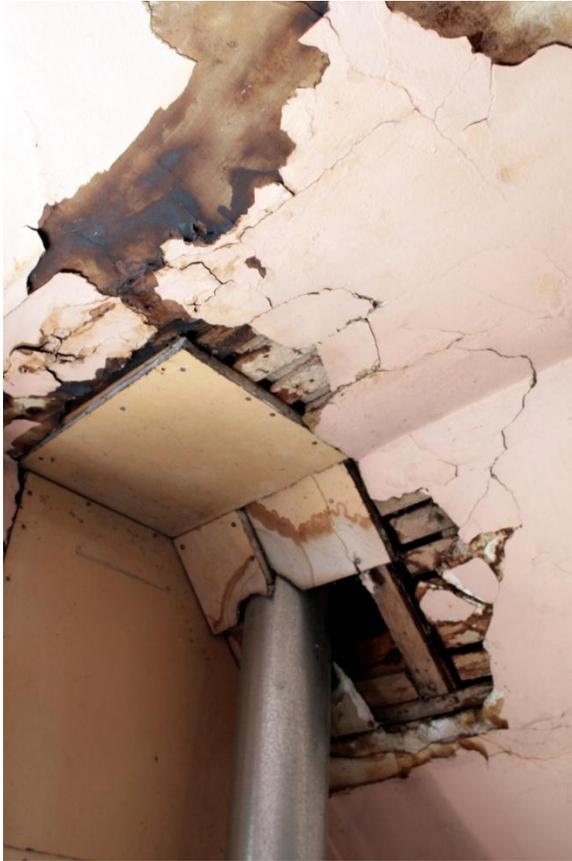
2009 photograph.

Space Heater Exhaust. The space heater exhaust is located at the south end of the west face of the intersecting gable roof. The space heater was located in Bedroom #5. This exhaust is also discussed in Section 3.1.8, Mechanical Systems, water and wastewater.

Condition: The ceiling below the exhaust in Bedroom #5 has severe water damage.

Priority: Critical.

Recommended treatment: Install new flashing when wood shingle roof is replaced.

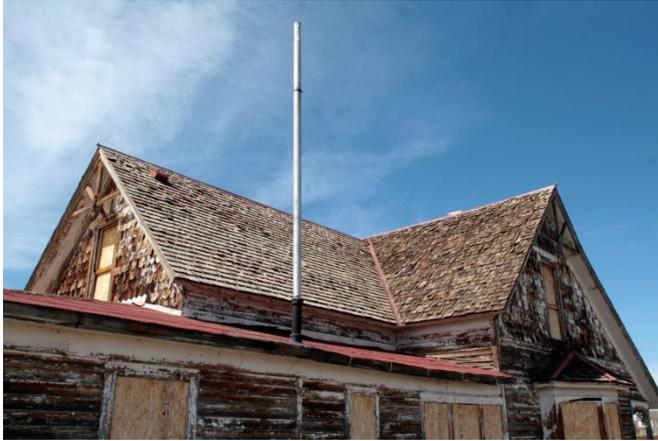
Plumbing vent. This vent is located at the southeast corner of the one-story wrap around hipped roof. This is also discussed in Section 3.1.8, Mechanical Systems, water and wastewater.

Condition: There is no water damage visible in the Bathroom ceiling below.

Priority: Minor.

Recommended treatment: New flashing for this vent should be installed when the asphalt roll roofing is replaced.

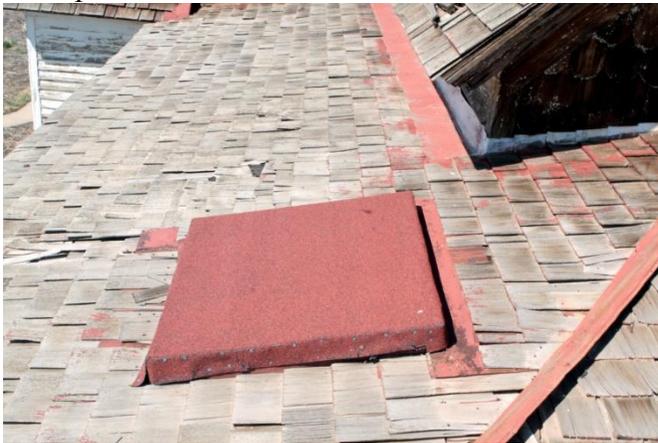
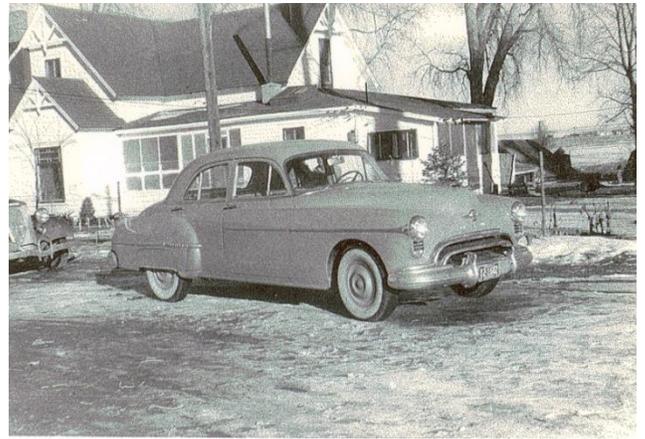
Historic skylight covered with asphalt roll roofing. 2009 photo.

This opening is not visible in the Kitchen ceiling below. Historically there was a skylight in the Kitchen ceiling.

Condition: There are no leaks visible in the ceiling below. The asphalt roll is deteriorated and in poor condition. Flashing is visible around the opening.

Recommended treatment: Since the hatch was a historic skylight, it is recommended that the asphalt roll roofing be removed and the skylight be reconstructed. Flashing around the skylight should be replaced when the new wood shingle roofing is installed. The Kitchen ceiling should be reconstructed so that the skylight is visible and serves its intended function.

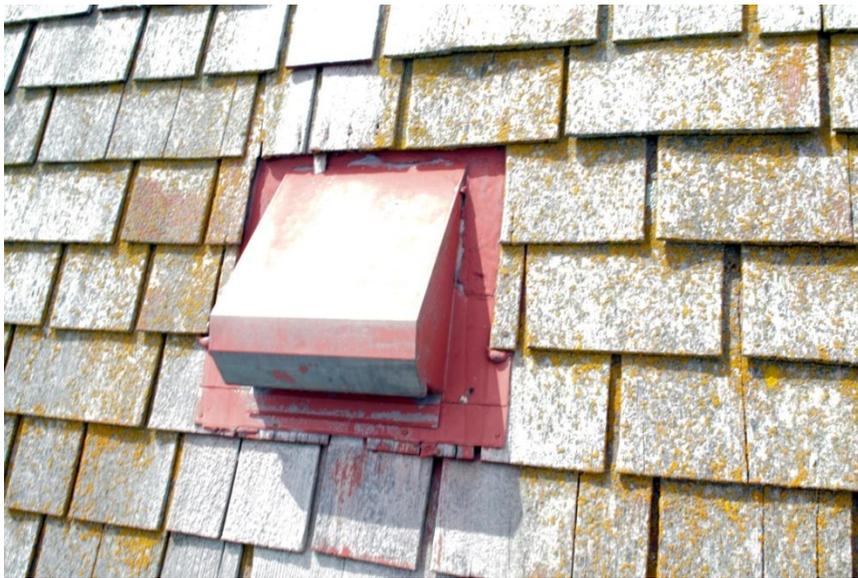
Photo 2009.

Rafter Space Vents. There are two rafter space vents. One vent is located on the east side of the north face of the cross gable roof and the other on the south side of the east face of the intersecting gabled roof. Each vent provides approximately 20 square inches of vent area. The total vented area does not meet the current minimum requirements of the building code.

Condition: The vents are in good condition but lack bird screens. There is no sign of water leakage below the vents. The rafter space shows no signs of moisture or water damage. Paint on the vents is weathered. The area of the vents is insufficient to meet current building code requirements.

Recommended treatment: Repaint existing vents and install bird screen. Add new additional vents to meet building code requirements when wood shingles are replaced.

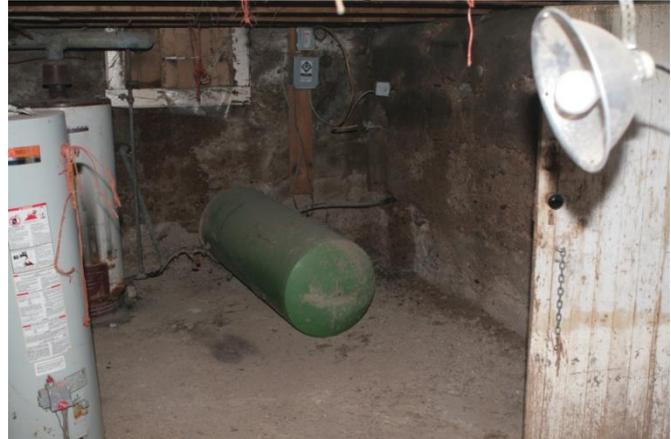
+Basement east wall. 2009 photo.

Condition: Floor is covered with debris and some animal droppings. Ceiling has cobwebs. Door does not open completely due to unlevel floor. Also see Sections 3.1.8, Mechanical Systems, water and wastewater and Section 3.1.9., Electrical systems and lighting.

Priority: Minor

Recommended treatment: Remove dirt covering concrete slab on grade. Thoroughly clean and disinfect floor, walls, and ceiling. Adjust door for smooth operation. Repaint door and frame.

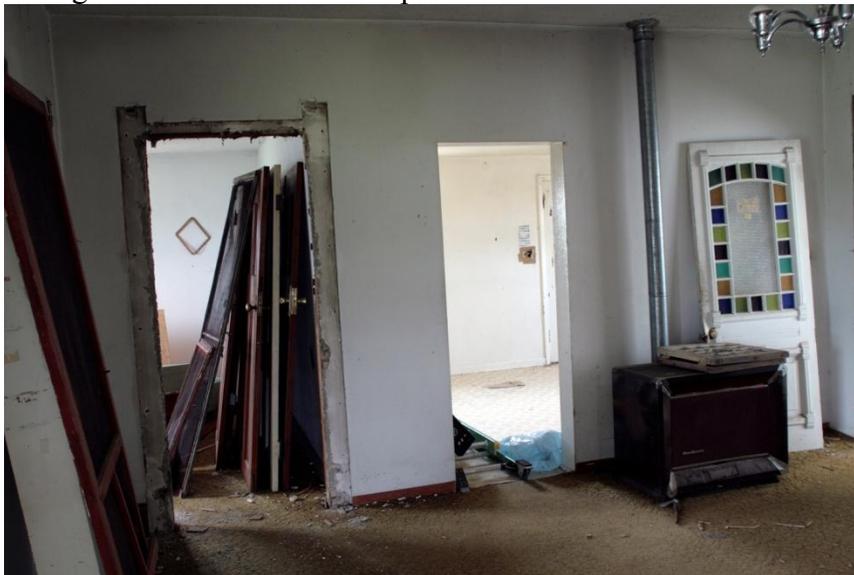
Dining Room south wall. 2009 photo.

Condition: The painted gypsum board walls are damaged where trim has been removed. The painted gypsum wallboard ceiling is in fair condition. The non-historic carpet is extremely soiled

and covered with debris and some animal droppings. Wood base is in fair condition. Door and window trim that has not been removed is in fair condition. Also see Sections 3.1.8, Mechanical Systems, water and wastewater and Section 3.1.9., Electrical systems and lighting.

Recommended treatment: Remove non-historic carpet and underlayment. Restore wood flooring. Thoroughly clean and disinfect floor, walls, and ceiling. Restore wood base. Restore and reinstall removed wood trim. Rehabilitate walls and ceiling to historically appropriate appearance. Install wallpaper of appropriate patterns and colors. Remove propane heater.

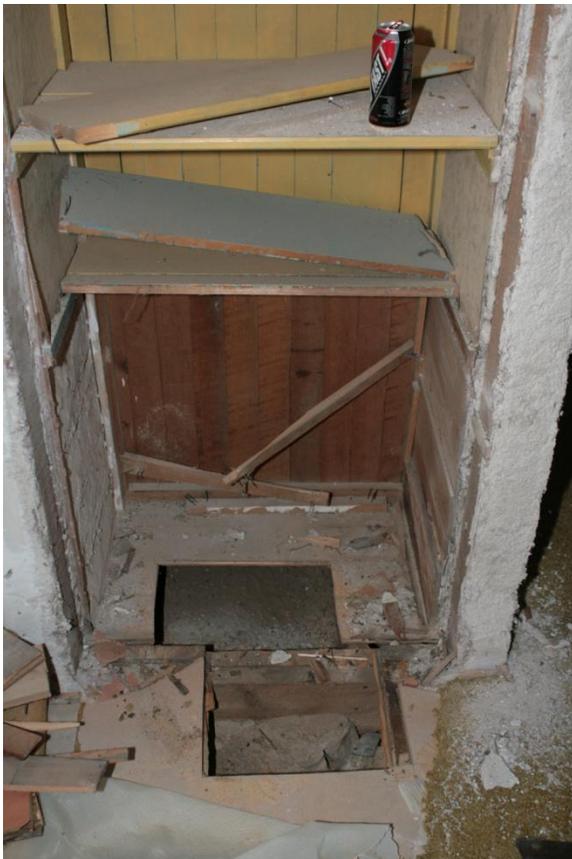
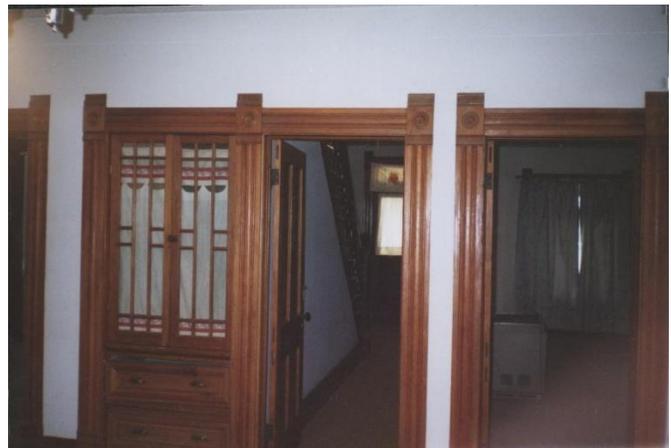
Closet. 2009 photo.

Circa 2005 photo showing doors and drawers.

Condition: Painted and stained vertical boards are in fair condition. Painted wallpaper is faded and in poor condition on the east wall, west wall, and ceiling. A 1' x 2' opening has been cut into the wood floor. Historic wood shelving, doors, and drawers have been removed.

Recommended treatment: Restore vertical board north wall. Clean wallpaper with non-destructive

methods, or install new historically appropriate wallpaper after repairing any loose or damaged plaster beneath existing wallpaper. Repair wood floor. Restore existing historic upper wood shelves. Locate or replace missing historic wood shelves, drawers, and doors with new historically accurate millwork.

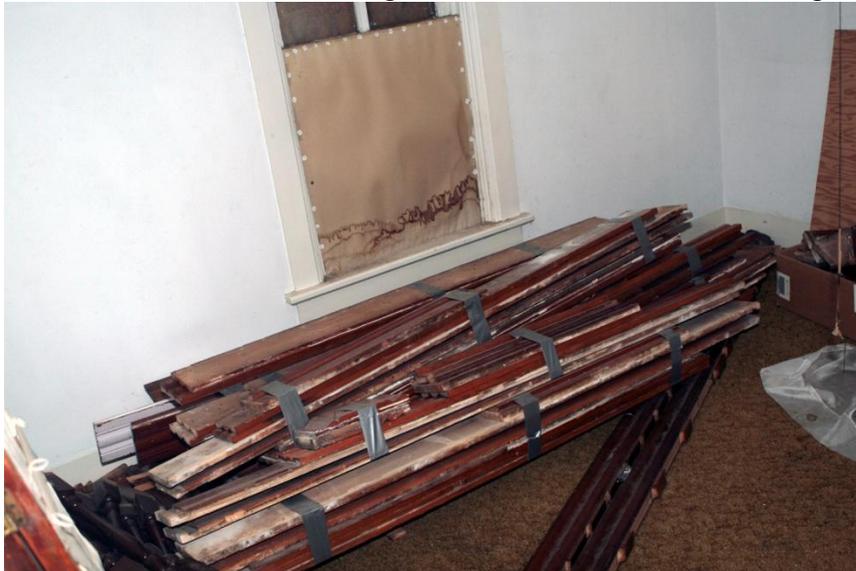
East wall Bedroom #2 showing stored interior wood trim. 2009 photo.

Condition: The painted gypsum board walls are damaged where trim has been removed. The painted gypsum wallboard ceiling is in good condition. The non-historic carpet is extremely soiled and covered with debris. Wood base is chipped and dented. The condition of wood trim around the door opening to Bedroom #2 could not be assessed, since it has been removed. Wood trim around door D3 and window 1W-09 is in good condition. Also see Sections 3.1.8, Mechanical Systems, water and wastewater and Section 3.1.9., Electrical systems and lighting.

Recommended treatment: This area will be reconfigured to contain new accessible bathrooms.
