Bromley Farm

Master Plan

Historic Structures Assessment

Prepared by:
Avenue L Architects
March 18, 2010

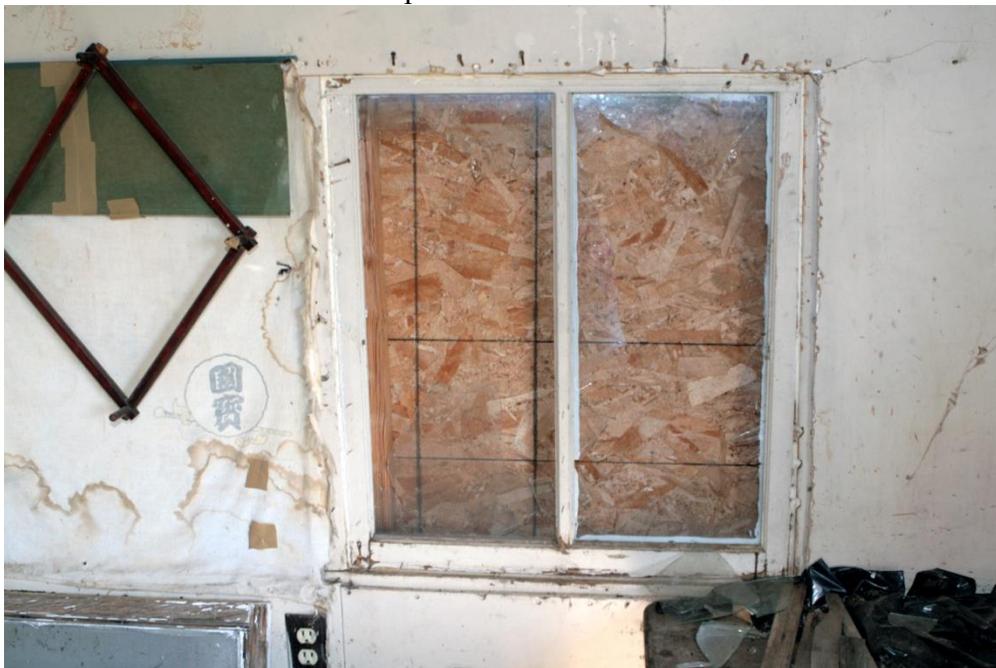
East wall of South Porch. 2009 photo.

Condition: The painted gypsum board walls have some water damage and are in poor to fair condition. The water damage is due to leaks around the window openings, through the siding, and through the roof. Gypsum board is missing in the northwest corner of the room. Insulation and wood siding are visible at these locations. The painted gypsum wallboard ceiling is in fair condition. The ceiling sags in some locations. This is probably due to water damage. The linoleum flooring is extremely soiled and covered with debris. The resilient base is loose and deteriorated. Also see Sections 3.1.8, Mechanical Systems, water and wastewater and Section 3.1.9., Electrical systems and lighting.

Recommended treatment: Remove and replace gypsum wallboard ceilings and walls. Replace any damaged wood flooring. Replace linoleum.

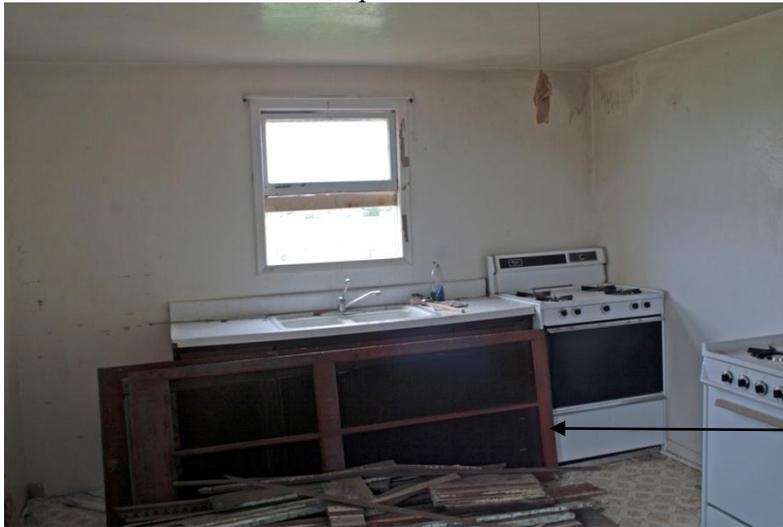
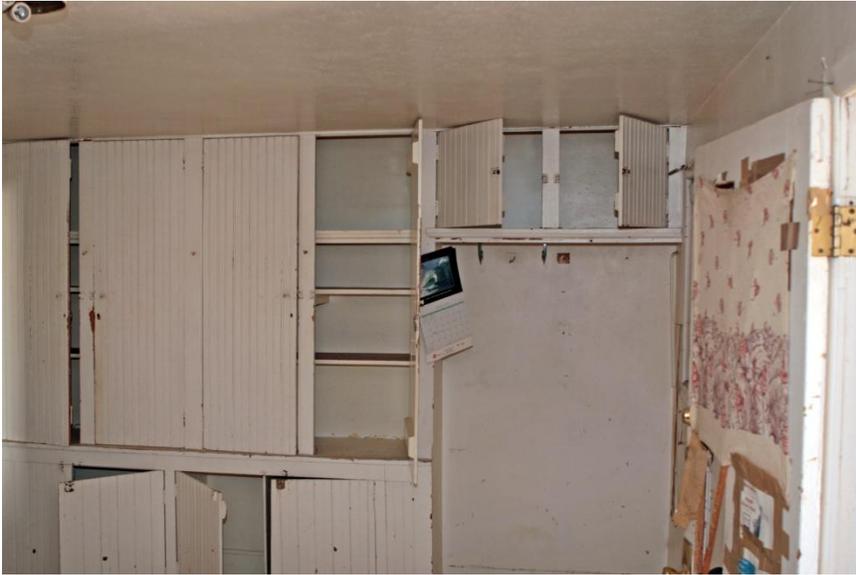
West wall of Kitchen. 2009 photo.

Non historic cabinet and counter top.

East wall of Kitchen. 2009 photo.

Condition: Painted gypsum board walls are in fair condition due chips, dents, holes, and peeling paint. Painted gypsum board ceiling is fair condition due to peeling paint. The linoleum flooring is soiled, covered with debris, and torn in several locations. The painted wood base and base shoe are in fair condition due to scratches, dents, and loose paint. The built-in wood cabinets are in fair condition, but missing some latch hardware. These cabinets are scratched, dented, and have some loose hardware. Doors have been removed from the non-historic base cabinet on the west wall. This non historic cabinet and counter are in poor condition due to broken hardware and de-lamination of the plastic laminate counter top. They are poorly constructed. The sink and stoves were not evaluated. See Sections 3.1.8, Mechanical Systems, water and wastewater and Section 3.1.9., Electrical systems and lighting for condition assessments for the sink and stoves.

Recommended treatment: Thoroughly clean and disinfect floor, walls, and ceiling. Restore wood base and base shoe. Install historic skylight opening in ceiling. Rehabilitate walls and ceiling. Restore historic built-in cabinets. Install historically accurate hardware that is missing. Remove stoves, non-historic base cabinet, and sink. Remainder of work in this room will be done by restaurant concessionaire.

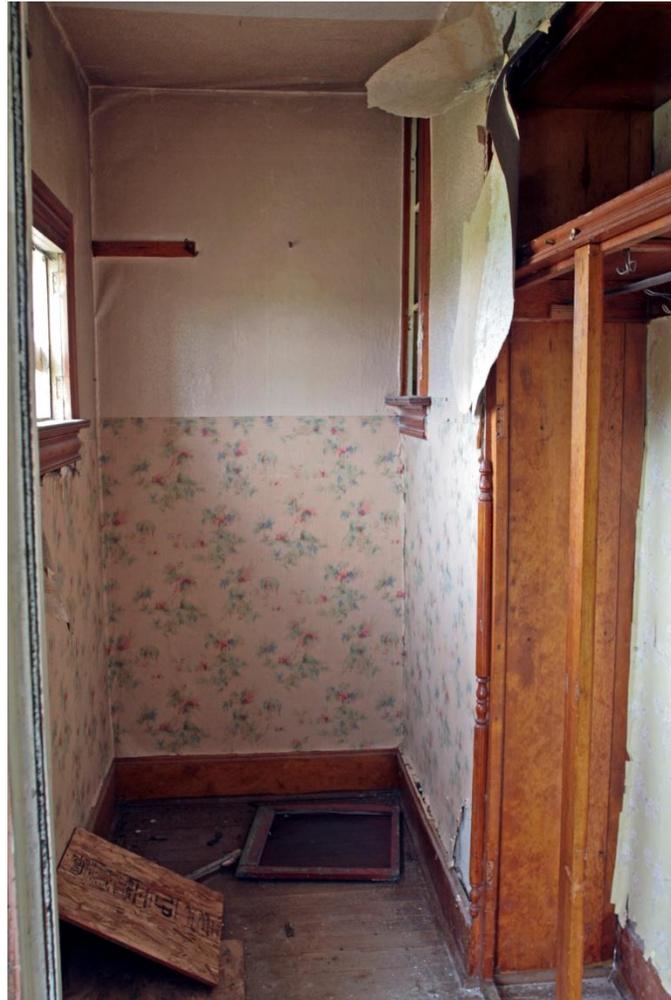
2009 photo.

wallpaper, plaster, and wood lath near the west chimney is severely water damaged. The wood tongue and groove flooring is in fair to condition. Wood base is in fair condition and intact. The wood cabinet is in good condition. The wood closet is in fair condition and missing a pair of doors. Also see Sections 3.1.8, Mechanical Systems, water and wastewater and Section 3.1.9., Electrical systems and lighting.

Recommended treatment: Leak in ceiling should be repaired as soon as possible to prevent further degradation to historical finishes and millwork. See Section 3.1.5, Envelope: roofing and waterproofing. Repair damaged plaster on east and north walls. Repair water damaged wallpaper on east and north walls. Clean wallpaper using preservative cleaning methods. Repair damaged ceiling lath and plaster. Restore ceiling wallpaper to the degree that restoration is possible. Refinish wood flooring. Refinish wood base, trim, historic cabinet, and historic closet. Refinish and reinstall, or reconstruct, historic wood closet doors.

Priority: Leak, critical. Interior finishes, serious.

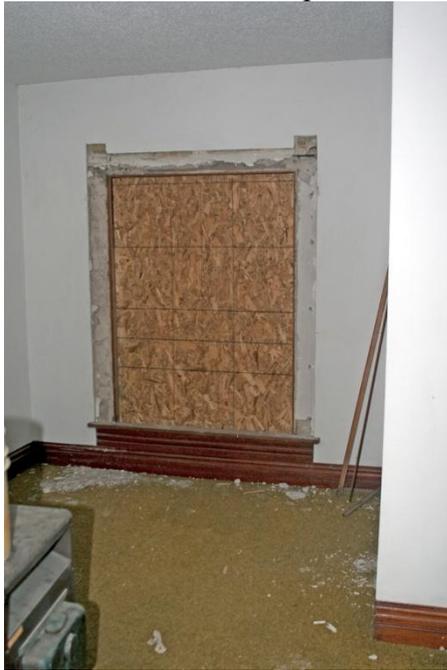
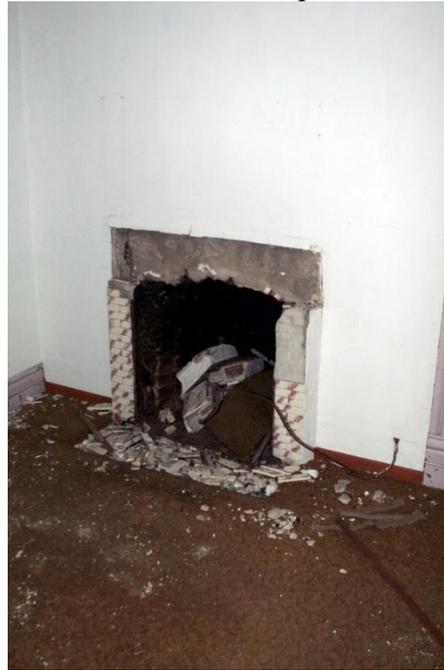
Parlor north wall. 2009 photo.

Condition: The walls and ceiling are in fair condition. The walls are damaged where wood trim has been removed. The walls and ceiling have numerous scratches, dents, and blemishes. The non-historic carpet is soiled and covered with debris. Wood base is in fair condition and intact. It also has scratches and dents. Wood trim around the door openings has been removed. Wood sill trim below window 1W-01 is in fair condition. The firebox has been removed from the fireplace. The surround and hearth have been extremely damaged by the removal. Also see Sections 3.1.8, Mechanical Systems, water and wastewater and Section 3.1.9., Electrical systems and lighting.

Recommended treatment: Remove non-historic carpet and underlayment. Restore wood flooring. Thoroughly clean and disinfect floor, walls, and ceiling. Restore wood base. Restore and reinstall removed wood trim. Restore walls and ceiling to historically appropriate appearance. Remove space heater. Reinstall firebox in fireplace and reconstruct historic surround and hearth. Ceramic tile and surround debris from the firebox removal remain at the fireplace. The firebox was observed in Bedroom #1. This material and the photograph above should be used as the basis for the fireplace and surround reconstruction, omitting the non historic space heater. The ceramic tile was a commonly used size and pattern. Replacement pieces may be available in architectural salvage outlets.

Priority: Serious.

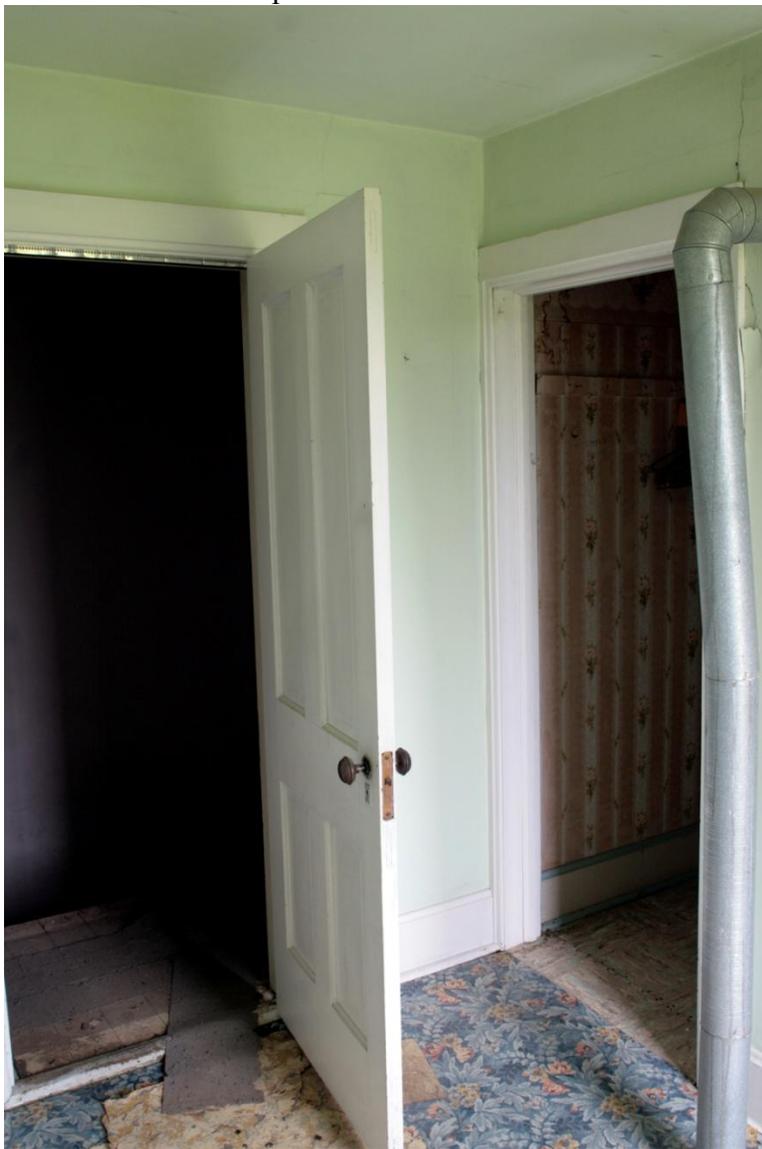
+**Bedroom #3.** 2009 photo.

Condition: Walls and ceiling have areas of peeling wallpaper and are in poor condition. The floor linoleum is in fair condition. The linoleum is loose in spots and has tears and cracks. There is a “soft spot” in the floor in the middle of the room. A potential source for this problem is discussed on page 3.1.3-2 of the Main House Structural System. A 2’ x 2’ section of ceiling has been removed adjacent to window 2W-01 to access the attic. Paint on door D9 is slightly worn. Paint on the floor base, door opening trim, and window 2W-01 trim is slightly worn.

Recommended treatment: Clean and disinfect the floor, walls, and ceiling. Repair or replace damaged or missing lath and plaster on walls and ceiling. The walls and ceiling should be restored with historically accurate wallpaper. Rehabilitate deteriorated wood flooring below linoleum in the middle of the room. Protect existing linoleum flooring so that it may be reinstalled after floor repair. Paint may contain lead. Sand, prep, and paint wood base and trim.

Priority: Minor.

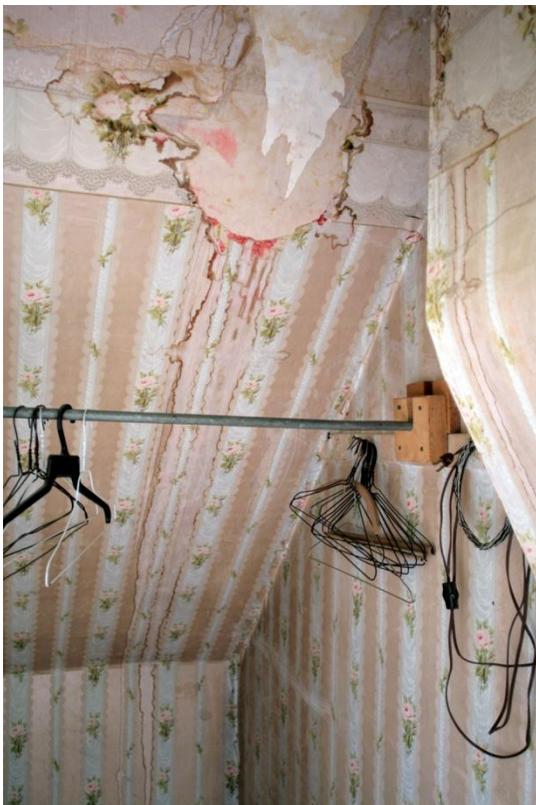
+Bedroom #3 Closet. 2009 photo.

Condition: Walls and ceiling have water damaged areas. This is due to improper flashing in the chimney above this room. Flooring may be vinyl asbestos tile. Flooring is in fair condition. Paint on the floor base is slightly worn.

Recommended treatment: Clean and disinfect the floor. Repair or replace damaged or missing lath and

plaster on walls and ceiling after the roof is replaced. Preserve historic wallpaper on walls and ceiling. Test tile floor for asbestos. If asbestos is found, abate flooring and install new historically accurate linoleum. Sand, prep, and paint wood base and trim.

Priority: Minor.

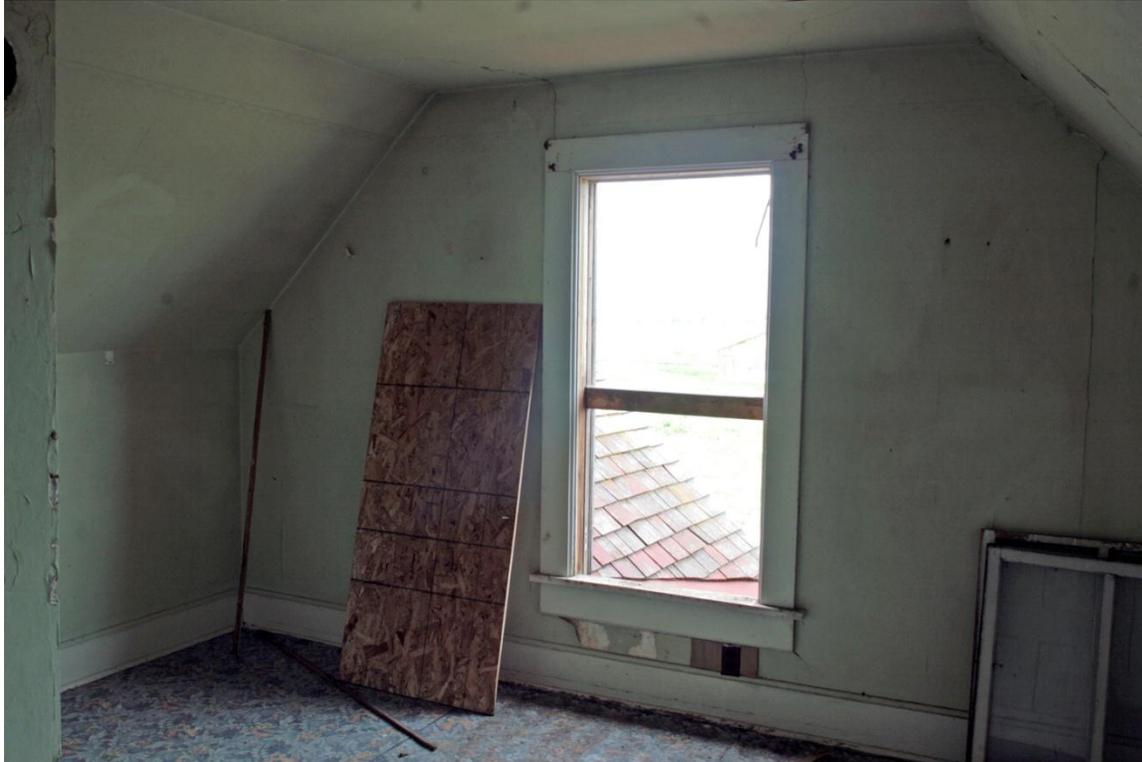
+Bedroom #4. 2009 photo.

Condition: Walls and ceiling have areas of peeling wallpaper and are in poor condition. The floor linoleum is in fair condition. Paint on door D10 is slightly worn. Paint on the floor base, door opening trim, and window 2W-03 trim is slightly worn.

Recommended treatment: Clean and disinfect the floor, walls, and ceiling. Repair or replace damaged or missing lath and plaster on walls and ceiling. The walls and ceiling should be restored with historically accurate wallpaper. Repair deteriorated wood flooring below linoleum

in the middle of the room. Protect existing linoleum flooring so that it may be reinstalled after floor repair. Sand, prep, and paint wood base and trim.

Priority: Minor.

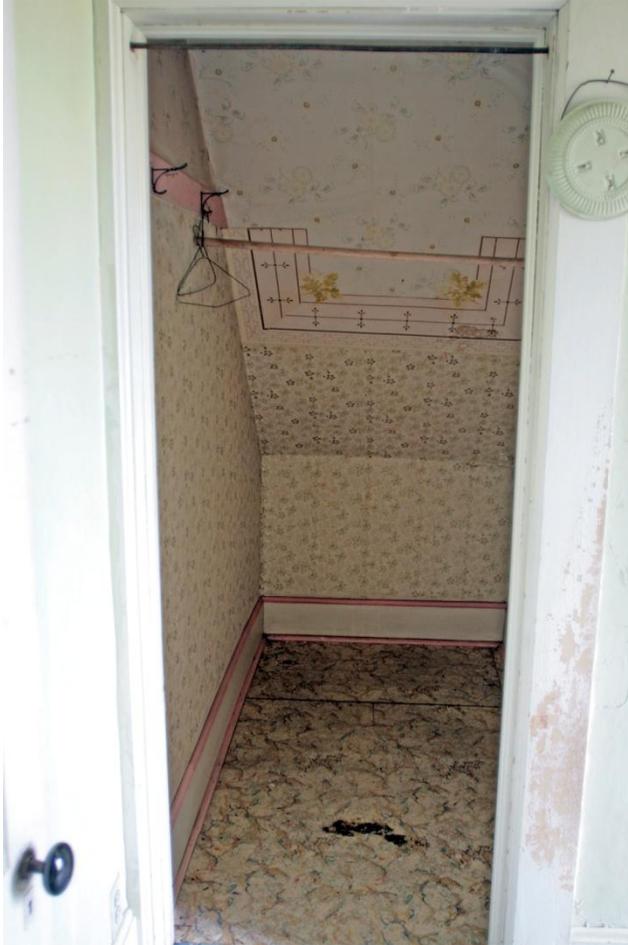
+Bedroom #4 Closet. 2009 photo.

Condition: Wall and ceiling wallpaper are somewhat faded, but in moderately good condition. Linoleum flooring soiled and split near south wall. Paint on the floor base is slightly worn.

Recommended treatment: Clean wallpaper using preservative cleaning methods. Clean and disinfect the floor. Repair split in linoleum. Paint may contain lead. Sand, prep, and paint wood base and trim.

Priority: Minor.

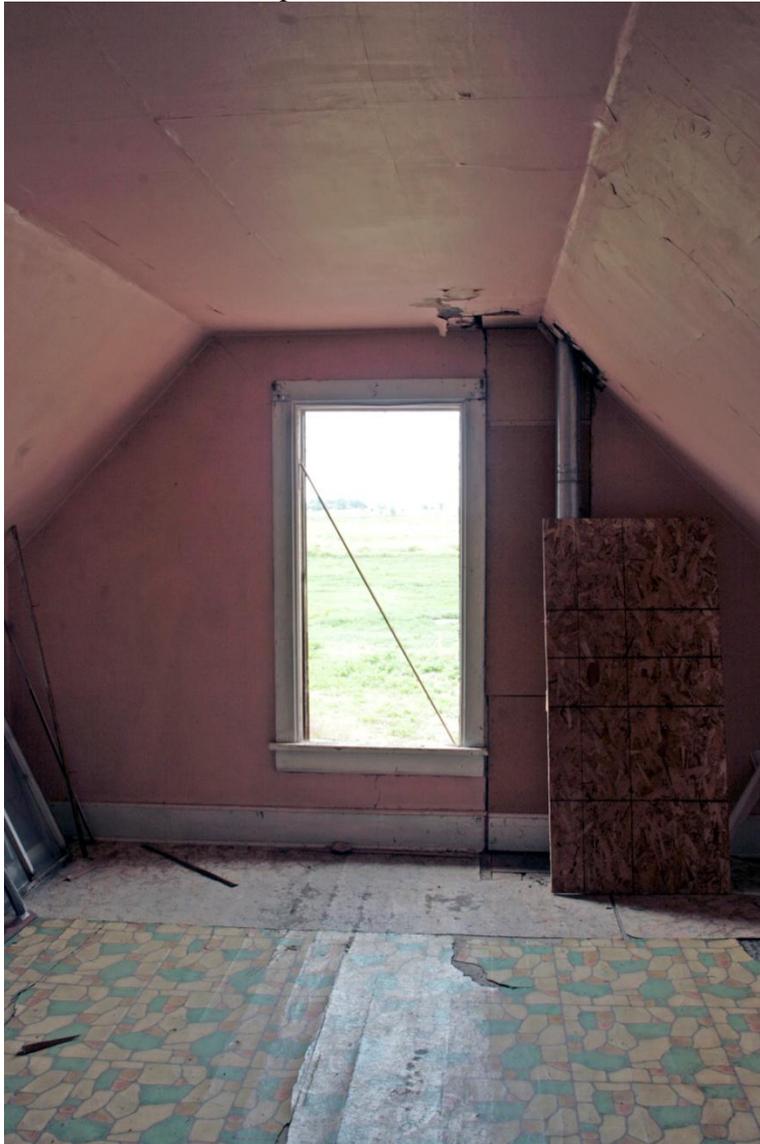
+Bedroom #5. 2009 photo.

Condition: Walls and ceiling have areas of peeling painted wallpaper and are in poor condition. There are two different layers of linoleum visible. Both layers are worn, torn, and have wood

flooring telegraphing through them. The linoleum is in poor condition. There is water damage to the ceiling around the vent opening in the southwest corner of the room. Paint on door D11 is slightly worn. Paint on the floor base, door opening trim, and window 2W-02 trim is moderately worn.

Recommended treatment: Clean and disinfect the floor, walls, and ceiling. Repair or replace damaged or missing lath and plaster on walls and ceiling. The walls and ceiling should be restored with historically accurate wallpaper. The linoleum flooring should be replaced with historically accurate sheet vinyl or linoleum. A new, thin layer of underlayment would help prevent telegraphing of the wood flooring through the new linoleum. Paint may contain lead. Sand, prep, and paint wood base and trim.

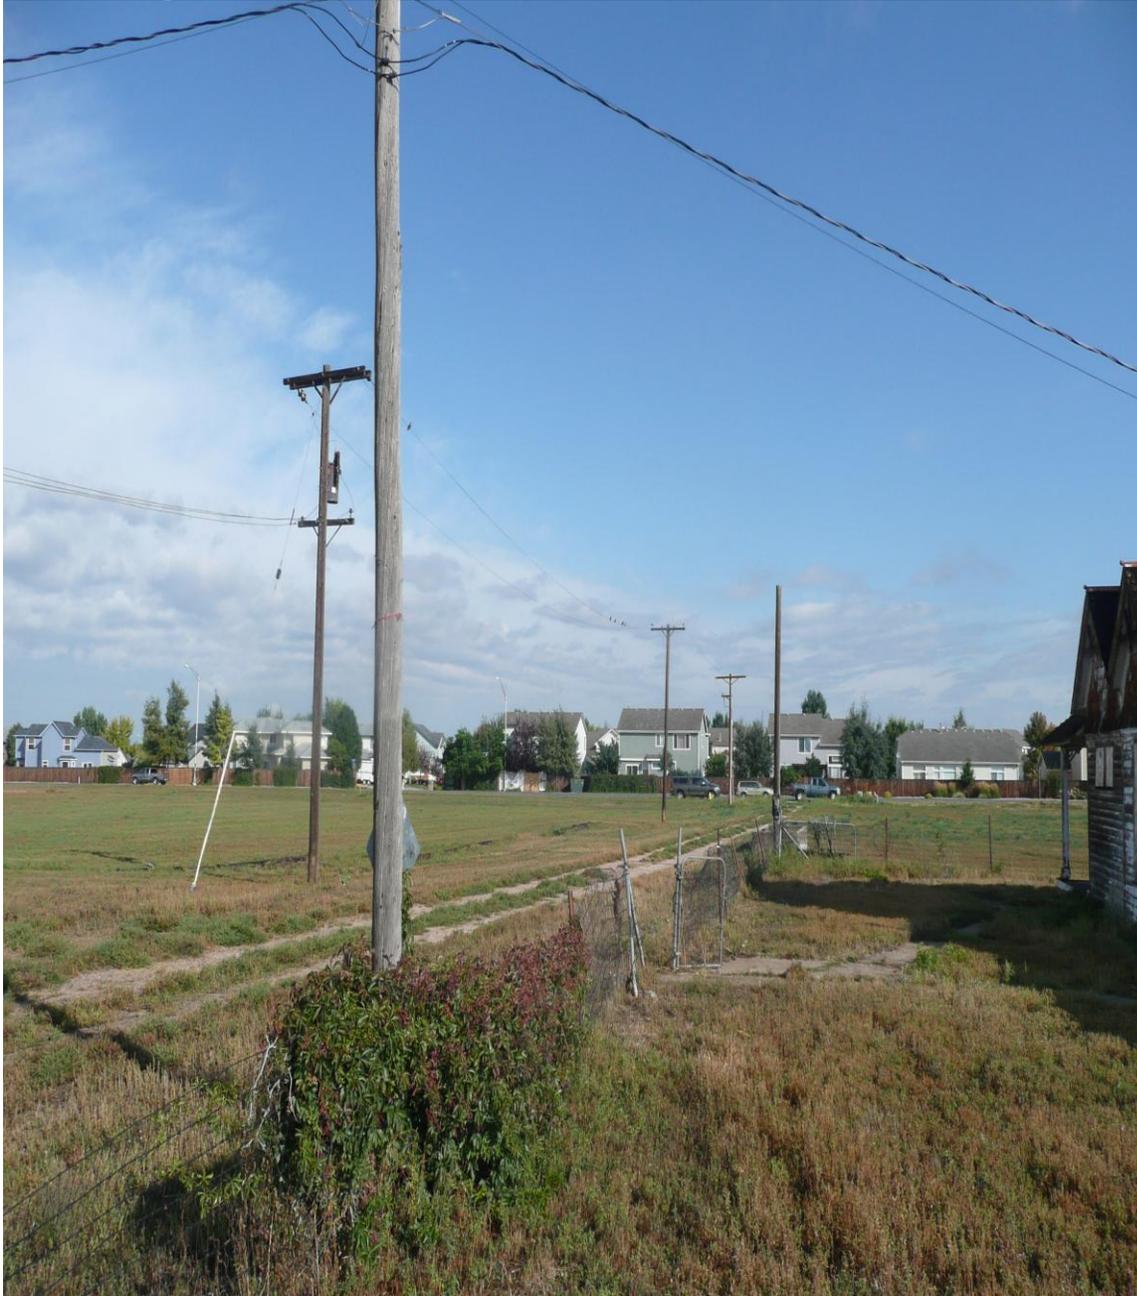
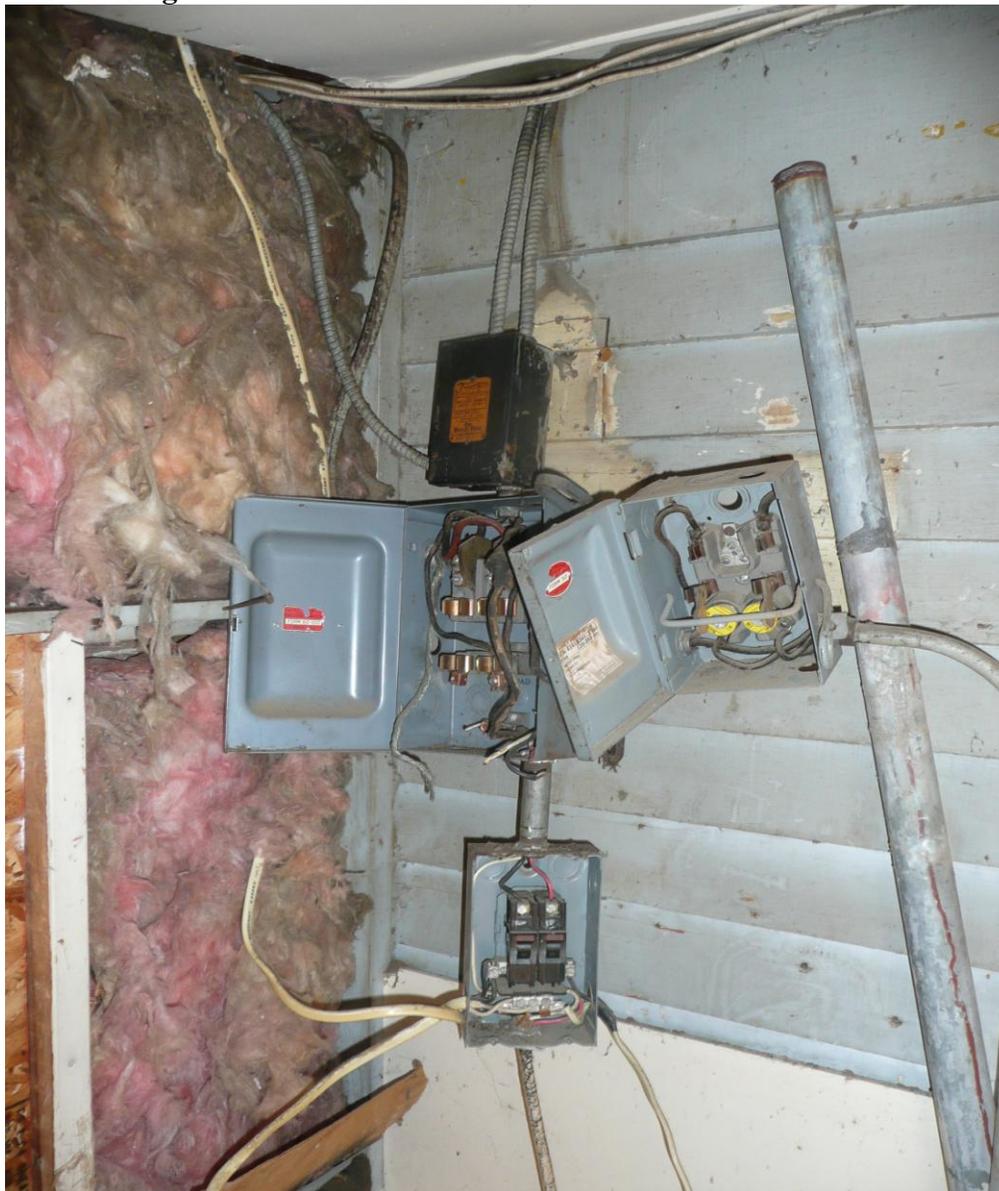
The Existing Main Overhead Service to the Site

The existing overhead service from Bromley Lane is 120/240 volts, single phase and is currently not active. The existing electrical systems include minimal exterior pole mounted lighting, interior incandescent lighting and no fire alarm or security devices.

All of the existing electrical systems are in poor condition due to their age and require replacement.

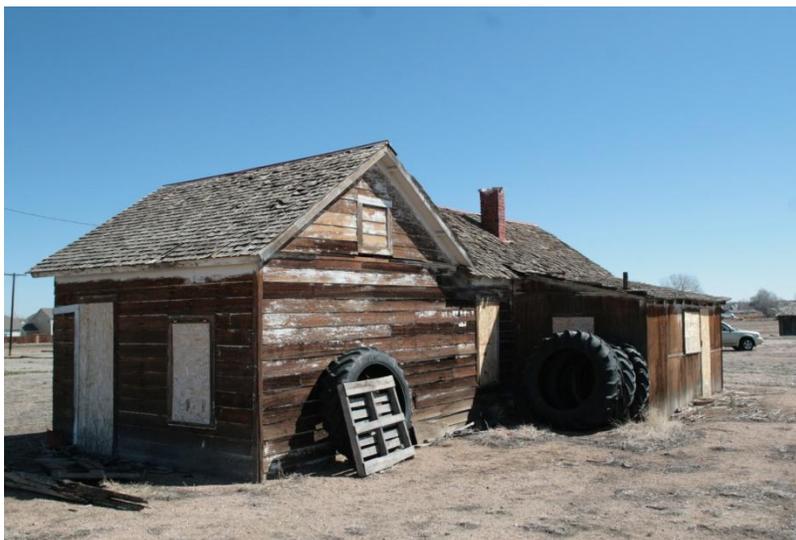
2009 photo.

Condition: Poor. Many of the wood shingles are brittle, warped, or split. Moss and lichen are also present. These slow down the drying process after rains and accelerate deterioration. The Bunk Room ceiling below has extensive water damage. See photograph below. The gable and eave fascia and soffit are weathered and missing paint. Attic ventilation area is not sufficient to meet current building codes.

- Investigate roof structural adequacy per recommendations on page 3.2.3-2.
- Roof -remove all shingles down to gapped board sheathing.
- Install new No. 1 blue label sawn wood shingles. Match size, exposure, nailing pattern, distinctive details, and decorative elements of existing wood shingles. Use a double layer of wood shingles for the starter course.
- Rehabilitate and reuse the existing galvanized metal ridge.
- Install historically sympathetic attic vents to meet current building codes.
- Paint may contain lead. Remove any loose paint from the gable fascia and soffit. Check them for decay. Consolidate or replace deteriorated areas.
- Sand and prep the fascia and soffit for new paint.
- Apply primer and two coats high-quality acrylic latex paint. Paint color(s) should be historically accurate.

Priority: Critical.

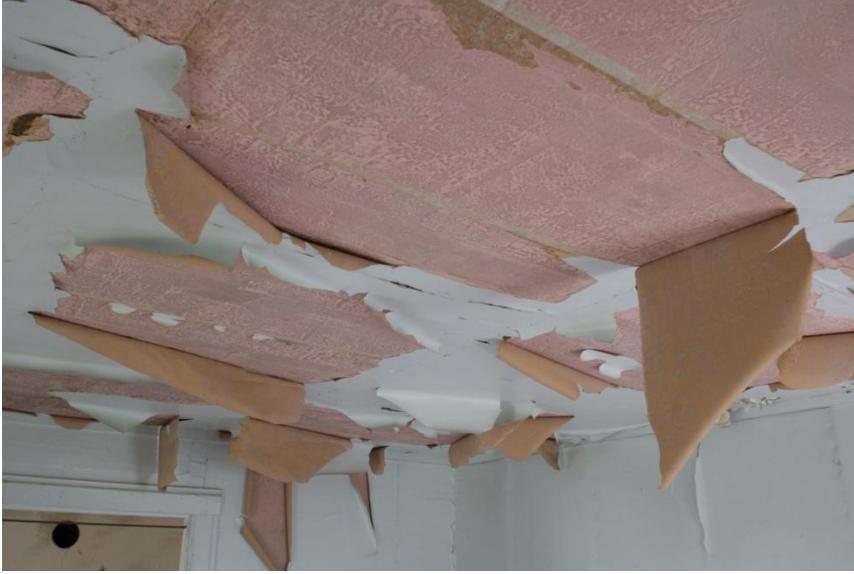
Bunk Room ceiling, 2009 photo.

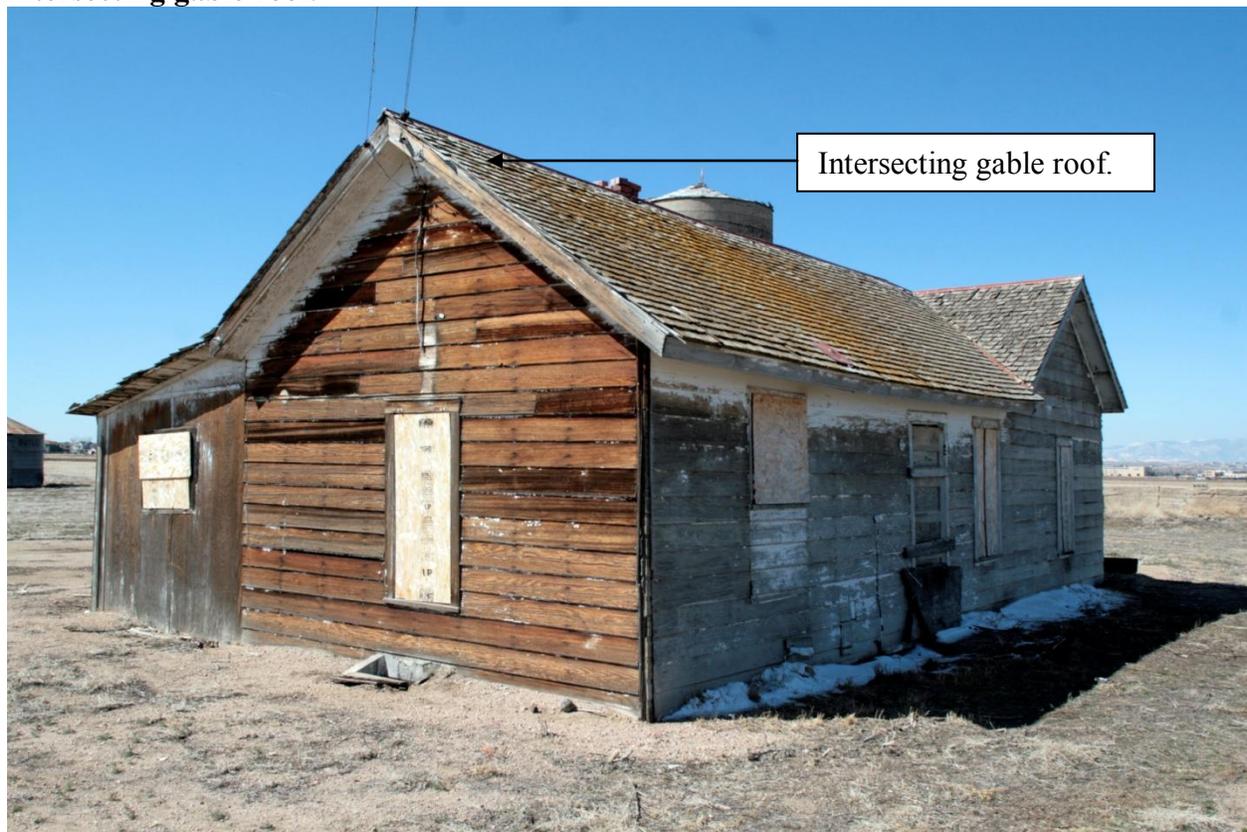
2009 photo.

Condition: Poor. Many of the wood shingles are brittle, warped, or split. The fascia and soffit are weathered and missing paint. Moss and lichen are also present. These slow down the drying process after rains and accelerate deterioration. The plumbing vent on the lower north face is missing its stack and is poorly flashed. The brick chimney has deteriorated mortar joints, has loose bricks at the top, is missing a cap, and is poorly flashed. (See photograph on next page.) The gable and eave fascia and soffit are weathered and missing paint

- Roof - Roof -remove all shingles down to gapped board sheathing.
- Install new No. 1 blue label sawn wood shingles. Match size, exposure, nailing pattern, distinctive details, and decorative elements of existing wood shingles. Use a double layer of wood shingles for the starter course. Per oral histories, the roof were painted red.
 - Recondition and reuse the existing galvanized metal ridge.
 - Paint may contain lead. Remove any loose paint from the gable fascia and soffit. Check them for decay. Consolidate or replace deteriorated areas.
 - Paint may contain lead. Sand and prep the fascia and soffit for new paint.
- Apply primer and two coats high-quality acrylic latex paint. Paint color(s) should be historically accurate.

Priority: Critical.

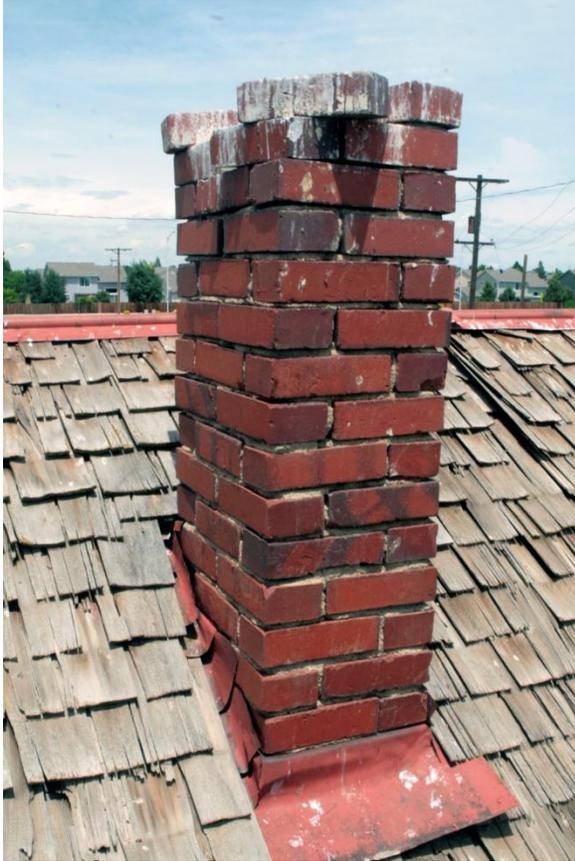
Brick chimney on south face of roof. 2009 photo.

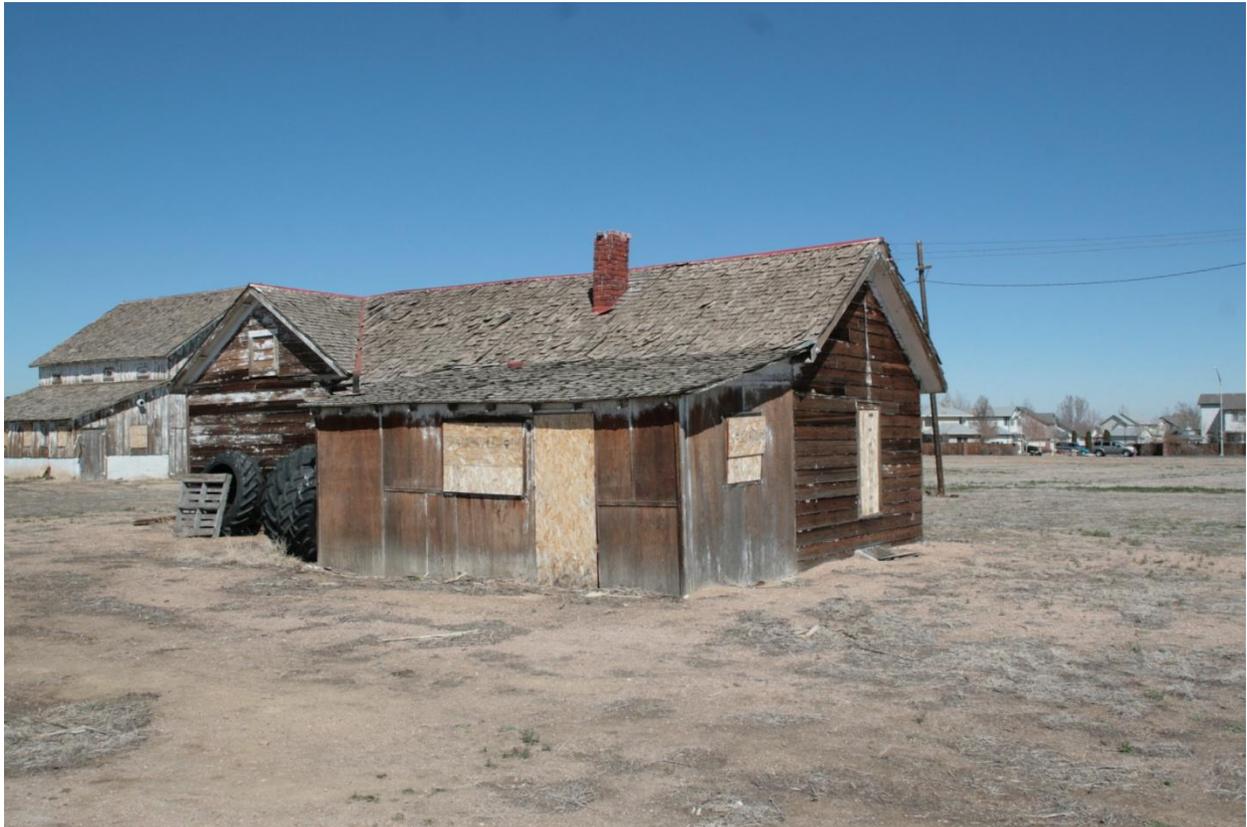
2009 photo.

Condition: Poor. Many of the wood shingles are brittle, warped, or split. Moss and lichen are also present. These slow drying after rains and accelerate deterioration. The Porch closet ceiling below has extensive water damage. Daylight is visible above the porch ceiling. (See photographs on page 3.2.5-6.). Plumbing vent flashing has pulled away from the roof. (See photograph on page 3.2.5-6.)

- Roof -remove all shingles down to gapped board sheathing.
- Install new No. 1 blue label sawn wood shingles. Match size, exposure, nailing pattern, distinctive details, and decorative elements of existing wood shingles. Use a double layer of wood shingles for the starter course.
- Repair or replace flashing around vent.
- Paint may contain lead. Remove any loose paint from underside of exposed sheathing boards and exposed rafter ends. Check them for decay. Consolidate or replace deteriorated areas.
- Sand and prep the underside of exposed sheathing boards and exposed rafter ends for new paint.
- Apply primer and two coats high-quality acrylic latex paint. Paint color(s) should be historically accurate.

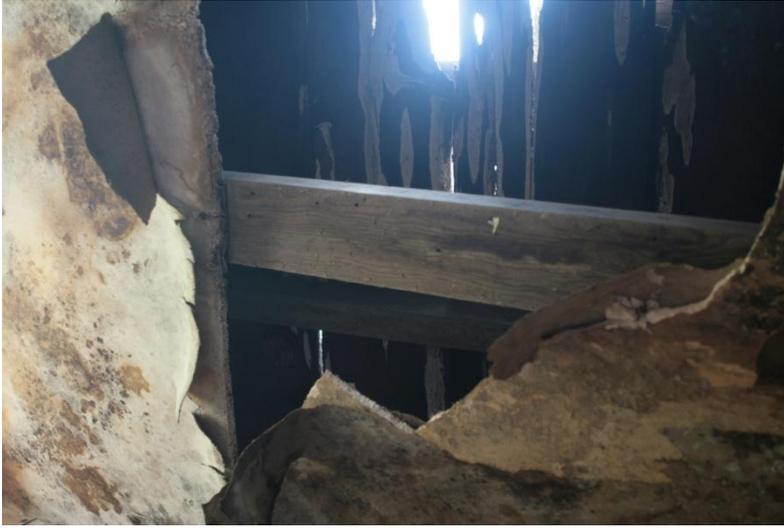
Porch closet ceiling. 2009 photo.

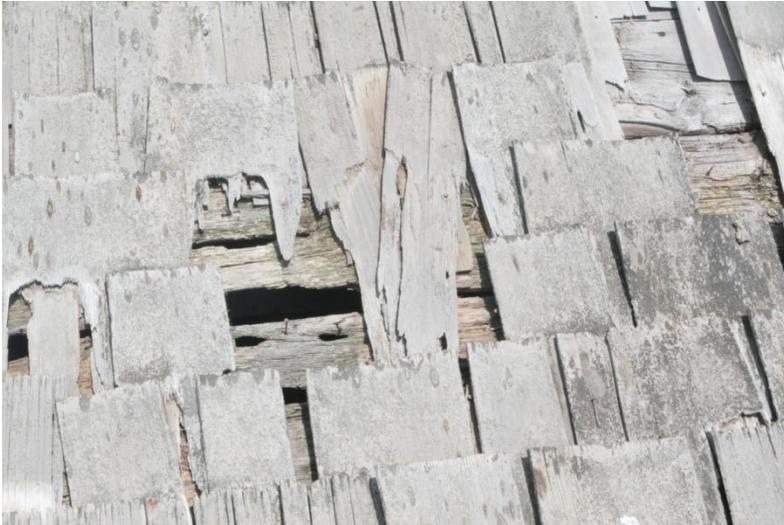
Deteriorated shed roof shingles above Porch closet. 2009 photo.

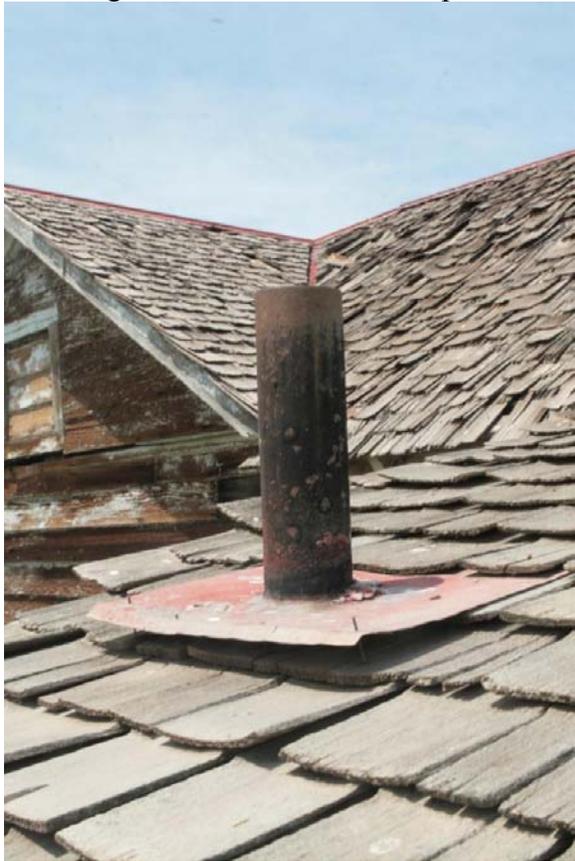
Plumbing vent on shed roof. 2009 photo.

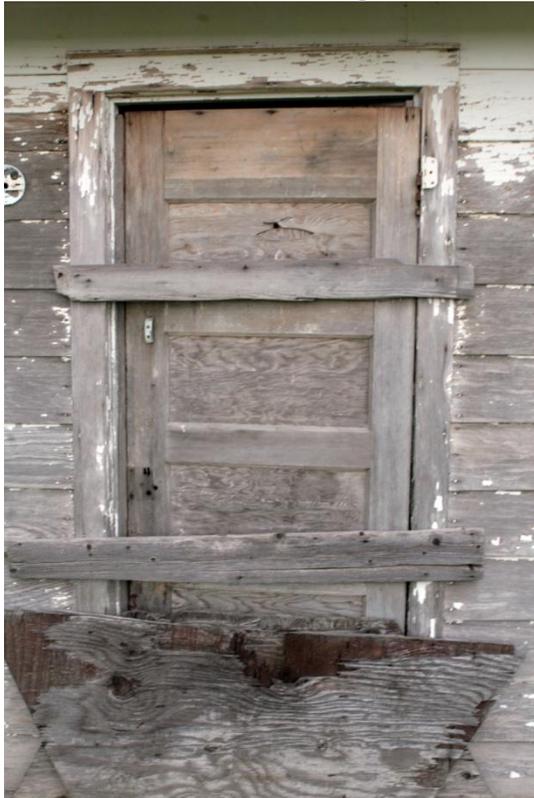
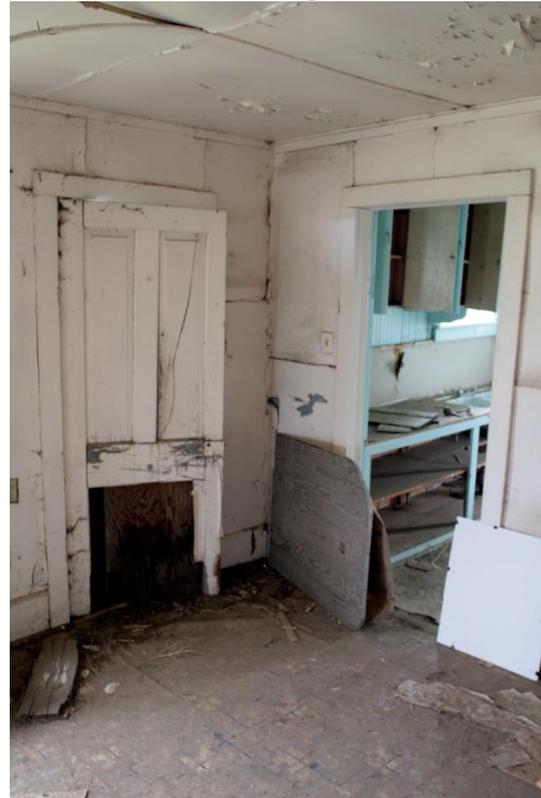
Door D1, exterior 2009 photo.

Description: The north entry door, D1, is actually a pair of wood doors, one swinging out, and one swinging in. They are located on the north façade of the Migrant Worker House between windows

1W-01 and 1W-09. Each is a 2'-8" wide x 7'-0" high historic wood stile and rail door. The exterior door has four horizontal panels and no lights. The exterior door is not mounted on hinges; it only rests in the door opening. Hinges for a screen door are surface mounted on the top right of this door frame. It is highly unlikely that these three doors were in place at the same time. Most likely the interior door was original and the exterior door was placed in the opening at a later time as protection. The interior door has a pair of vertical panels and one horizontal panel. Both doors are painted white. Exterior and interior trim is painted 1" x 4" wood.

Priority: Serious.

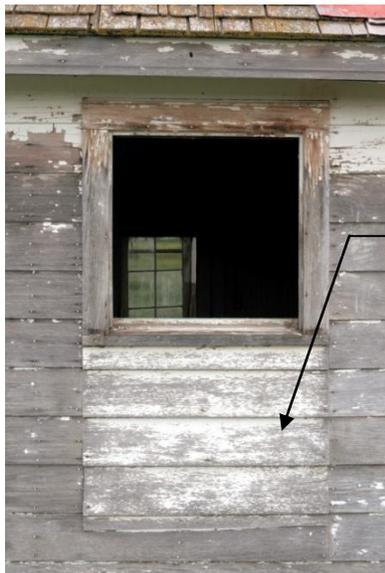
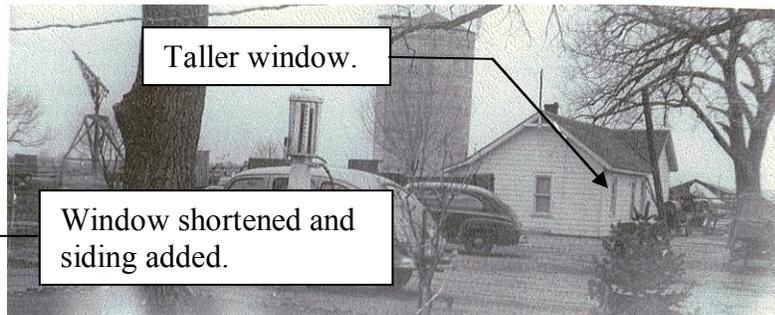
Window 1W-01. 2009 photo. Window 1W-01. Circa 1947 photo.

Description: This window is located on the north wall of the Kitchen. The sash is missing. It appears that this was a fixed sash window. The window opening measures 3'-0" wide x 2'-6" high. The historic photograph shows that this window was once much taller and double hung. The inset wood siding below the window in the current photograph is also suggestive of this modification. The exterior trim is painted white. The interior trim is also painted

white. There is clip hardware on the exterior face of the frame for a screen, but the screen has been removed.

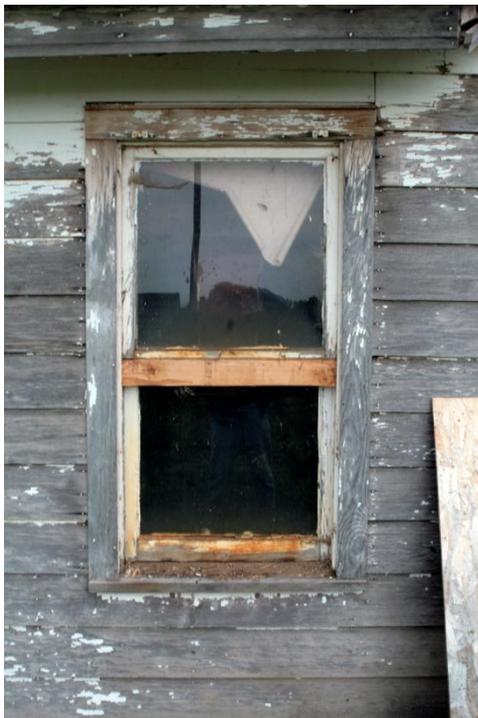
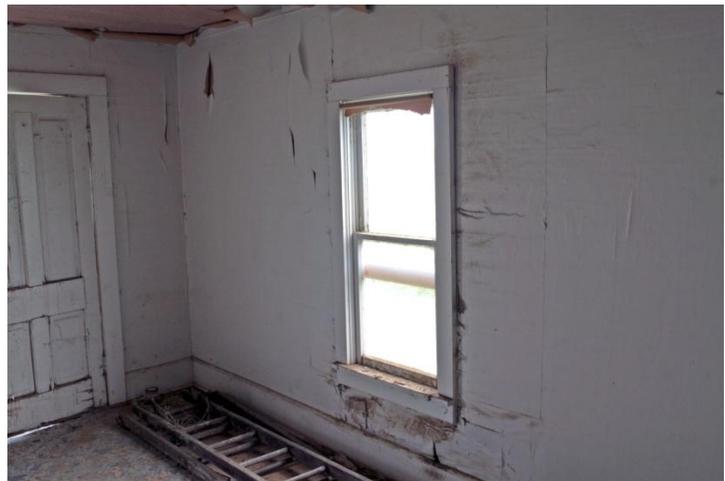
Windows 1W-08 (interior photo) and 1W-09 (exterior photo). Both 2009 photos.

Description: These are historic 2'-4" wide x 4'-7" high wood double hung windows. They are located west of door D1 on the north facade. The upper sash, lower sash, and window frame have been painted white on the inside and outside faces. Glazing is single pane. Protective particle

board panels currently cover each opening. There is clip hardware on the exterior face of each frame for a screen, but both screens have been removed. Exterior window trim consists of painted 1" x wood. Interior window trim is a painted wood molding and sill.

Condition: The exterior finish of the sash, frame, and trim for both windows is extremely weathered. The interior finish is slightly worn at each window. The lower sash of window 1W-08 is extremely deteriorated. The bottom rails of the upper and lower sash of window 1W-09 are extremely deteriorated. Neither window is currently operational. Lock hardware is missing.

Priority: Serious.

Recommended treatment: Paint may contain lead. Remove all loose paint on the exterior face of the sash, frame, and the exterior trim for both windows. Rebuild the lower sash of window 1W-08. Replace the lower sash rails of window 1W-09. Sand and prep. Replace broken glass pane in window 1W-09. Install new glazing putty for all lights. Repaint with two coats high quality acrylic latex paint. On the interior sand and prep the sash, frame, and trim. Paint. Remove, refinish, and reinstall all stops. Replace missing hardware with historically accurate hardware. Restore windows and hardware to operable and functional condition. The historic screens for these windows may be stored inside the Migrant Worker House, or another building on the site. If the historic screens for these windows can be located, they should be rehabilitated, repainted, and installed. If they cannot be located, new, historically accurate wood screens should be fabricated and installed. The screens for these windows are not shown in the historic photograph currently available. Further research may yield more complete information about this screen.

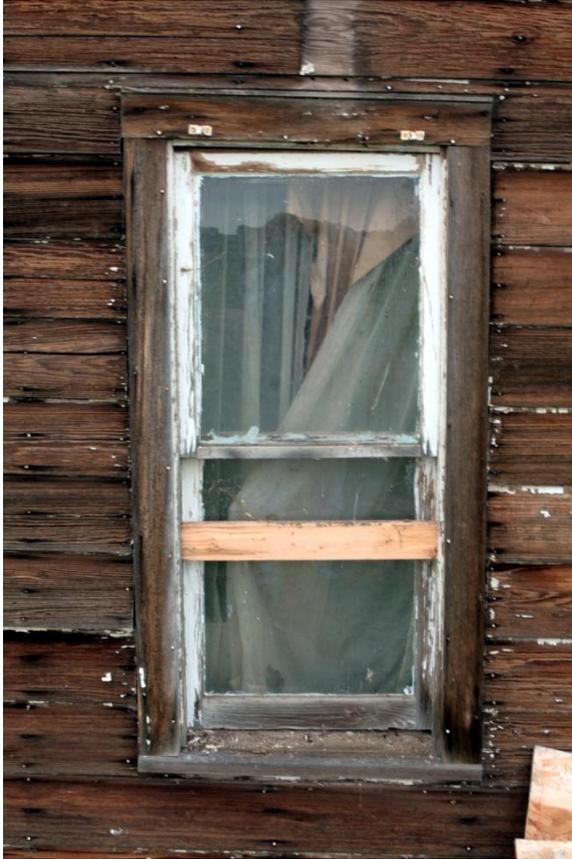
Window 1W-02. 2009 photo.

Description: This is a historic 2'-0" wide x 4'-7" high wood double hung window. It is located at the far north end of the east façade. The upper sash, lower sash, and window frame have been painted white on the inside and outside faces. Glazing is single pane. Protective particle board panels currently cover the opening. There is no window screen. There are, however, hooks on the frame for an exterior screen. Exterior window trim consists of painted 1" x wood. Interior window trim is a painted wood molding and sill.

Condition: The exterior finish of the sash, frame, and trim is extremely weathered. The head trim piece is warped and beginning to rot. The exterior stops are very deteriorated. The upper and lower sash do not fit tightly in the frame. The interior finish is slightly worn. Lock hardware is missing. The window is not currently operable.

Priority: Serious.

Recommended treatment: Paint may contain lead. Remove all loose paint on the exterior face of the sash, frame, and the exterior trim. Remove deteriorated stops in the frame. Recondition sash

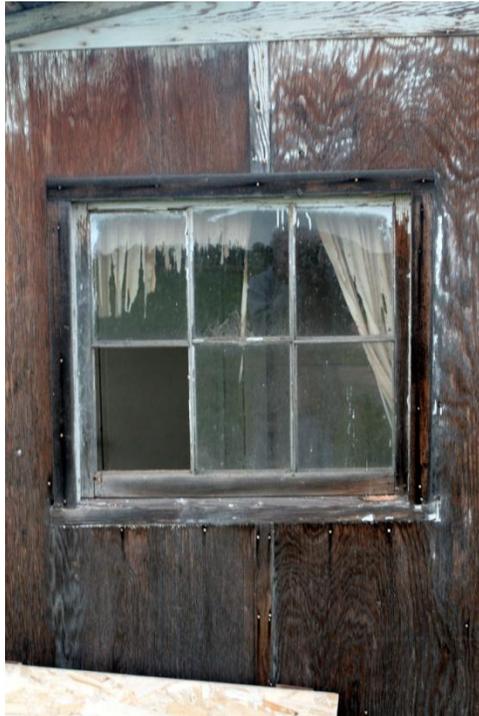
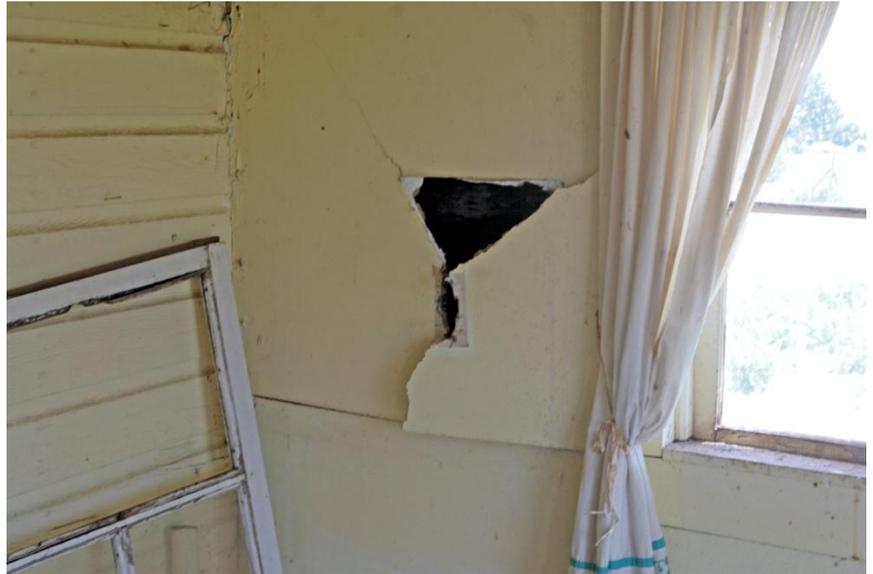
Window 1W-03. Exterior and interior. Both 2009 photos.

Description: This window is a 3'-0" wide x 2'-4" high historic wood six-light. The glazing is single pane in a fixed sash. Exterior trim is painted 1" x 2" wood. Interior trim is painted wood molding with a painted wood sill.

Condition: The exterior frame, sash, and wood trim are extremely weathered, but structurally sound. The interior of the sash, frame, and molding are worn and need paint. The lower left light is broken.

Priority: Serious.

Recommended treatment: Paint may contain lead. Remove all loose paint on the exterior face of the sash, frame, and the exterior trim. Replace missing glazing. Install new glazing putty for all lights. Repaint with two coats high quality acrylic latex paint. On the interior sand and prep the sash, frame, and trim. Paint. Remove, refinish, and reinstall all stops.
