Bromley Farm

Master Plan

Historic Structures Assessment

Prepared by:
Avenue L Architects
March 18, 2010

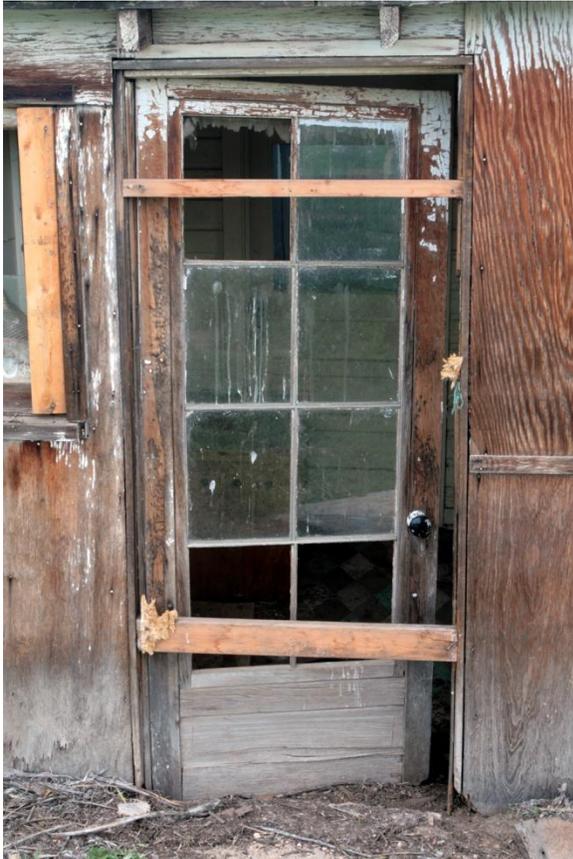
Door D2.

Description: Door D2 is 2'-8" wide x 6'-4" high. It is a historic wood 8-light, single pane, stile and rail door. There is no exterior trim. Interior trim is molding painted white. There is no screen door. There is no hardware or other visible evidence which suggests that this opening ever had a screen door. There are no known historic photographs which show this side of the Migrant Worker House.

Condition: The exterior finish for the door and frame is severely weathered. Dirt has accumulated against the bottom of the door and is migrating inside the door opening. This prevents the door from closing completely. The bottom rail and lower end of both stiles water damaged and rotted. The bottom two lights and the top left light are broken. The interior face of the door and interior wood trim finish are moderately degraded. Currently the door opening is covered with a plywood security panel.

Priority: Critical.

Recommended treatment: Paint may contain lead. Remove the existing door, frame, and interior wood trim. After the exterior grade has been corrected,

reconstruct the door and frame. Remove loose paint from the interior wood trim. Reinstall the door, frame, and wood trim. Rehabilitate and reuse existing hardware, if possible. Otherwise

replace hardware with new historically accurate hardware. Replace missing glazing. Install new glazing putty for all lights. Prime and repaint with two coats high quality acrylic latex paint.

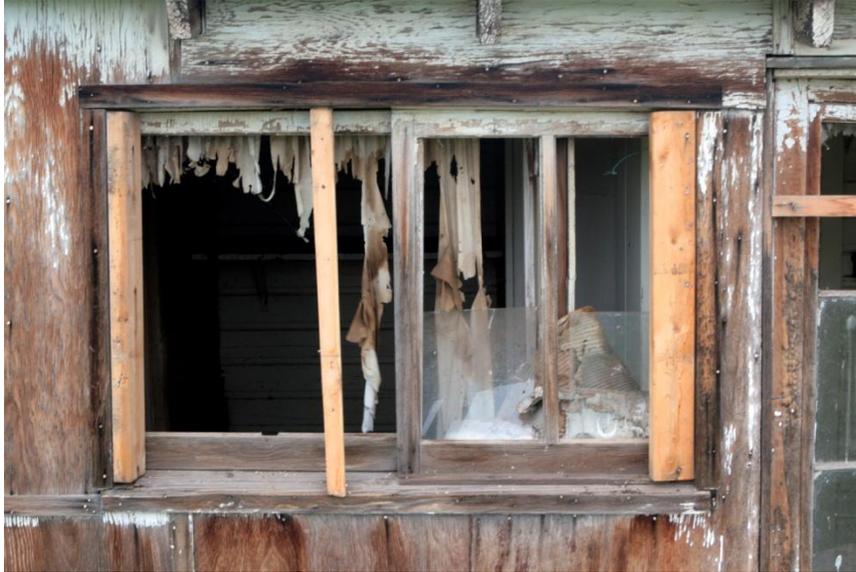
Window 1W-04. 2009 photo.

Description: This window is a historic 3'-10" wide x 2'-6" high wood slider. It is located on the south wall of the Porch and the Porch Closet. Glazing is single pane. Exterior and interior trim are painted 1" x 2" wood. There is no screen window. There is no hardware or other visible evidence which suggest that this opening ever had a window screen. Currently the window is protected by a plywood security panel. There are no known historic photographs which show this window.

Condition: The exterior finish is mostly worn away. Each sash is water damaged and has broken glazing. The frame is in poor condition. Exterior trim and sill are warped and water damaged. Interior trim is also water damaged due to the leaky ceiling and lack of glazing. Hardware is missing. The window does not appear to be operational.

Priority: Serious.

Recommended treatment: Remove existing sliders and all wood trim including the sill. Reconstruct the window frame. Reconstruct each sash. Replace glazing. Install new glazing putty. Restore windows and hardware to operable and functional condition. Replace interior and exterior wood trim. Sand and prep sash, frame, and trim. Prime and repaint with two coats high quality acrylic latex paint.

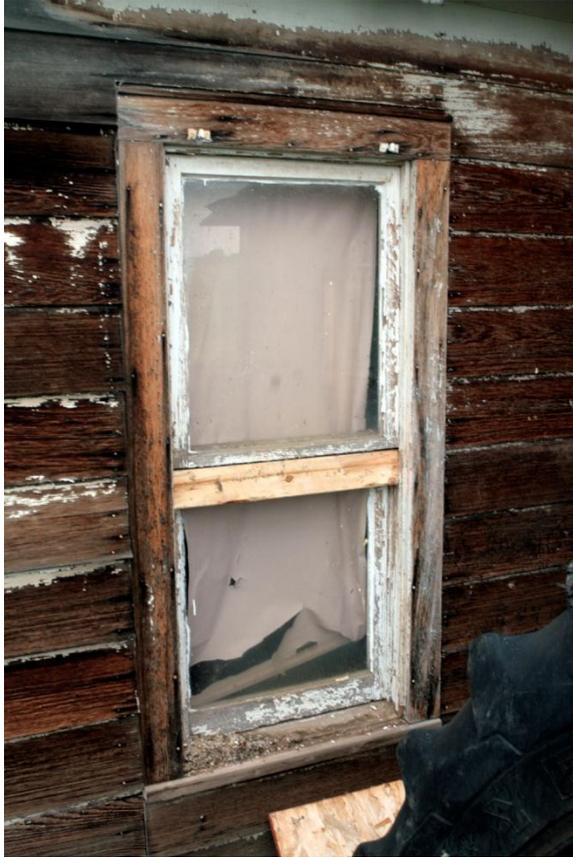
Window 1W-05. 2009 photo.

Description: This is a historic 2'-0" wide x 4'-7" high wood double hung window. It is located at the southwest corner of the Dining Area. The upper sash, lower sash, and window frame have been painted white on the inside and outside faces. Glazing is single pane. Protective particle board panels currently cover the opening. There is no window screen. There are, however, hooks on the frame for an exterior screen. Exterior window trim consists of painted 1" x wood. Interior window trim is a painted wood molding and sill.

Condition: The exterior finish of the sash, frame, and trim is extremely weathered. The head trim piece is warped and beginning to rot. The exterior stops are very deteriorated. The upper and lower sash do not fit tightly in the frame. The interior finish is slightly worn. Lock hardware is missing. The window is not currently operable.

Priority: Serious.

Recommended treatment: Paint may contain lead. Remove all loose paint on the exterior face of the sash, frame, and the exterior trim. Remove deteriorated stops in the frame. Restore windows

and hardware to operable and functional condition. Sand and prep. Install new glazing putty for all lights. Repaint with two coats high quality acrylic latex paint. On the interior sand and prep the sash, frame, and trim. Paint. Remove, refinish, and reinstall all stops. The historic screen for this window may be stored inside the Migrant Worker House, or another building on the site. If the historic screen for this window can be located, it should be rehabilitated, repainted, and installed. If it cannot be located, a new, historically accurate wood screen door should be fabricated and installed. There are no known historic photographs which show this window. Further research may yield more complete information about this screen.

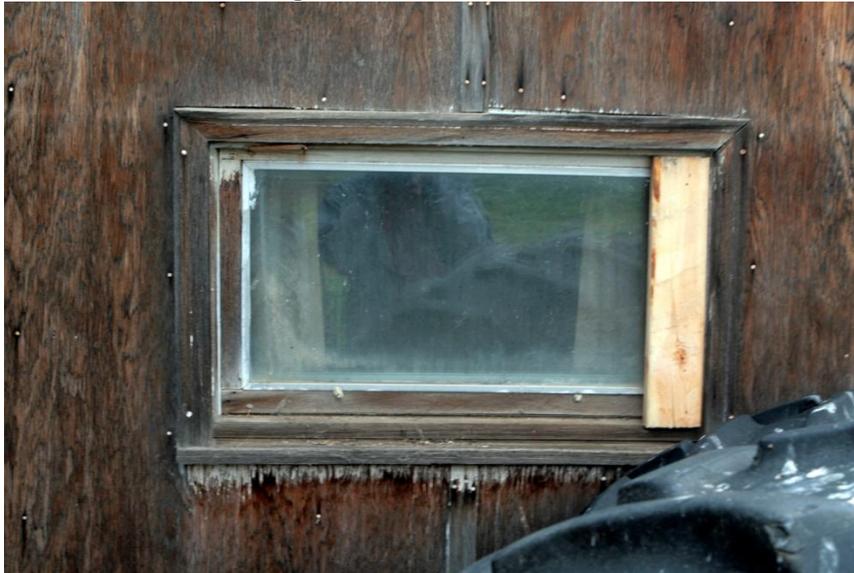
Window 1W-06. 2009 photo.

Description: This window is located on the west wall of the Bathroom. It is a 2'-6" wide x 1'-8" high awning style window with single pane, clear glazing. Exterior trim is 1" x 2" wood. There is an aluminum screen located on the inside face of the opening. Interior trim is painting wood molding.

Condition: Paint on the exterior sash, frame, and trim is mostly worn away. Paint of the interior of the frame, sash, and molding has deteriorated. The sash does not fit tightly in the frame. Operation of the window could not be tested.

Priority: Serious.

Recommended treatment: Paint may contain lead. Remove any loose paint on the window. Reconstruct the frame so that the sash fits more tightly. Replace the non-historic aluminum screen with a wood framed screen. Install new glazing putty. Sand and prep the sash, frame, and trim. Prime and repaint the exterior with two coats high quality acrylic paint. Repaint the interior frame, sash, screen frame, and wood trim. Recondition the window and provide historically accurate hardware so that the window is operational.

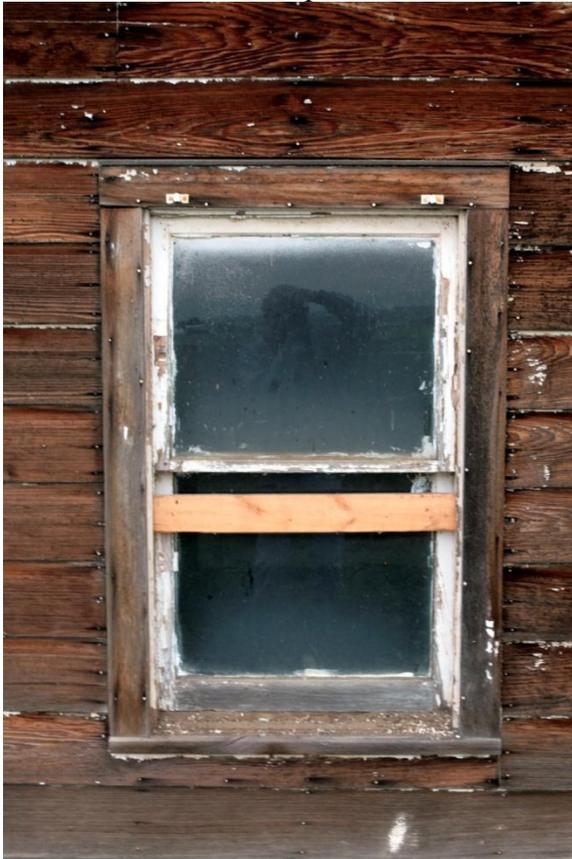
Window 1W-07. 2009 photo.

Description: This is a historic 2'-4" wide x 3'-11" high wood double hung window. It is located at the west wall of the Bunk Room. The upper sash, lower sash, and window frame have been painted white on the inside and outside faces. Glazing is single pane. Protective particle board panels currently cover the opening. There is no window screen. There are, however, hooks on the frame for an exterior screen. Exterior window trim consists of painted 1" x wood. Interior window trim is a painted wood molding and sill.

Condition: The exterior finish of the sash, frame, and trim is extremely weathered. The head trim piece is warped and beginning to rot. The exterior stops are very deteriorated. The upper and lower sash do not fit tightly in the frame. The interior finish is slightly worn. Lock hardware is missing. The window is not currently operable.

Priority: Serious.

Recommended treatment: Paint may contain lead. Remove all loose paint on the exterior face of the sash, frame, and the exterior trim. Remove deteriorated stops in the frame. Restore windows and hardware to operable and functional condition. Replace head trim. Sand and prep. Install new glazing putty for all lights. Repaint with two coats high quality acrylic latex paint. On the interior sand and prep the sash, frame, and trim. Paint. Remove, refinish, and reinstall all stops. The historic screen for this window may be stored inside the Migrant Worker House, or another building on the site. If the historic screen for this window can be located, it should be refurbished, repainted, and installed. If it cannot be located, a new, historically accurate wood screen door should be fabricated and installed. There are no known historic photographs which show this window. Further research may yield more complete information about this screen.

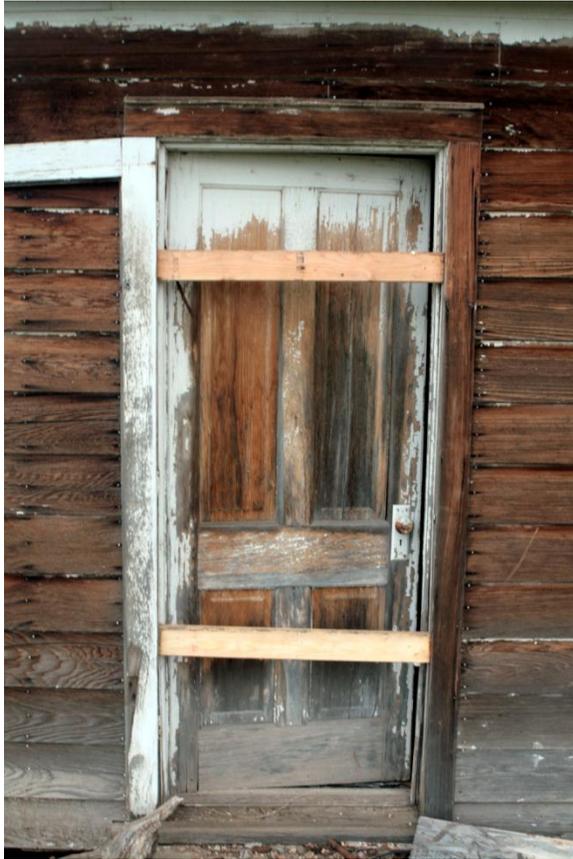
Door D3. 2009 photo.

Description: Door D3 opens onto the west wall of the Bunk Room. It is a 2'-8" wide x 6'-11" high historic wood stile and rail door. The door has four vertical panels. The historic wood screen door has been removed. Hinges for the screen door are visible on the south edge of the door frame. The exterior of the door and frame are painted white. The interior of the door and frame are also painted white. Exterior trim is painted 1" x 4" wood. The interior trim is a simple wood molding painted white. Door hardware consists of a historic keyed latch set.

Condition: The exterior of the door, frame, and the exterior trim are extremely weathered and missing most of their paint. The frame is not square. This condition does not allow the door to close completely. The door sill is rotted. The interior finish on the door, frame, and trim is in fair condition. The historic latch set is in place, but it could not be determined if the latch set was operable.

Recommended treatment: Paint may contain lead.

Remove all loose paint on the exterior face of the door, frame, and the exterior trim. Rebuild the frame so that is square. Refinish, repair, and reinstall all stops. Replace the wood door sill. Sand and prep the door, frame, and trim. Re-hang the door. Repaint exterior with two coats high quality acrylic latex paint. Sand and prep the interior face of the door and, frame, and trim. Apply new paint. Restore door and hardware to operable and functional condition. The historic wood screen door may be stored inside the Migrant Worker House, or another building on the site. If the historic wood screen door can be located, it should be rehabilitated, repainted, and installed. If it cannot be located, a new, historically accurate wood screen door should be fabricated and installed. There are no known historic photographs which show this window. Further research may yield more complete information about this screen door.

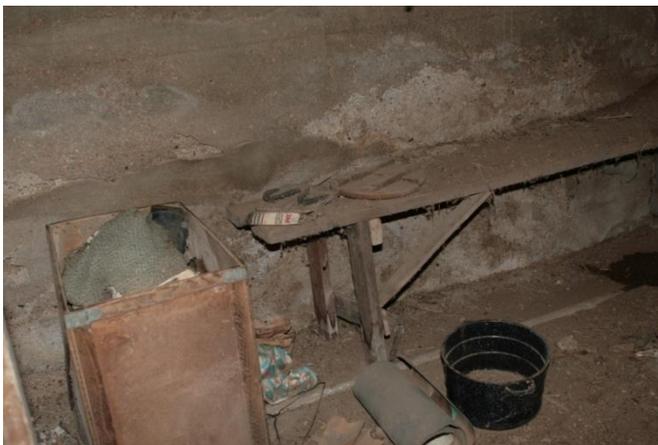
+Cellar south wall looking at floor. 2009 photo.

Walls: Concrete parging.
Ceiling: None. Exposed floor joists.
Floor: Concrete.
Base: None.
Interior Doors: D5. Floor hatch in ceiling above stair.
Window-coverings: None.
Special features, historic: Wood stairs on east side. Concrete shoulder walls, approximately 18" thick, on north, west, and south sides. Built-in wood shelving on west wall.

Condition: Floor is covered with dirt, debris, and some animal droppings. The wall is spalling due to efflorescence and freeze-thaw effects. Ceiling has thick cobwebs. Hatch is operable.

Recommended treatment: Thoroughly clean and disinfect floor, walls, and ceiling. Treat walls for spalling per structural recommendations on page 3.2.2-1, item b.

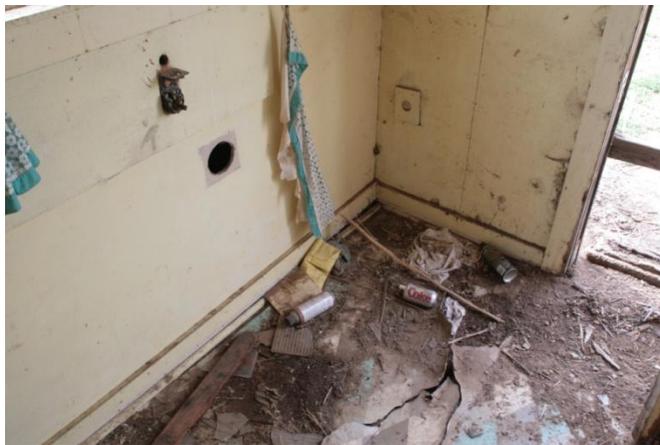
+Porch looking at southeast corner. 2009 photo.

Walls: Painted 5/8" fiberboard.
 Ceiling: Painted plywood.
 Floor: Linoleum over 3 1/4" tongue and groove wood flooring.
 Base: Painted 1"x 4" wood with 1/4 round shoe at floor.
 Interior Doors: See Kitchen and Closet descriptions.
 Window-coverings: None.
 Special features, historic: None.
 Special features, non-historic: None.

Condition: Floor structure and wood flooring are rotted near exterior door. Linoleum is torn and loose. Floor is covered with dirt, debris, and some animal droppings. 1/4 round base is broken and deteriorated. Fiberboard wall is broken in northeast corner. Wall paint is in poor condition. Ceiling has light minor water damage.

Recommended treatment: Remove linoleum. Repair floor structure per structural recommendations on page 3.2.3-2. Replace rotted tongue and groove flooring. Replace damaged fiber board wall with new fiber board and paint. Refinish painted plywood ceiling. Thoroughly clean and disinfect floor, walls, and ceiling. Treat for mold.

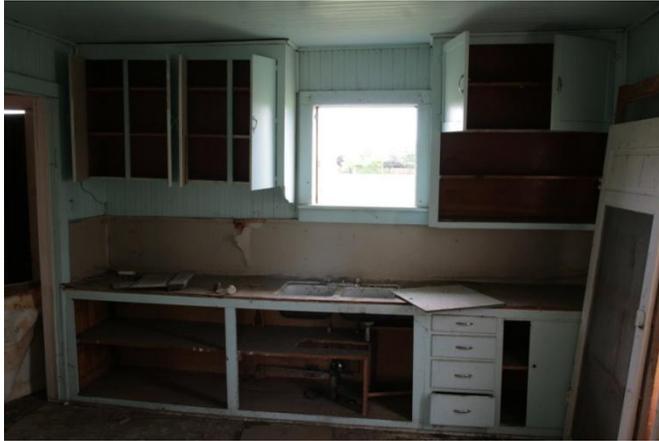
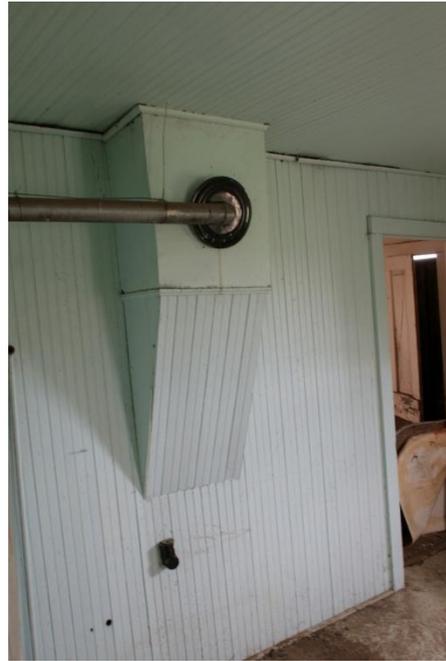
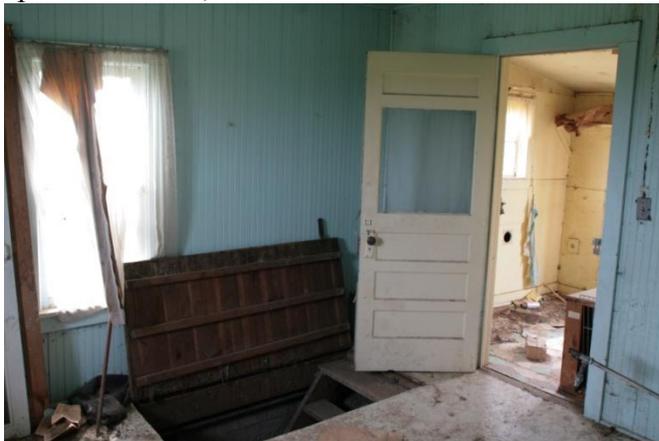
+Kitchen.

Kitchen north wall. 2009 photo.

Kitchen west wall. 2009 photo.

Condition: Floor is covered with dirt and some animal droppings. Linoleum has cracks and is torn or missing in some locations. Base has gouges and scratches. Bead board wall has scratches,

dents, stains, and deteriorated paint. Door and trim are scratched and dented. Drapes are in extremely poor condition. Curtains are in poor condition. Ceiling has deteriorated paint. Wall cabinet doors do not close completely or stay latched. Four base cabinet sliding doors have been removed. Linoleum on counter top is torn and missing. Counter top underlayment is decomposing.

Recommended treatment: Thoroughly clean and disinfect floor, walls, and ceiling. Treat for mold. Replace linoleum flooring and underlayment. Sand, prep, and repaint walls, floor base, door and trim, and ceiling. Restore door D6 and hardware to operable and functional condition. Replace counter top. Rehabilitate or replace wall and base cabinet doors and catch hardware. Reuse and rehabilitate wall cabinet hinges. Thoroughly clean cabinet shelving and drawers. Repair and rehabilitate drawers and drawer slides for smooth operation. Replace window-coverings with new, historically accurate window-coverings. It is recommended that further research be conducted to determine what the kitchen configuration may have been before the sill for window 1W-01 was raised. The final layout of the kitchen is dependent upon the final use of this building and corresponding period of historical significance.

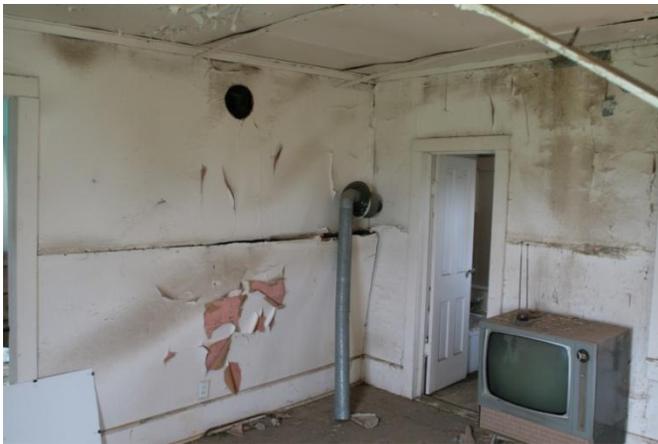
+Dining Area south east corner. 2009 photo.

Walls: Two layers wall-covering over 1/4" masonite over wood studs.
Ceiling: Painted 1/4" masonite covered with painted wood battens.
Floor: Two layers linoleum over 3 1/4" tongue and groove wood flooring. Dates of linoleum could not be determined.
Base: Painted 1" x 8" wood with 1/4 round shoe at floor.
Interior Doors: None. Trim: 1" x 4" wood trim on openings between Dining Area and Kitchen and Dining Area and Bathroom. 1" x 5" shiplap trim on opening between

Condition: Extensive water damage to all walls. Masonite is becoming detached on east wall. Walls have mold. Extensive water damage to ceiling. Ceiling panels are sagging and bowed. Some battens have become detached from ceiling. Ceiling has mold. Floor is covered with dirt and some animal droppings. Linoleum is torn and split. Base is scratched and dented. Door and window opening trim is scratched and dented with deteriorating paint. Window shades are brittle and torn. Heater vent is detached from east wall. No heater was observed.

Recommended treatment: The floor in this room should be removed and replaced. See recommendation b. on page 3.2.3-2 for alternative replacement methods and additional information. Salvage existing tongue and groove flooring so that it could be rehabilitated and re-

used as a finish floor material over the new floor. Alternatively a new, historically appropriate linoleum could be used as a finish floor material. Treat walls and attic for mold. Remove and replace damaged wall-covering and masonite with new gypsum wallboard and historically appropriate wall-covering. Replace damaged ceiling with new painted gypsum wallboard and wood battens. Remove and rehabilitate existing wall base and re-install. Rehabilitate wood trim around openings. Replace shades with new historically appropriate shades.

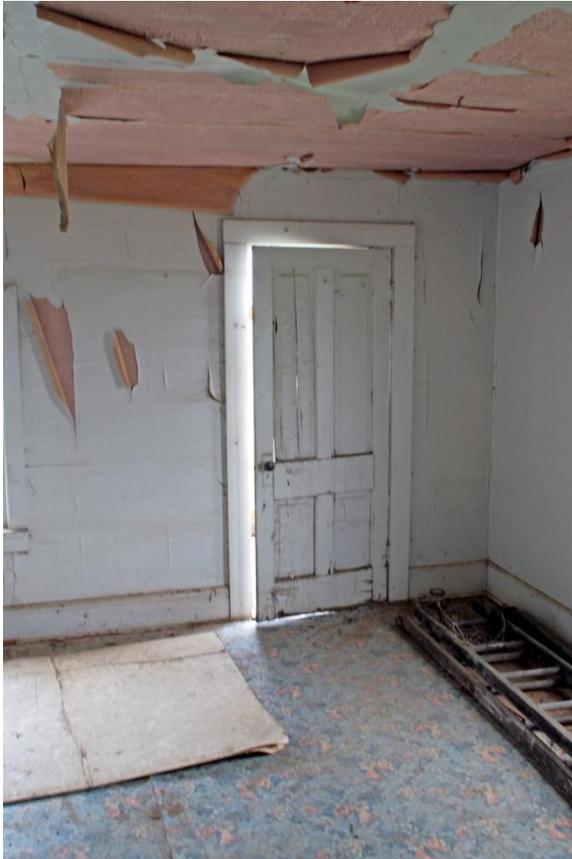
+Bunk Room northwest corner. 2009 photo.

Walls: Two layers wall-covering over 1/4" masonite over wood studs.

Ceiling: Painted 1/4" masonite covered wallpaper. Painted 1" x 2" wood ceiling trim.

Condition: Extensive water damage to all walls. Extensive water damage to ceiling. Ceiling has mold. Floor is covered with dirt and some animal droppings. Linoleum is torn and missing in spots. Base is scratched and dented with deteriorating paint. Door and window opening trim is scratched and dented with deteriorating paint. Window

Recommended treatment: The floor in this room should be removed and replaced. See recommendation b. on page 3.2.3-2 for alternative replacement methods and additional information. Salvage existing tongue and groove flooring so that it could be rehabilitated and re-used as a finish floor material over the new floor. Alternatively a new, historically appropriate linoleum could be used as a finish floor material. Treat walls and ceiling for mold. Replace damaged wall-covering and masonite with new gypsum wallboard and historically appropriate wall-covering. Replace damaged ceiling with new painted gypsum wallboard and historically appropriate wallpaper. Remove and rehabilitate existing wall base and re-install. Rehabilitate wood trim around openings. Replace shades with new historically appropriate shades.

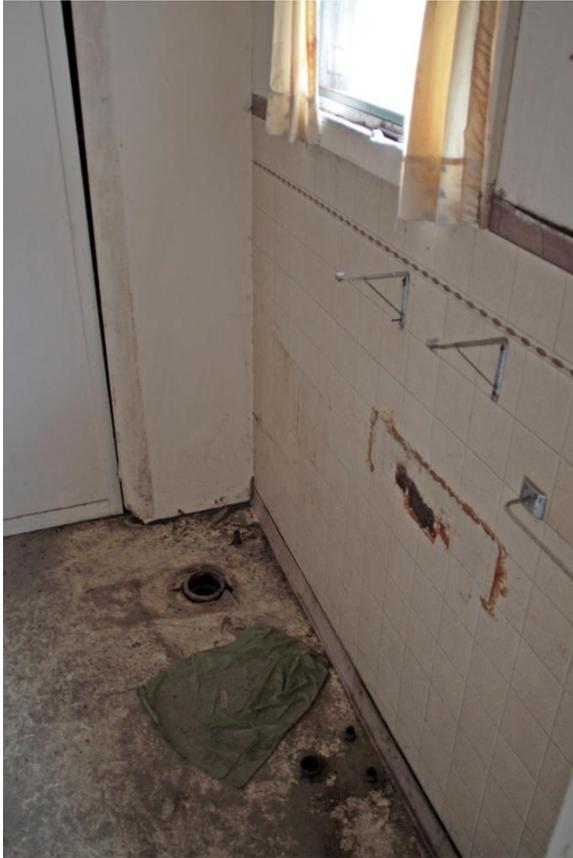
Bathroom west wall. 2009 photo.

Walls: Wainscot. Wall-covering over fiberboard over wood studs. Above Wainscot. Painted fiberboard.

Ceiling: Painted fiberboard.

Condition: Moisture damage to all walls. Walls are not water resistive. Moisture damage to ceiling. Ceiling is not water resistive. Ceiling has mold. Floor is covered with dirt and mold.

Linoleum is torn and brittle. Flooring is soft around water closet opening. Base is dented and water damaged, but is not historic. Door and window opening trim is in fair condition. Window

shade is brittle and extremely deteriorated.

Recommended treatment: This room will be redesigned to new handicap accessible bathroom.

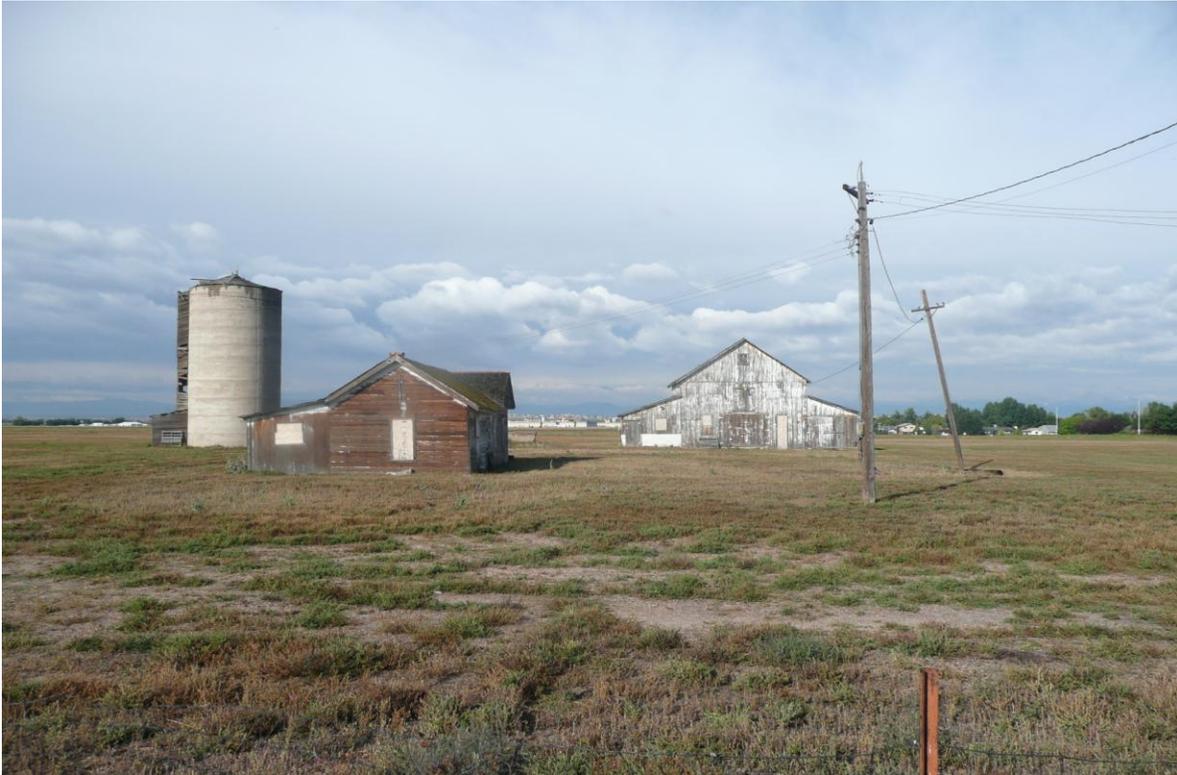
Overhead service to the house

The existing structure is fed with an overhead service to a weatherhead on the east side of the building. Within the structure there is a small breaker/fuse panel and minimal lights and receptacles. There are no fire alarm or security devices.

All of the existing electrical systems are in poor condition due to their age and require replacement.

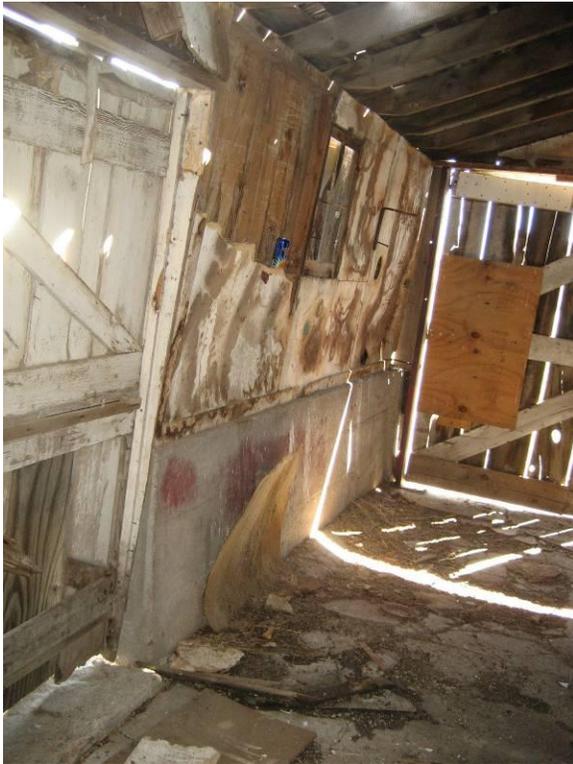
The exterior foundation system is generally in fair condition except at the concrete knee walls. The knee walls have rotated outward by between 1" and 3". The worst deflection has occurred at the north and northwest walls. Rotation appears to be a direct result of the lack of foundation support along the exterior while the inside of the walls are supported by the slab. The south walls are cracked over their full height in three locations. The cracking along the southwest wall is particularly severe and appears to be a result of vehicle impact.

North concrete knee wall and stud wall leaning outward, 2009.

- a. Cut new reinforcing bars in across existing cracks in knee walls and grout. Pull the concrete knee walls back to plumb where they are displaced. Underpin all of the concrete knee walls with intermittent pad footings at frost depth supporting a short segment of 6" stem wall up to the bottom of the knee wall. Cut slots in the interior side of the walls to accept dowels from the new foundation elements and grout the slots. Backfill. Priority: Critical.

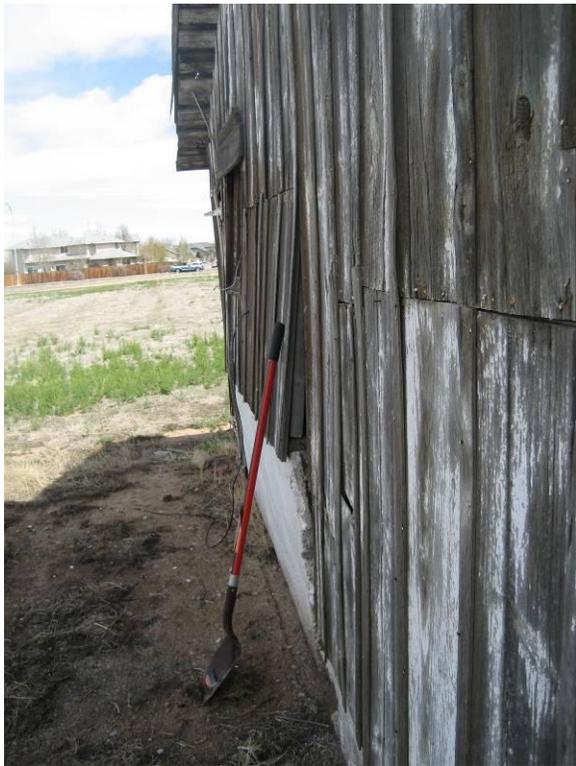
Northwest knee wall rotation, 2009.

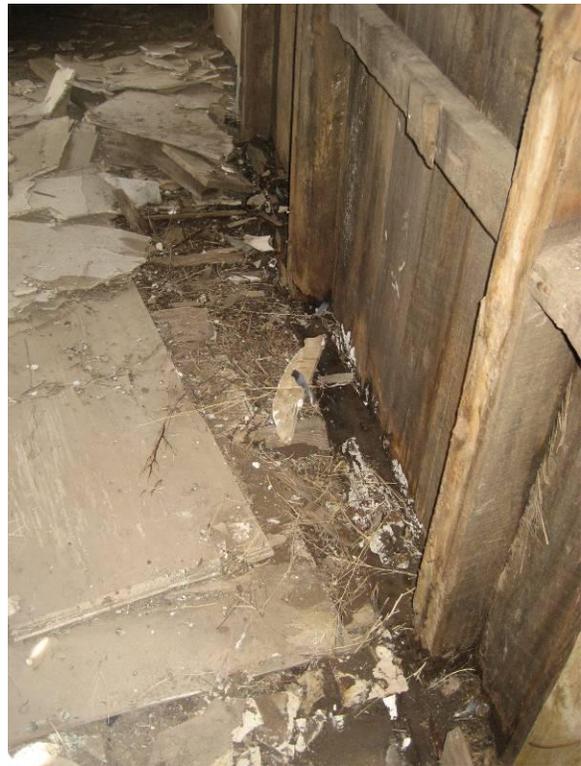
The interior foundation system is in fair condition. Some areas have built-up detritus on the floor which is holding moisture and rotting the wood sills and post bases. A complete evaluation cannot be made until the interior is cleaned down to the slab. Preliminary calculations indicate that new foundations will be required for conformance with wind and seismic provisions of the IBC as noted in the recommendations.

Rotting post bases and sill at south interior bearing wall, 2009.

- d. Clean the slab, sills and post bases for inspection. Replace 12 feet of deteriorated sill along the south interior stud wall. Epoxy consolidate or splice new ends to three deteriorated posts. Since the condition of the rest of the elements is unknown the cost estimate includes an informed guess for additional quantities of work required. Priority: Serious.

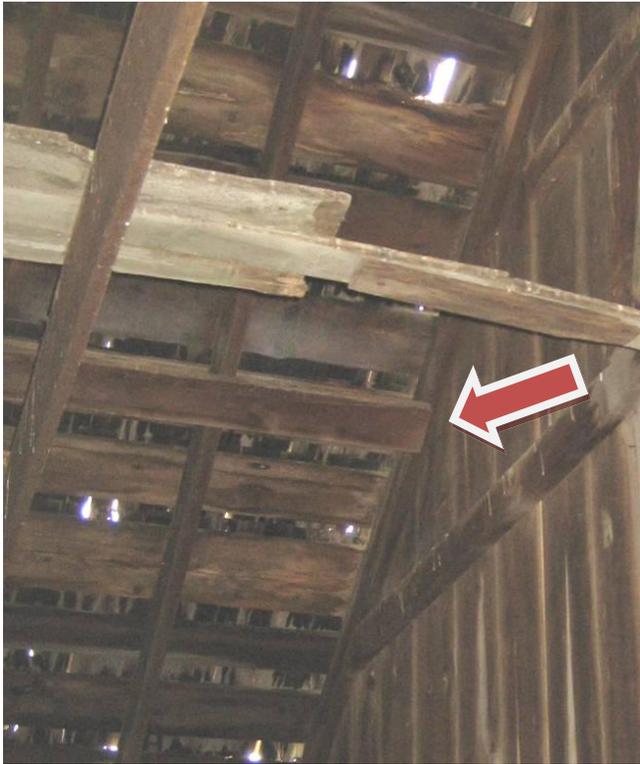
The double 2x6 intermediate roof girders are inadequate to meet current Code and require support at the exterior walls. None of the rafters are tied down to resist wind uplift.

Typical high roof girder unsupported at exterior wall, 2009.

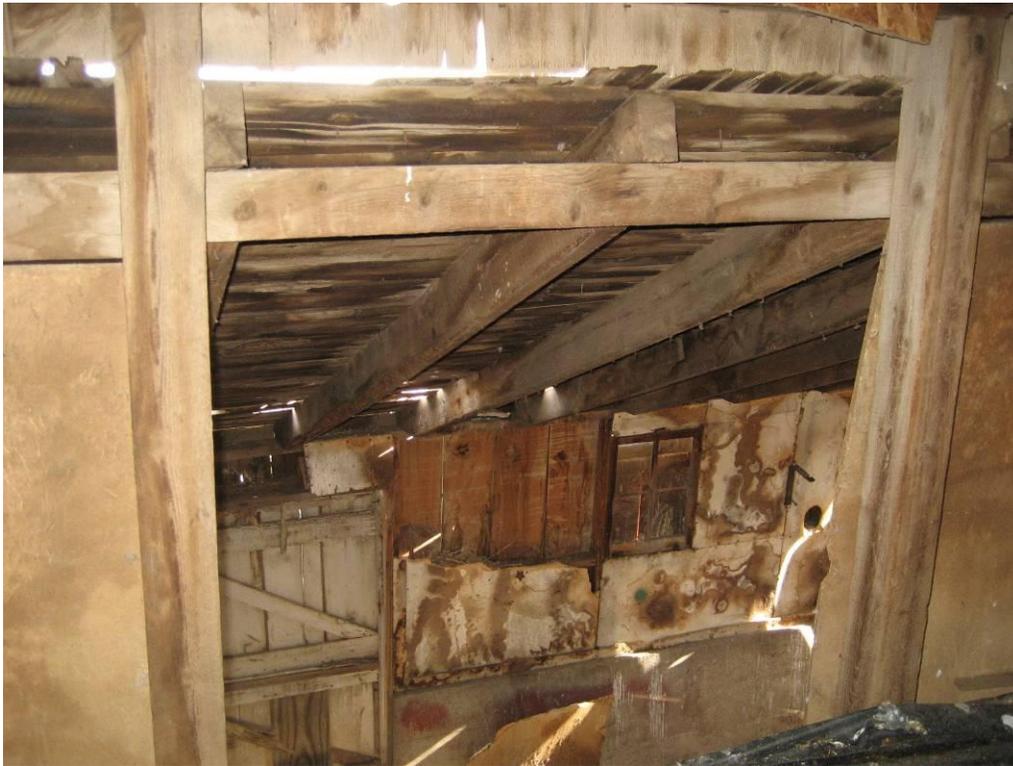
The shed roof rafters are substantially deflected; probably due to snow drifting from the upper roofs. The framing does not meet current Code requirements for snow load. The single top plate is inadequate to carry rafter loads under current Code. The 1x exterior vertical sheathing is currently carrying part of those loads to the knee walls. The non-structural ceiling at the South Area is in poor condition and has partially collapsed.

Shed roof framing with significant deflection, 2009.

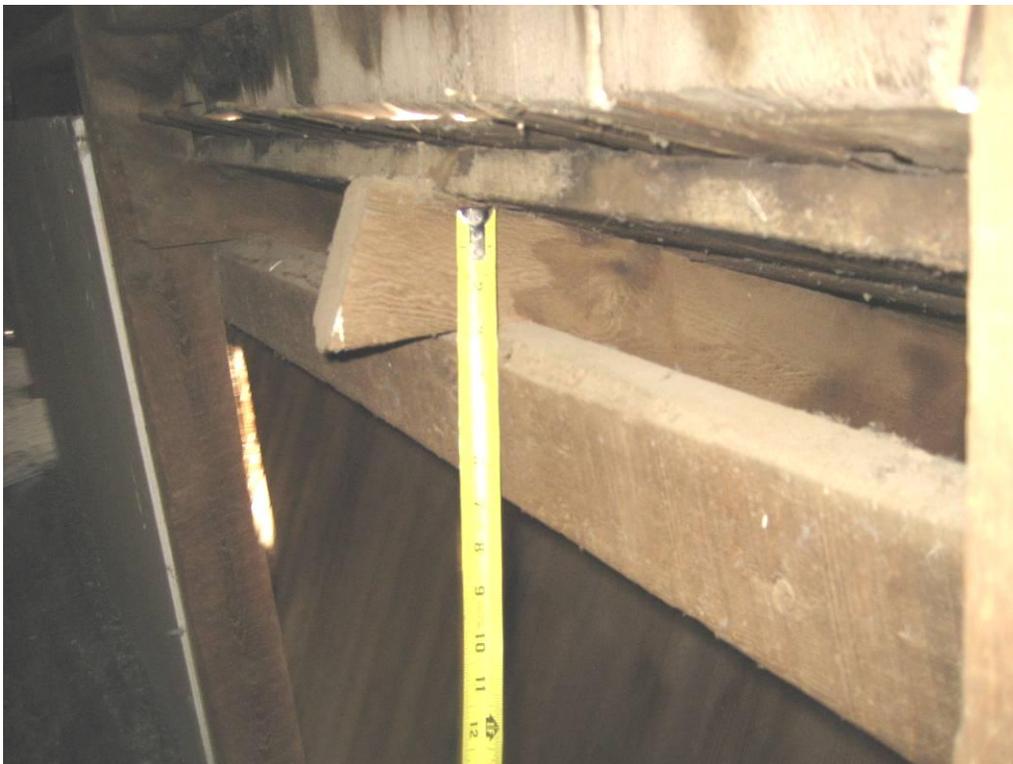
Shed roof framing; ledger and bearing notch through about half of rafter, 2009.

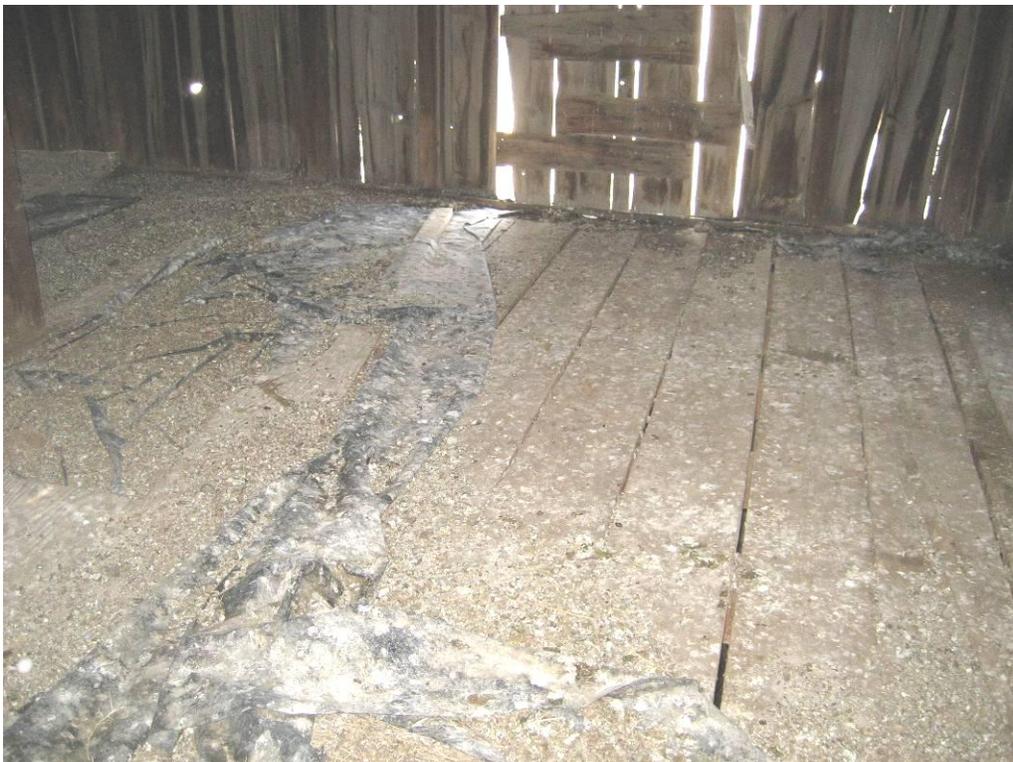
The Loft floor decking is covered by plastic and bird feces. It should be cleaned and carefully inspected for deterioration as it will be required to act as part of the new lateral force resisting system. The decking appeared to be in good condition from below.

Loft floor decking covered with bird feces, 2009.

- f. Inspect the loft floor decking and connections for damage. Repair as necessary. Add nails from decking to joists if analysis indicates it is required for lateral force resistance. Priority: Serious.

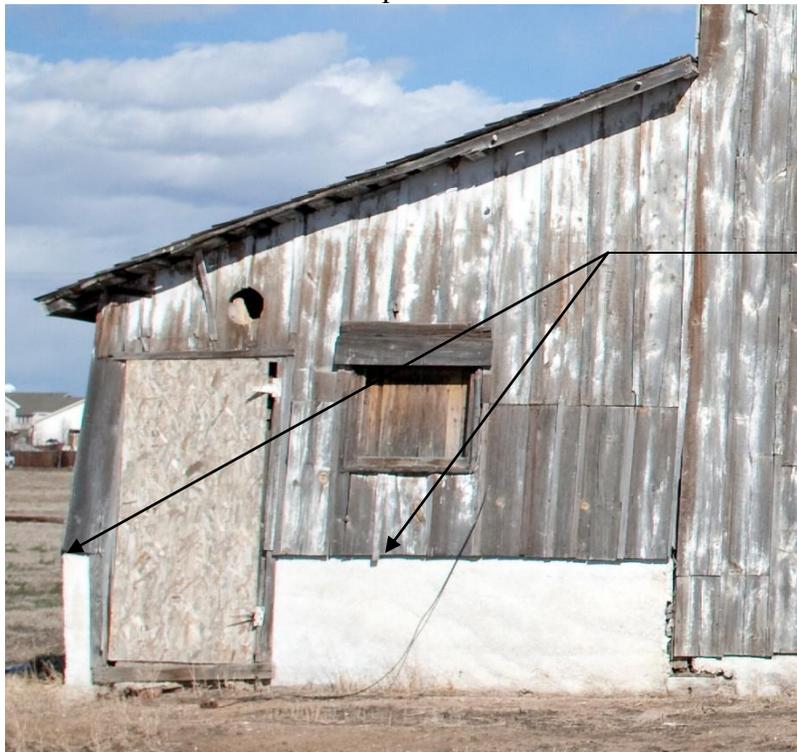
Barn south east corner. 2009 photo.

Wood siding overlaps concrete knee-wall indicating that siding was installed over the knee-wall. Wood sill plate rests on top of knee-wall.

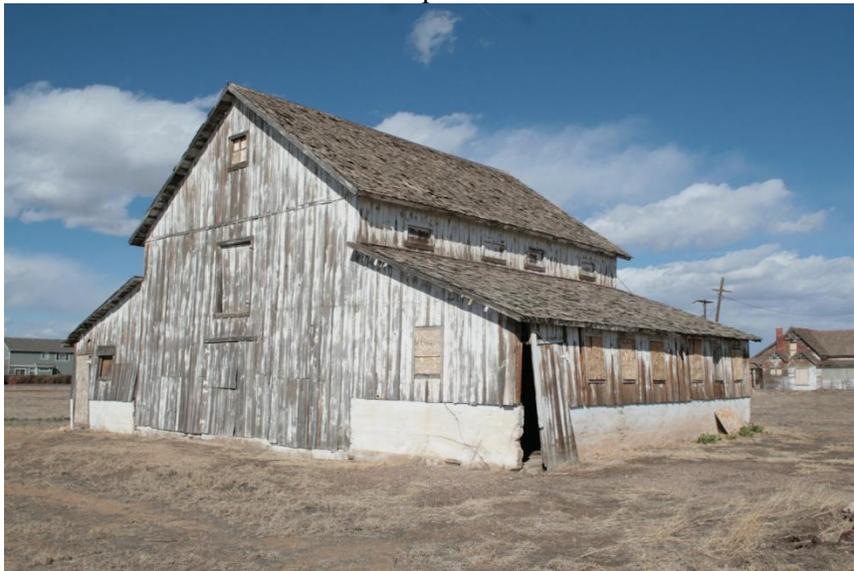
Condition: Poor. Many of the wood shingles are brittle, warped, or split. Daylight is visible through the roof in many locations from below. The wood fascia is broken or missing on the east and west gable ends. Moss and lichen are also present. These slow drying after rains and accelerate deterioration. The historic vented cupola visible in the picture above has been removed.

Underside of Barn roof. 2009 photo.

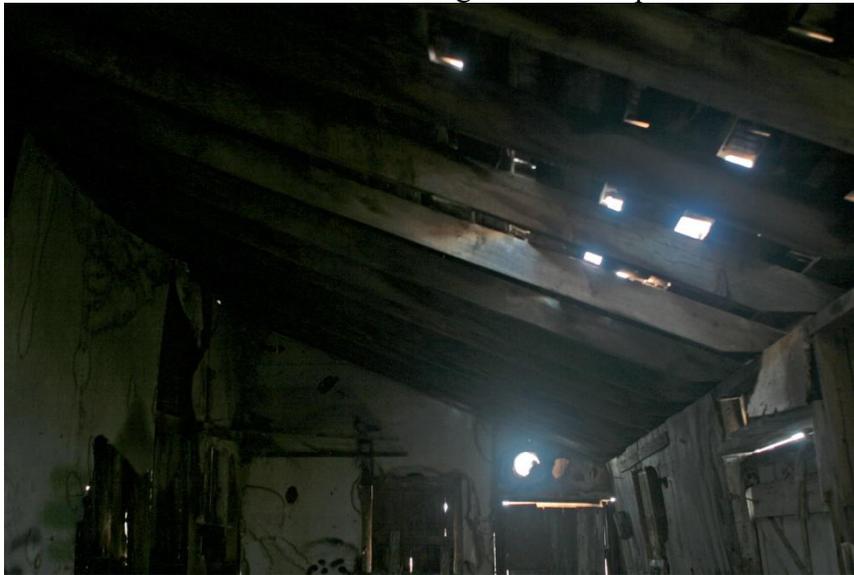
Condition: Poor. Many of the wood shingles are brittle, warped, or split. Daylight is visible in many locations from below the roof. The wood fascia is broken or missing on the rake and eave ends.

Underside of north shed roof looking west. 2009 photo.

- Refer to the gable roof recommendations on pages 3.3.5-3 and 3.3.3-4 for roof structural and shingle recommendations.
- Completely replace the fascia board on the rake and gable ends.

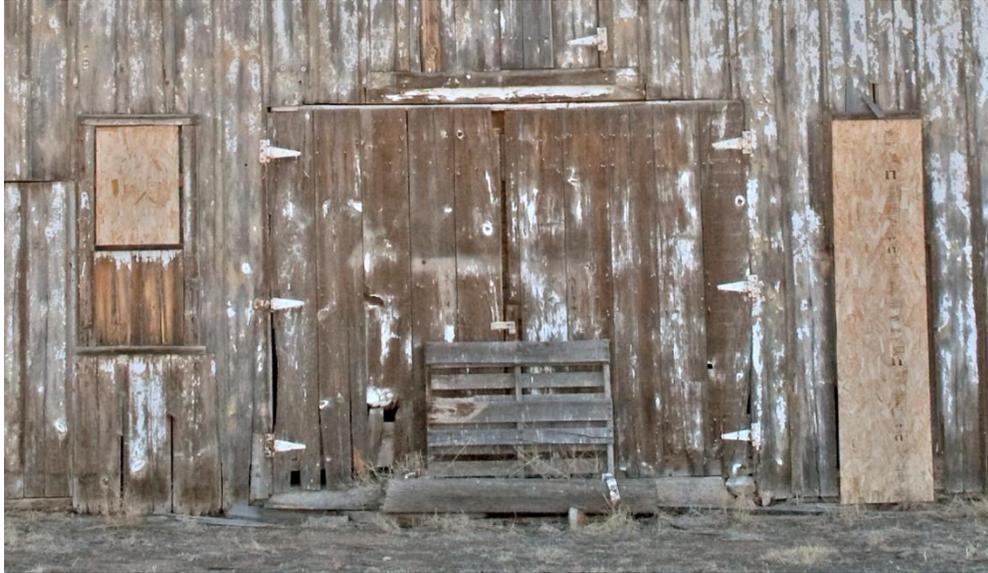
Windows 1W-01 and 1W-02. Door D2. 2009 photo.

Condition: The exterior finish of both windows is severely weathered and missing most of their protective paint coating. One light is broken in window 1W-01. All lights are broken and one horizontal muntin is missing in window 1W-02. The sash, frame, and trim for each window have warped, broken, and rotted areas.

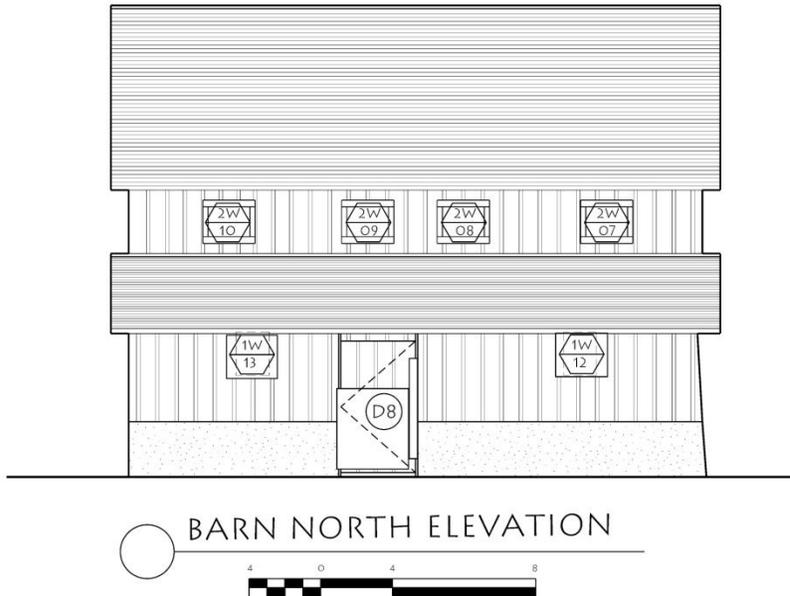
Windows 1W-12 and 1W-13.

Description: These windows are located above the concrete knee wall on either side of door D8 on the north elevation. Each is approximately 1'-10" wide x 2'-4" high. Each window is a historic wood, four light hopper with single pane glazing. They are currently protected by an unpainted particle board panel on the exterior face.

Condition: The exterior finish of all windows is severely weathered and missing most of its protective paint coating. All lights are broken in window 1W-13. The functionality of each window could not be tested.

Recommended treatment: Preserve the historic appearance and material of both windows to the greatest extent possible, while restoring their degraded weather-tight qualities and functionality. Remove the sash and preserve with consolidant and/or new materials in degraded areas. Replace broken or missing lights. Install new glazing putty for all lights. Paint may contain lead. Remove all loose paint on the exterior face of the sash, frame, and the exterior trim. Repair or rebuild the frame and trim so each sash fits tightly. Repair existing hopper hardware, or, if necessary, replace with new historically accurate hopper hardware. Sand and prep. Repaint with two coats high quality acrylic latex paint. Refinish and reinstall the sash and all stops.

Priority: Serious.

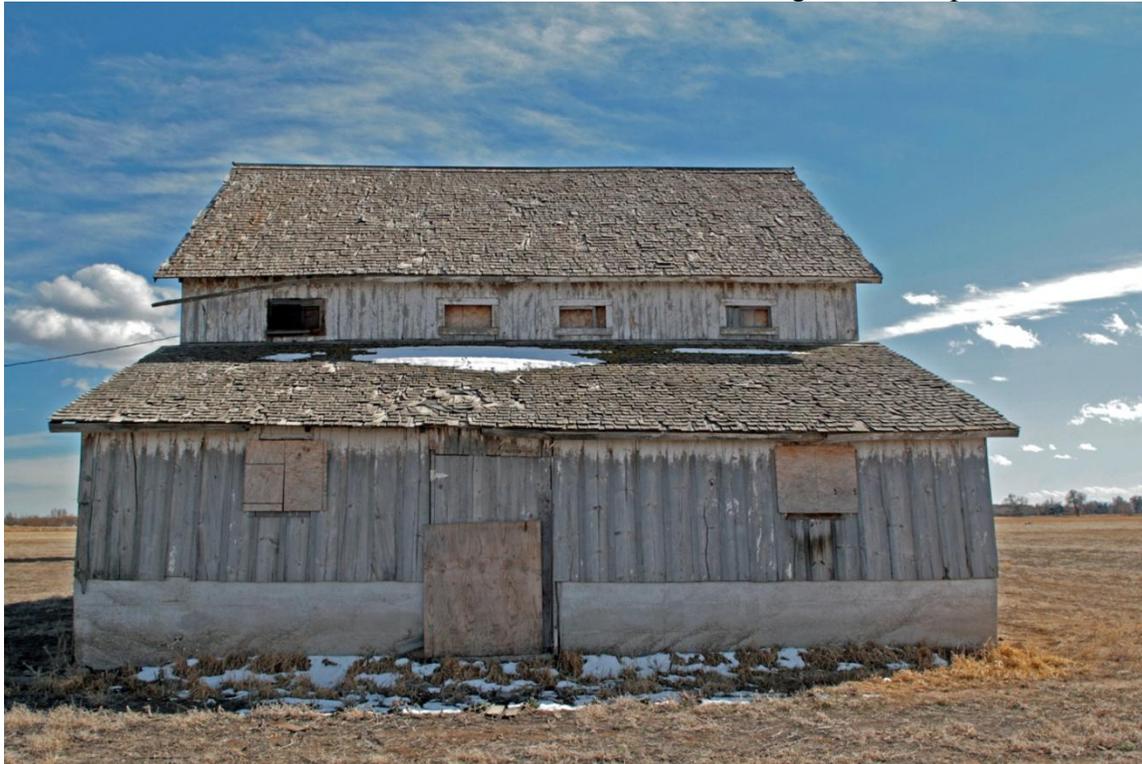
Door D8. Windows 1W-12 and 1W-13. Windows 2W-7 through 10. 2009 photo.

Description: Door D8, is a vertical plank door located the middle of the north façade between two concrete knee walls. The door is supported by strap hinges fastened to an exposed wood jamb. The door is approximately 4'-2" wide x 7'-4" high. The lower two-thirds of the opening is currently protected by an unpainted particle board panel on its exterior face.

Condition: The vertical wood planks are severely weathered and have lost most of their protective paint covering. This door frame is twisted along with the rotated concrete knee wall and no longer plumb or square. This door could not be tested for functionality, but it is unlikely that it is operational due to its extremely distorted frame.

Recommended treatment: Preserve the historic appearance and material of the vertical plank door to the greatest extent possible, while restoring the door's functionality. Excessively damaged parts of the door and frame must be rebuilt or replaced. This should be done after the north wall is repaired. (Refer to Section 3.3.3, Structural System.) Paint may contain lead. Sand and prep the rehabilitated door and frame. Repaint with two coats high quality acrylic latex paint.

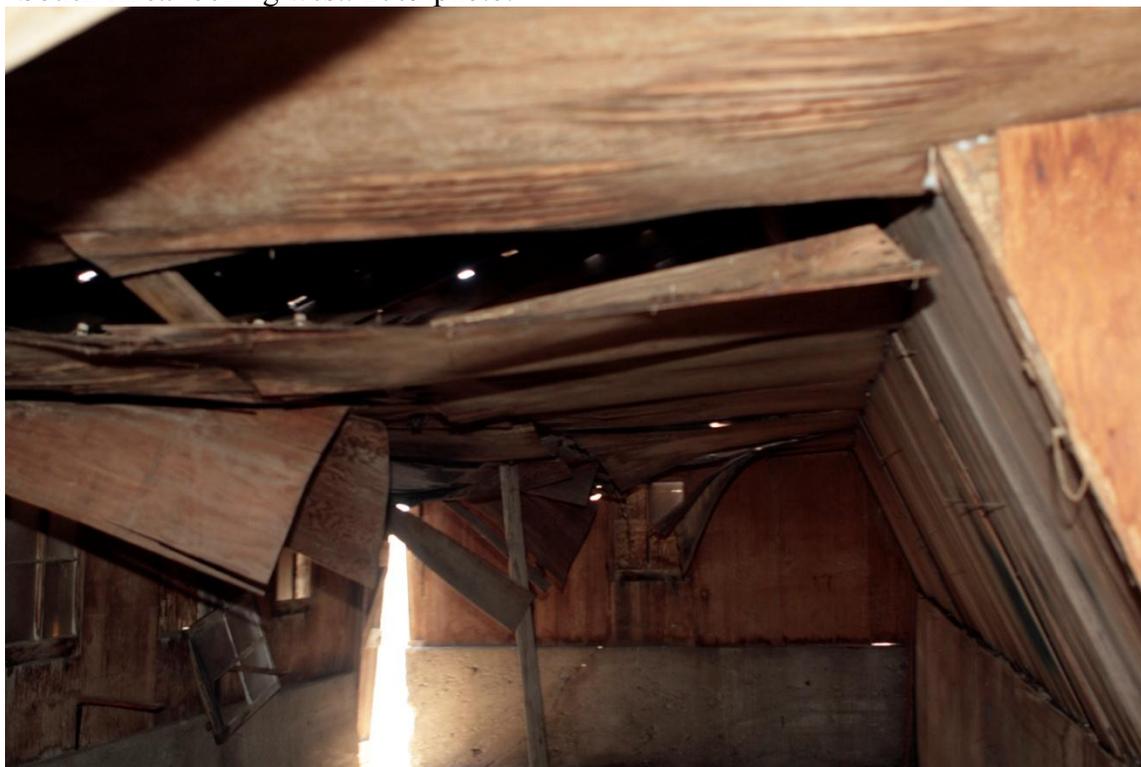
+**South Area** looking west. 2009 photo.

Condition: Floor is covered with dirt, debris, and animal droppings. Ceiling has extreme water damage.

Recommended treatment: Thoroughly clean and disinfect floor and wall. Replace plywood ceiling after roof repairs are completed. Also refer to recommendation b. on page 3.3.2-1 and recommendations c., d., and e. on page 3.3.2-2 for additional work.
