Bromley Farm

Master Plan

Historic Structures Assessment

Prepared by:
Avenue L Architects
March 18, 2010

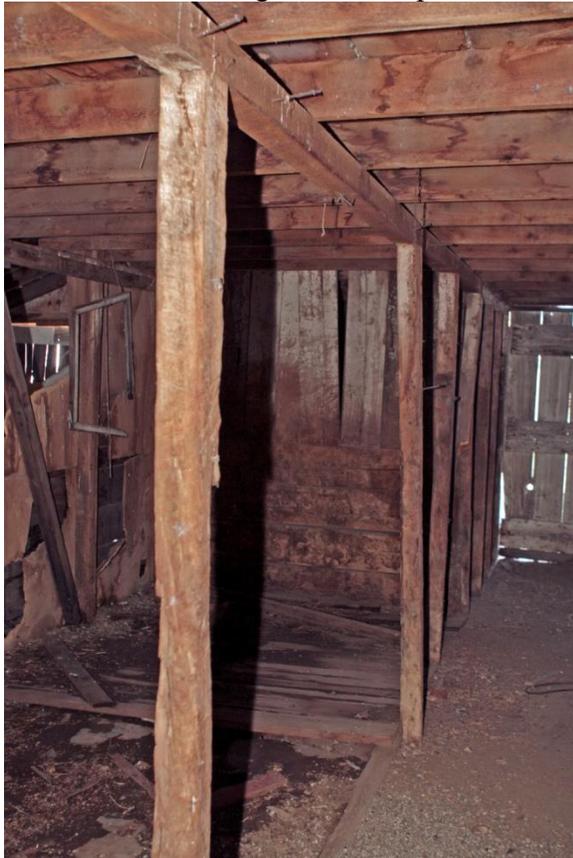
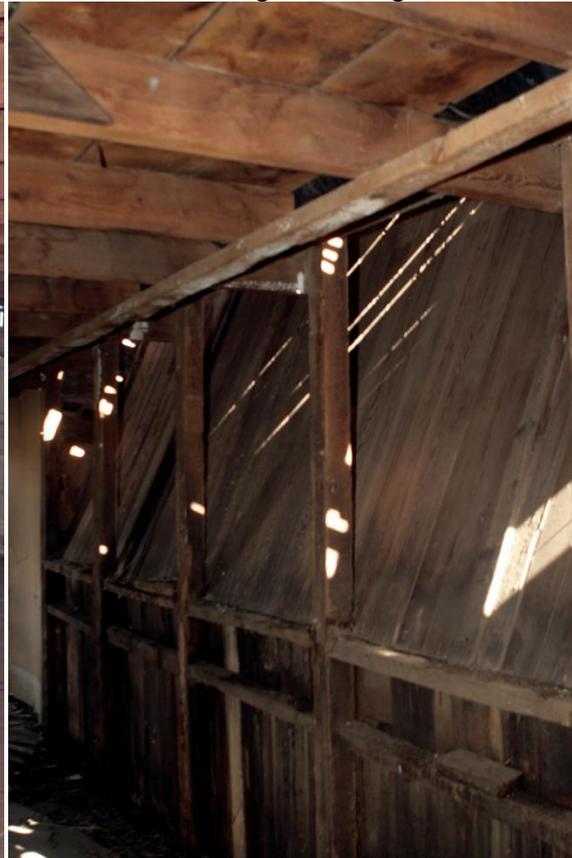
+Main Area looking east. 2009 photos.

Condition: Floor is covered with dirt, debris, and animal droppings.

Recommended treatment: Thoroughly clean and disinfect floor and wall. Also refer to recommendation b. on page 3.3.2-1 and recommendations c., d., and e. on page 3.3.2-2 for additional work.

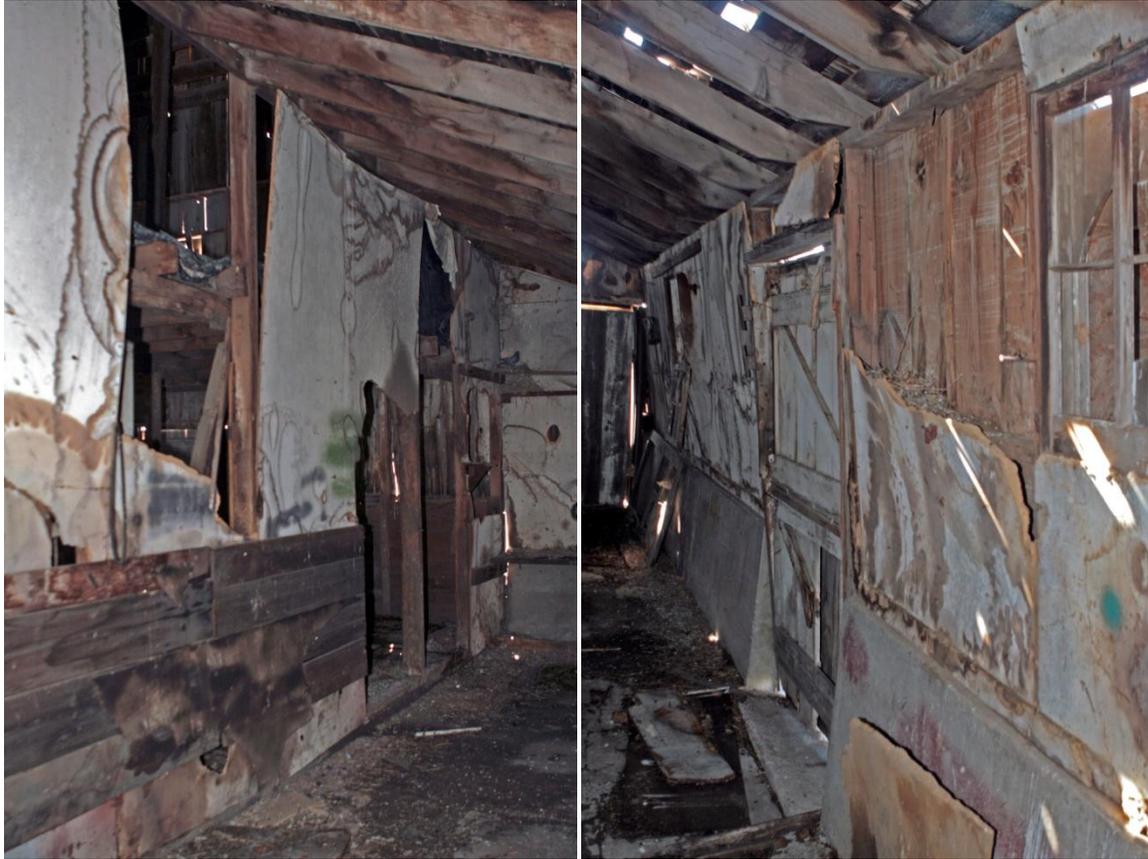
+North Area looking west. 2009 photos.

Condition: Floor is covered with dirt, debris, and animal droppings. Pressed board is water damaged, broken, and becoming detached from walls. Wainscot is stained and dented.

Recommended treatment: Thoroughly clean and disinfect floor and wall. Remove nests from walls. The pressed board may possibly contain asbestos. It is recommended that it be tested to determine if it is a hazardous material. This testing may help determine the time period that it was installed. Depending upon the historic time period associated with the ultimate use of the Barn and its content, the pressed board should either be removed or replaced with a material with a similar appearance. Also refer to recommendation b. on page 3.3.2-1 and recommendations c., d., and e. on page 3.3.2-2 for additional work.

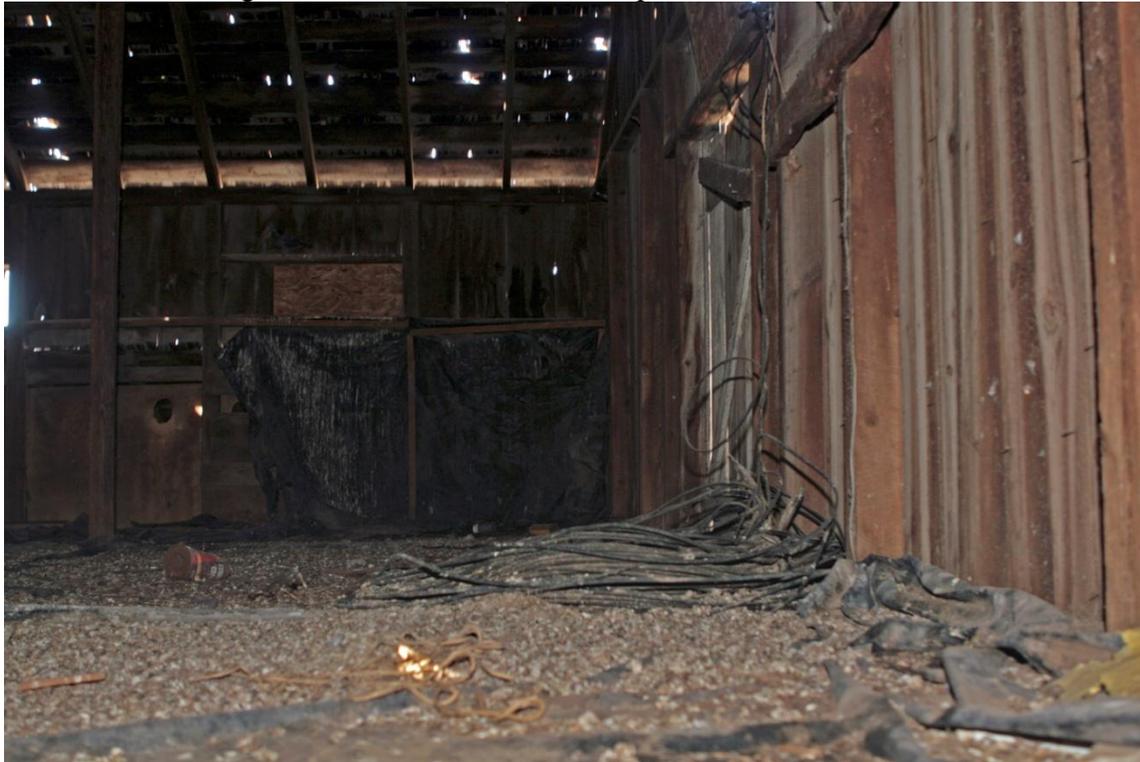
+Loft Area looking at north and east walls. 2009 photo.

Condition: Floor is covered with dirt, debris, and animal droppings.

Recommended treatment: Thoroughly clean and disinfect floor and wall. Also refer to recommendations f. and g. on page 3.3.3-3 for additional work.

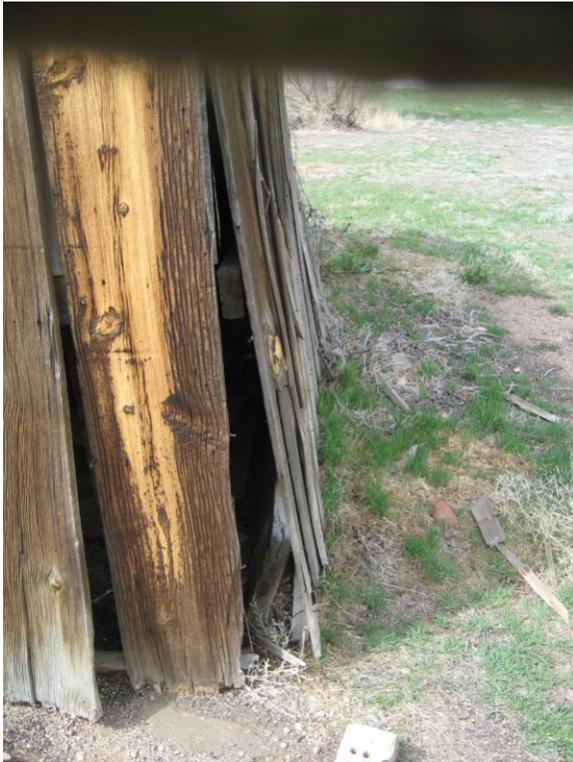
The exterior walls are in poor condition with extensive deterioration at the base, weathering and missing boards. The 2x4 untreated sill is severely degraded to the point of being unidentifiable due to contact with grade. There are no corner studs or other ties to keep the building corners from spreading. The entire building leans up to 3-1/2" inches out of plumb. The building is unlikely to collapse in the near future but repairs should be commenced as soon as funding allows.

Displaced and deteriorated southeast corner of wall, 2009.

- a. Move the building to install the new foundation. Install a new pressure treated sill plate with anchor bolts to the new foundation. Move building onto new foundation. Push or pull the building back to plumb. Install new corner studs. Epoxy consolidate roof and wall boards that are salvageable. Finger joint in new pieces or replace boards entirely depending on severity of deterioration. If a weatherproof wall is required, the existing boards should be removed to allow installation of new 7/16" sheathing and vapor barrier. All of the previous repairs to boards, and installation of a new sill

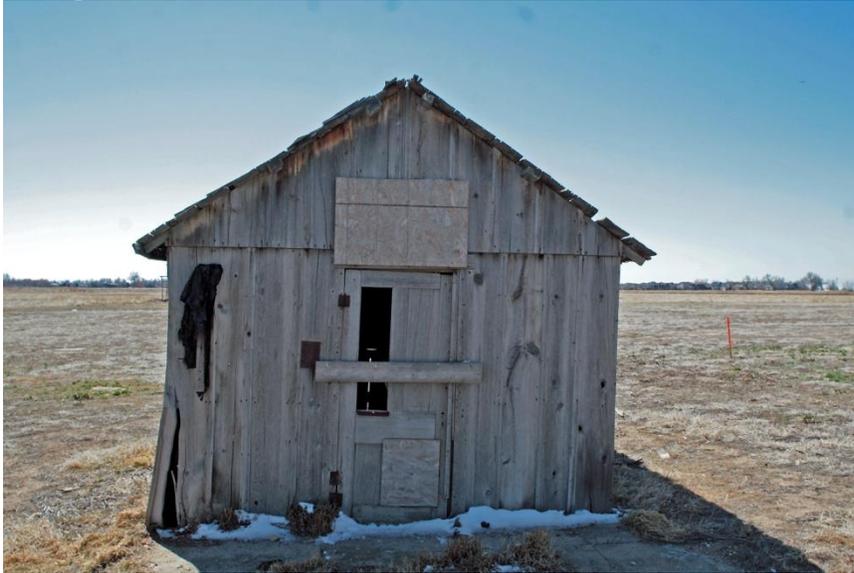
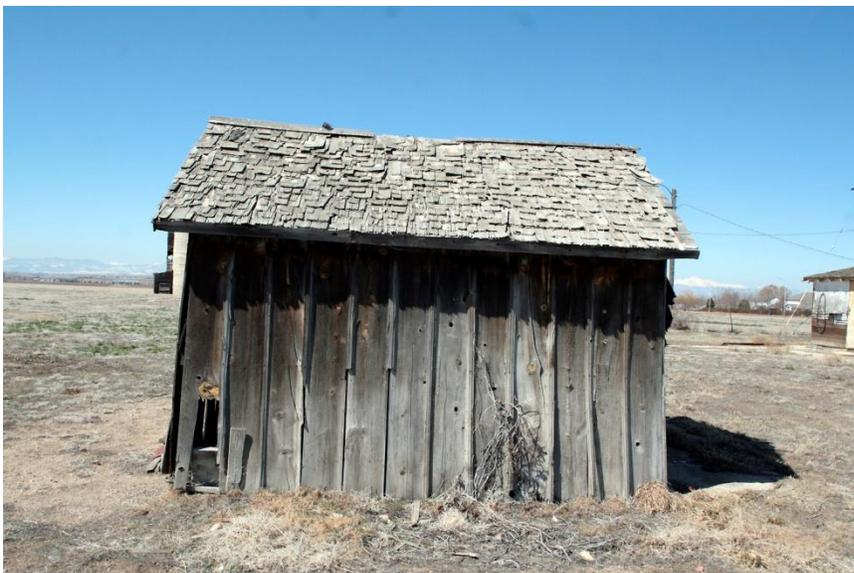
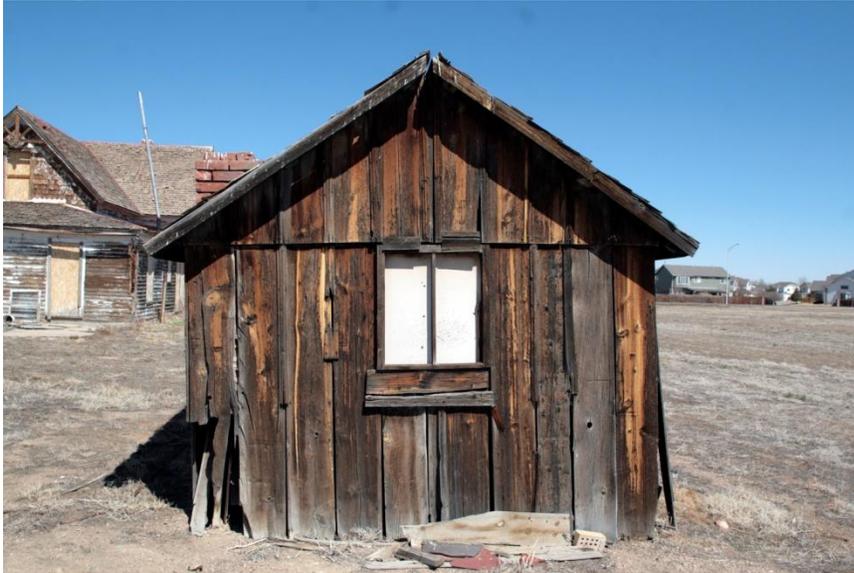
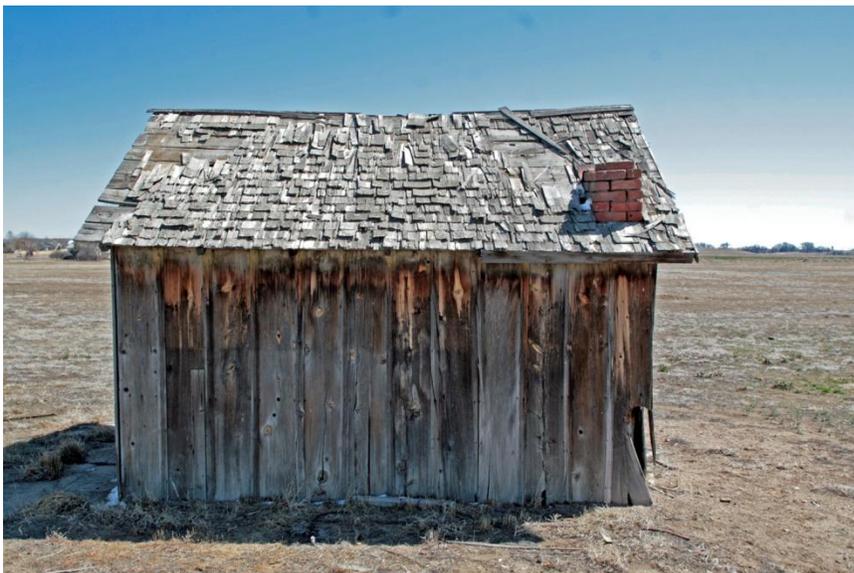
Condition: Poor. Wood siding on all sides is very weathered. Much of this siding is cupped, split, or broken. The cupping has caused the nails of many boards to work loose from the horizontal framing beneath. The cupping has also created large gaps between some of the siding boards. This allows wind driven rain to the building. The northeast, southeast, and southwest corners of the building have significant damage and large openings. The east and west walls are out of plumb and the building has a pronounced “lean” to the west. A significant number of wood battens are missing, broken, or loose. The protective coating of paint is severely degraded on all sides of the Wash House.

- Move the building to a new foundation per recommendations of Sections 3.4.2 and 3.4.3.
- Remove all existing siding. Retain any salvageable siding and battens.
- Rebuild the foundation exterior wall per recommendations of Sections 3.4.2 and 3.4.3. The proposed solutions may not meet the Secretary’s Standards. If not, then other solutions should be explored during the design development stage.
- Install new and salvaged wood siding and battens on all facades.
- Apply primer and two coats high-quality acrylic latex paint to new siding. Paint color(s) should be historically accurate.

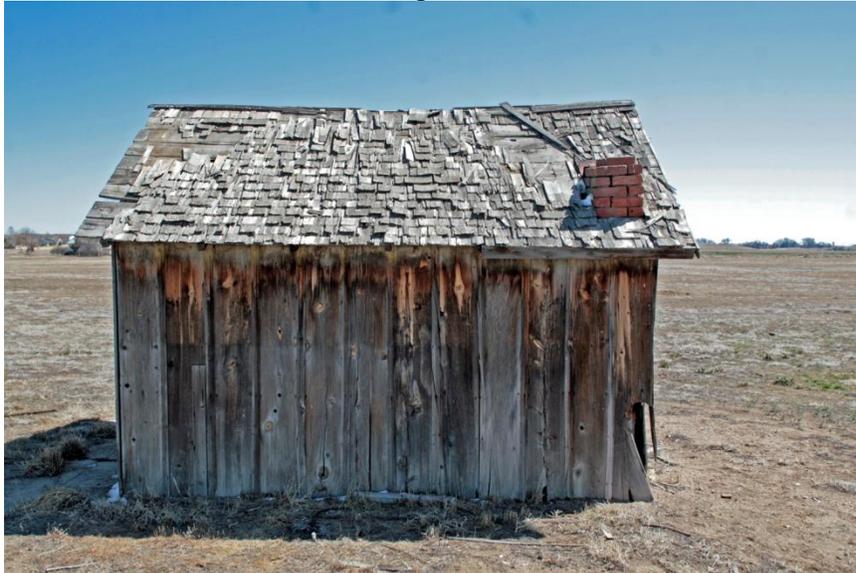
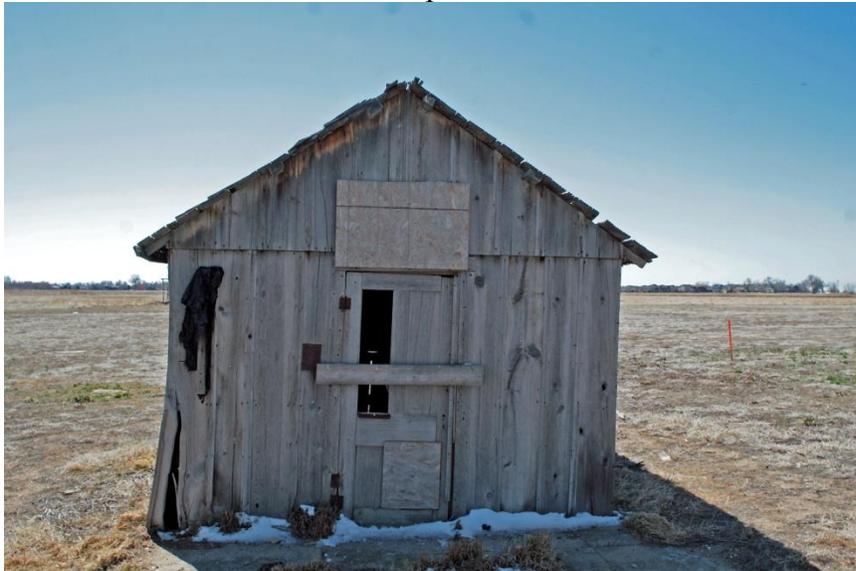
Condition: Poor. Approximately 15% to 25% of the wood shingles are missing from each side of the roof. There is no underlayment between the shingles and sheathing. The ridge board is broken and mostly missing. The north side fascia is missing. The brick chimney is not flashed, does not have a cap, and is missing bricks at the top. Its mortar joints are severely degraded.

- Roof -remove all shingles.
- Replace any deteriorated sheathing boards.
- Install new sawn wood shingles over existing board sheathing. Match style and exposure of existing wood shingles. Paint shingles red.
- Install new flashed roof ridge.
- Completely rebuild the chimney using existing brick. Test mortar to determine its composition. Replace existing flashing with new stepped flashing. Install a two-piece cricket to facilitate drainage around the chimney. This work should be done by a professional mason specializing in historic masonry.
- Replace the 1" x 4" fascia at the north and south gable ends. Sand and prep the fascia and soffit for new paint. Apply primer and two coats high-quality acrylic latex paint. Paint color(s) should be historically accurate.

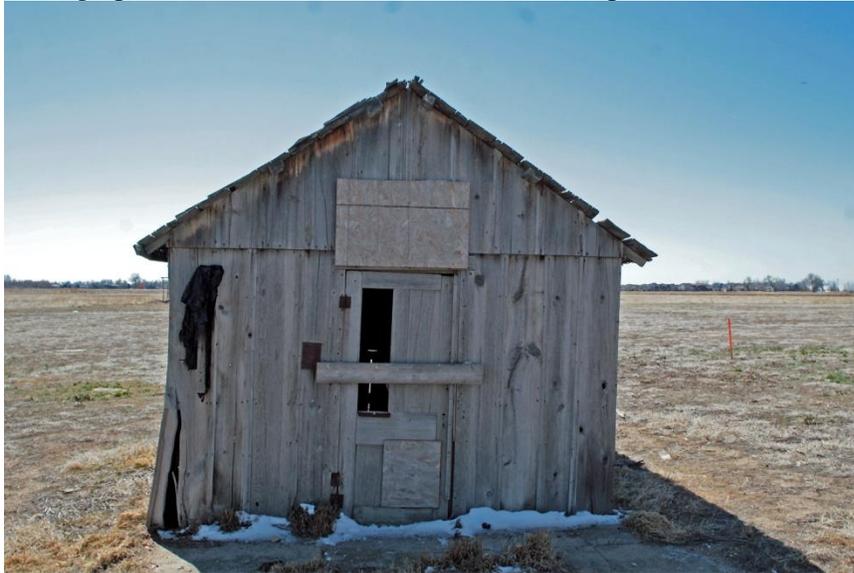
Photograph of north side of Wash House. 2009 photo.

Condition: The door is severely weathered. At least one of the panels is missing. The other visible panels have long vertical splits. The top rail and stile do not align. The door frame is out of square. The hinges are extremely rusty. One of the lower butt hinges is no longer fastened to the door. Door hardware is missing. Even if the door was operation, the high grade in front of the door would prevent it from opening.

Recommended treatment: Preserve the historic appearance and material of the door to the greatest extent possible, while restoring the door's functionality. This may require that excessively deteriorated parts of the door and frame be consolidated, rebuilt, or replaced. Install new historically accurate door hardware. Re-grade in front of the door to help restore the doors functionality and operation. Sand and prep the rehabilitated door and frame. Repaint with two coats high quality acrylic latex paint.

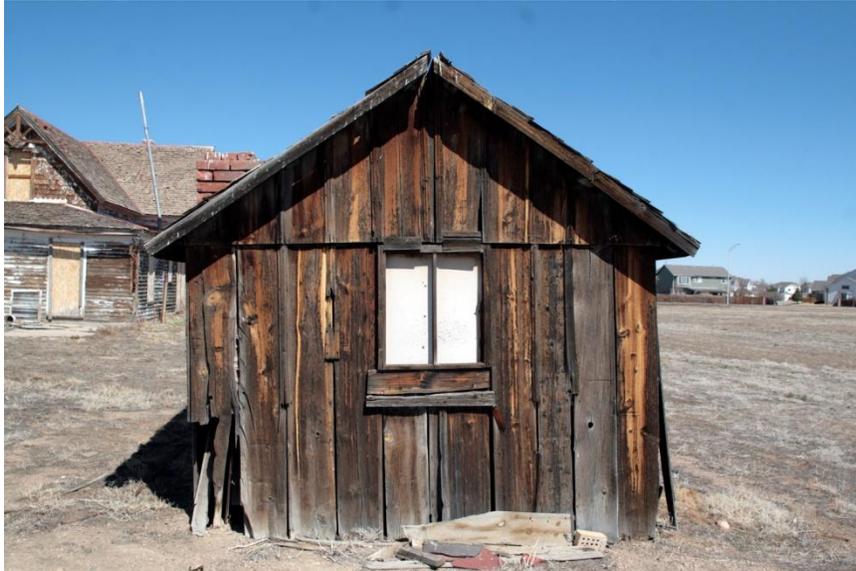
Photograph of south side of Wash House. 2009 photo.

Condition: The exterior finish is severely weathered and missing most of their protective paint coating. Glazing is missing in the window. The sash, frame, and trim for this window is warped, broken, and rotted areas.

Recommended treatment: Preserve the historic appearance and material of the window to the greatest extent possible, while restoring its degraded weather-tight qualities. Remove the sash and preserve with consolidant and/or new materials. Install new glazing and glazing putty for both glass lights. Remove all loose paint on the exterior face of the sash, frame, and the exterior trim. Repair or rebuild the frame and trim so that the sash fits tightly. Sand and prep. Repaint with two coats high quality acrylic latex paint. Refinish and reinstall the sash and all stops.

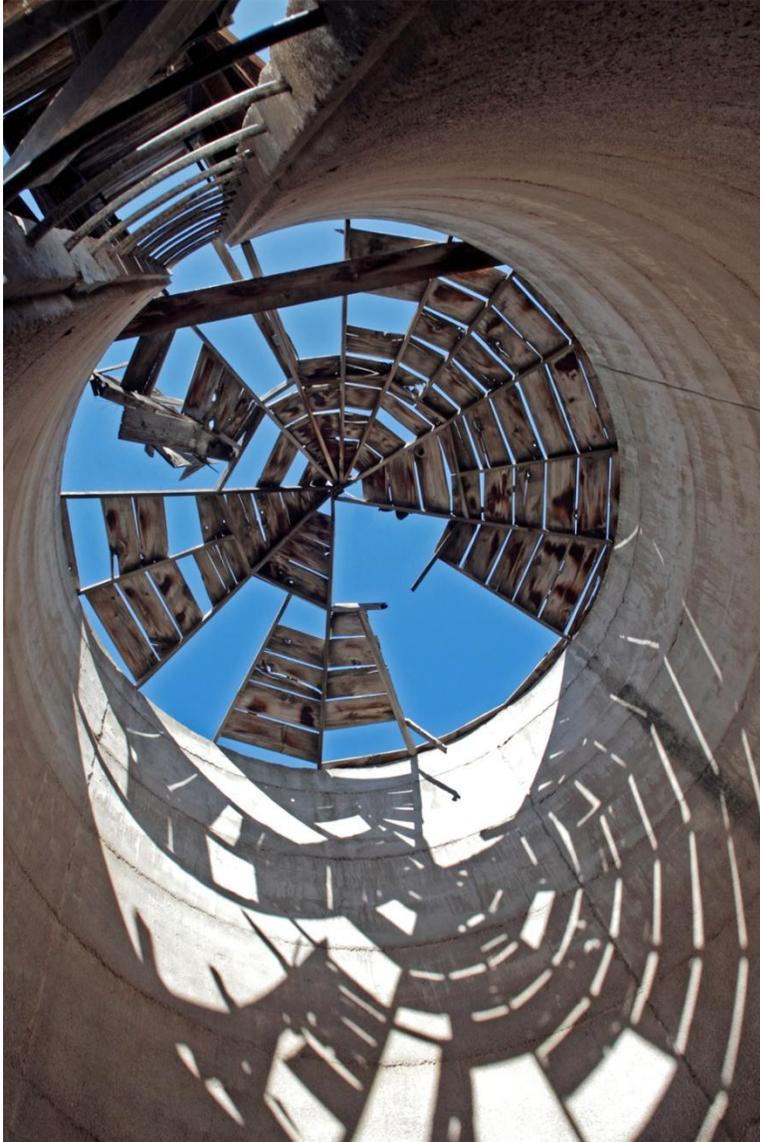
The Silo Roof– from below. 2009 photo.

Condition: The roof framing is degraded and partially collapsed. Sheathing is missing and appears in poor condition from the ground below. It could not be determined, if any wood shingles still remain.

Priority: Critical.

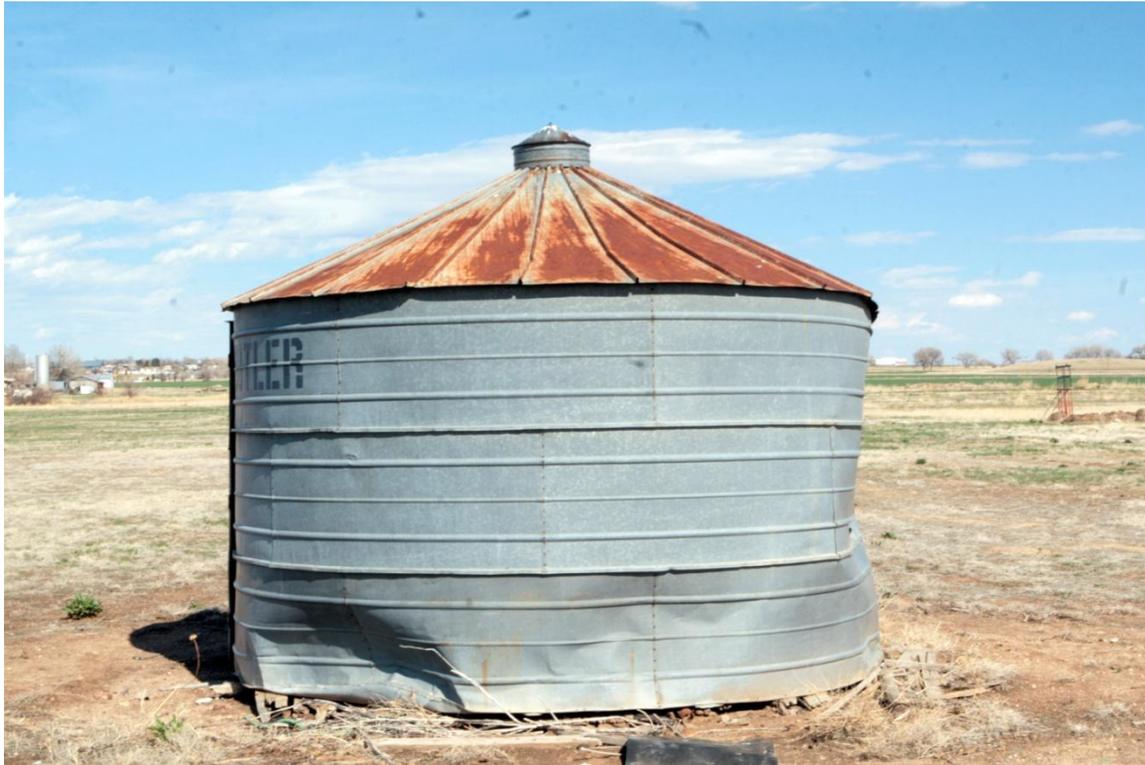
Metal Granary Roof.

Condition: The roof is moderately rusted. The conical roof vent appears to be in good condition.

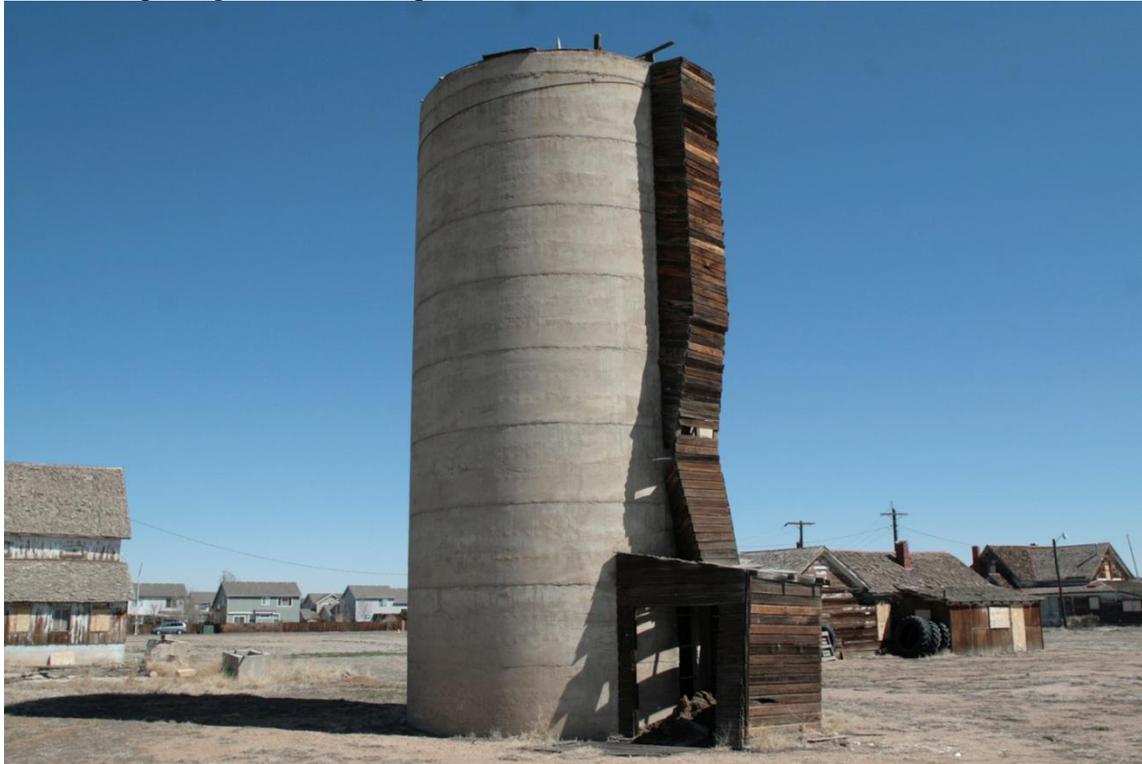
Silo door opening to shed. 2009 photo.

Condition: The door is severely weathered and may be damaged.

Priority: Serious.

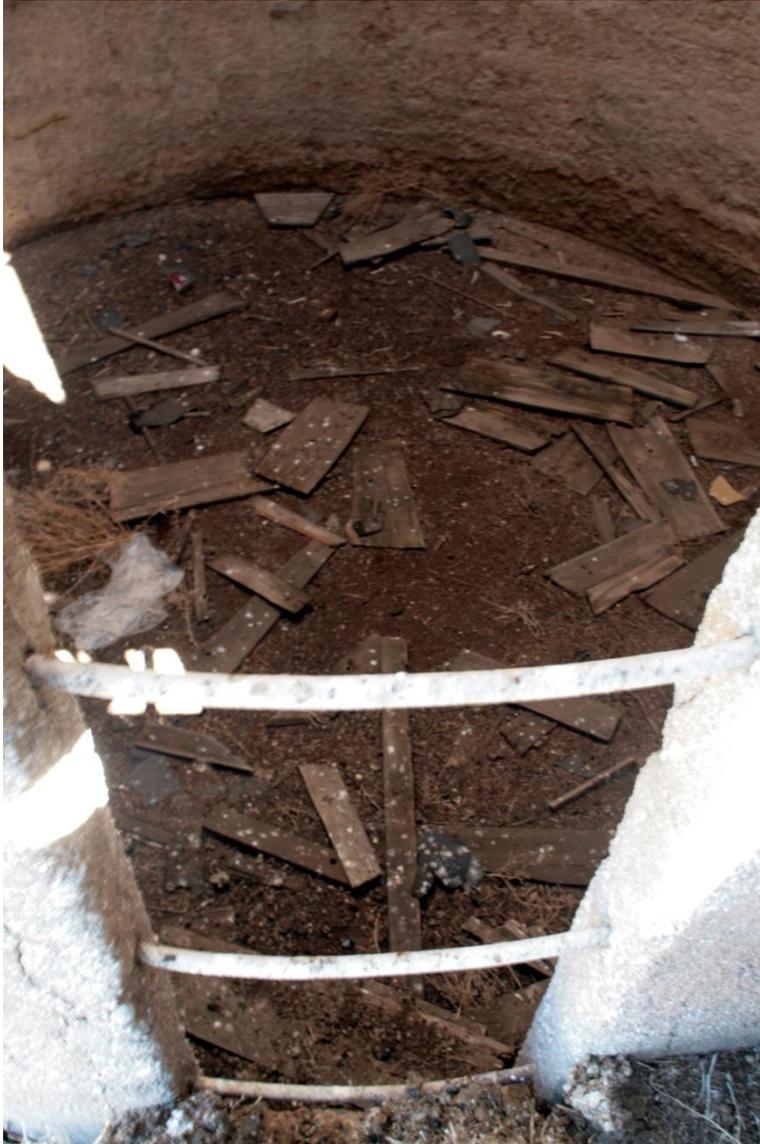
Interior of Silo. 2009 photo.

Condition: Floor is covered with debris and animal droppings.

Priority: Minor.

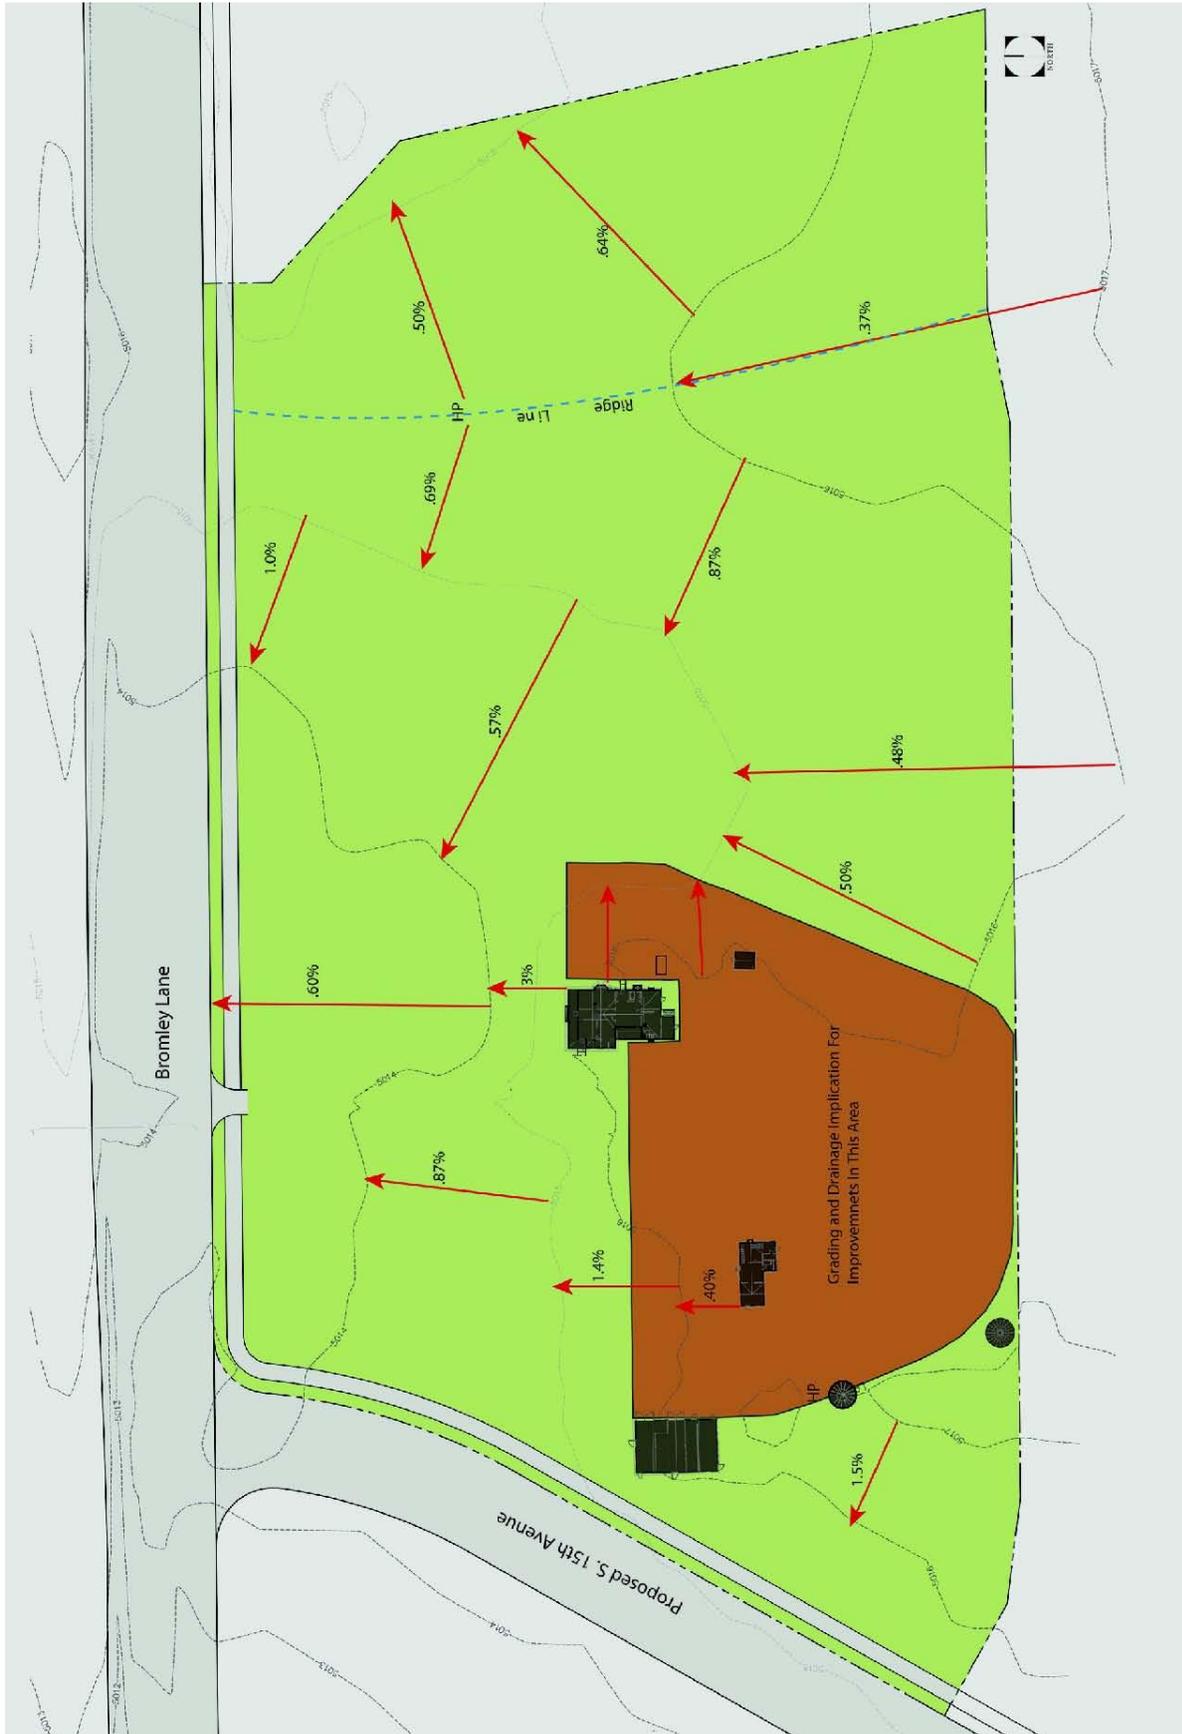
Existing Drainage Patterns Bromley-Hishinuma Farm

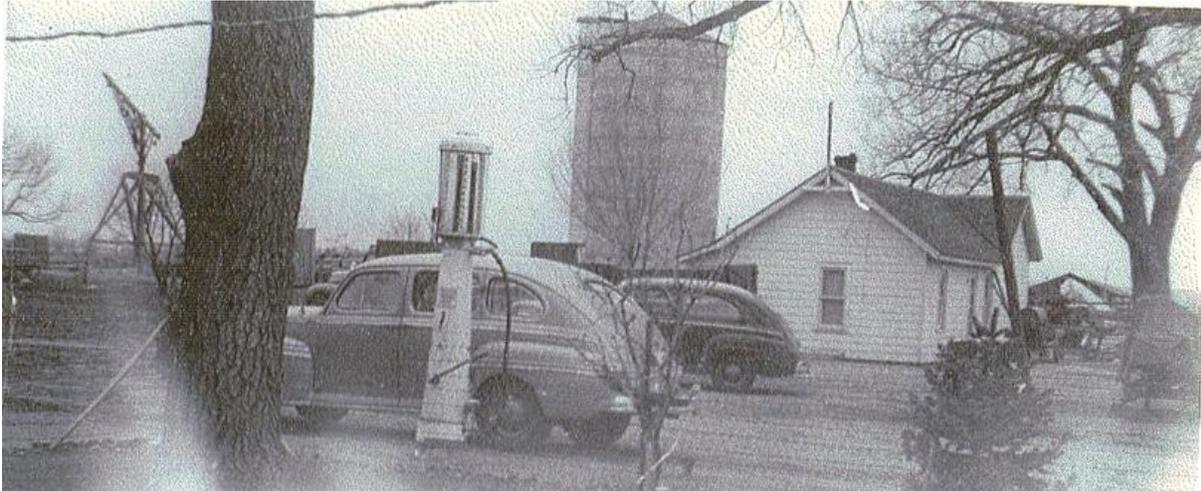
Historic Photos, ca. 1950. Windmill and gas pump were removed at an unknown date. Note gas pump in picture. Environmental assessment recommendations (see Section 7) to clean up gasoline remnants throughout site have been implemented.

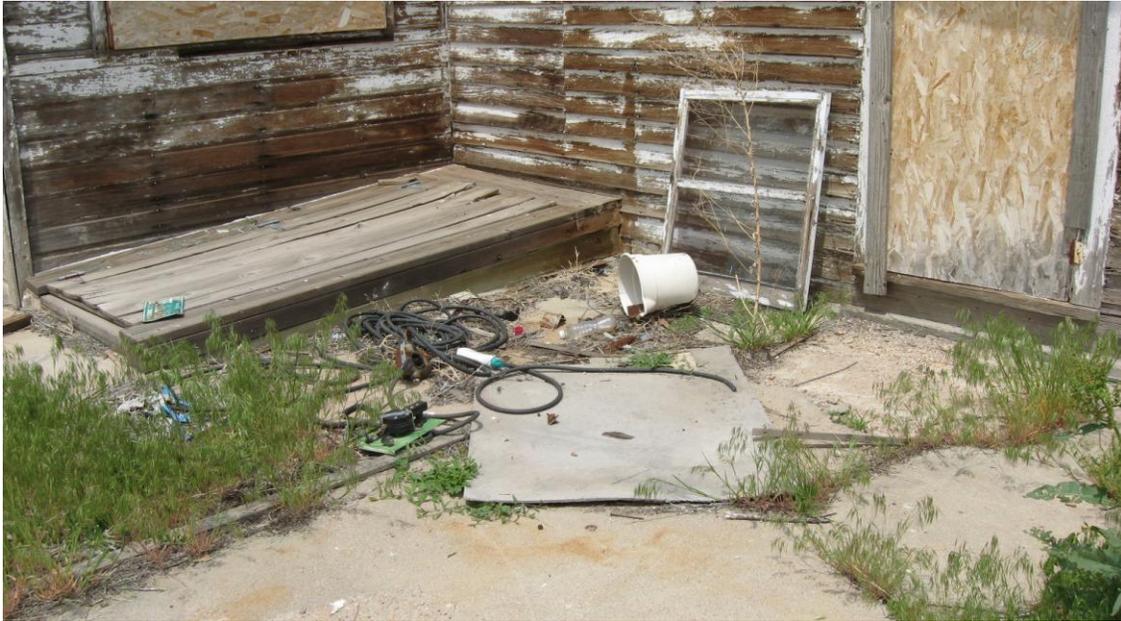
Figure 1. Artifacts and modern trash south of main house.

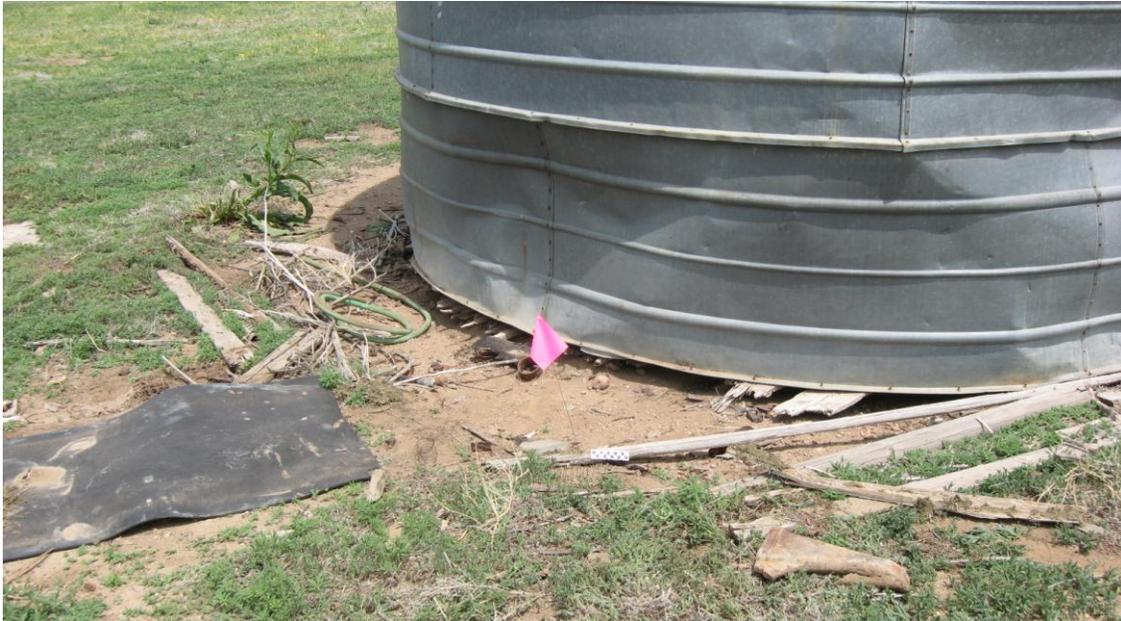
Figure 2. Artifacts located adjacent to metal granary. The flag marks the location of the spoon (FS-2).

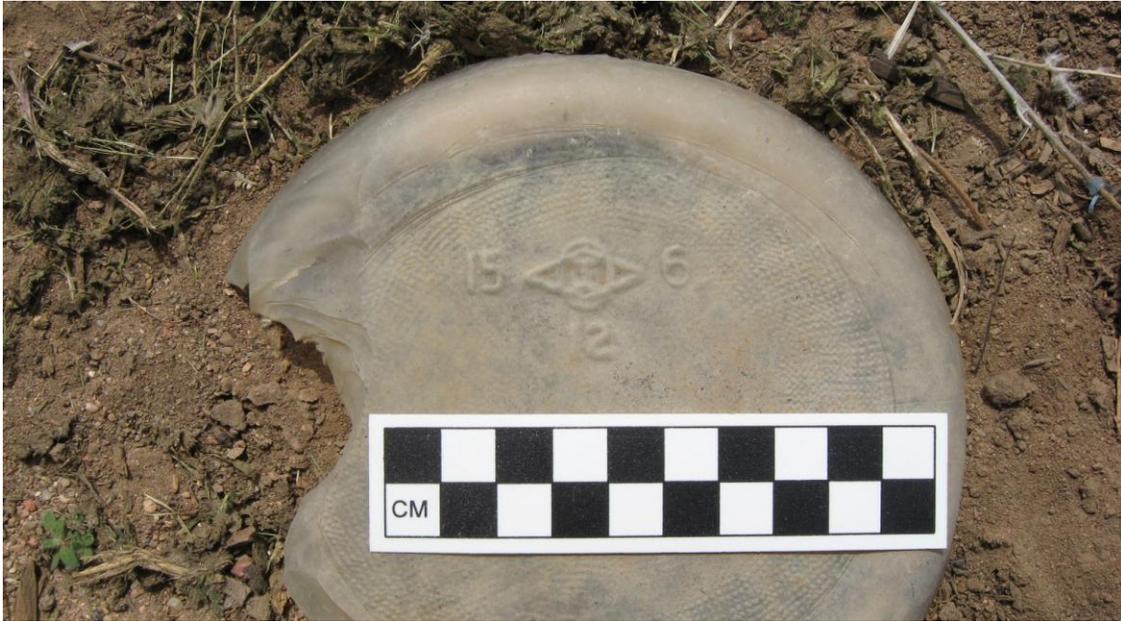
Figure 3. Clear glass bottle bottom with Owens-Illinois trademark (ca. 1929-1957) found adjacent to the metal granary.

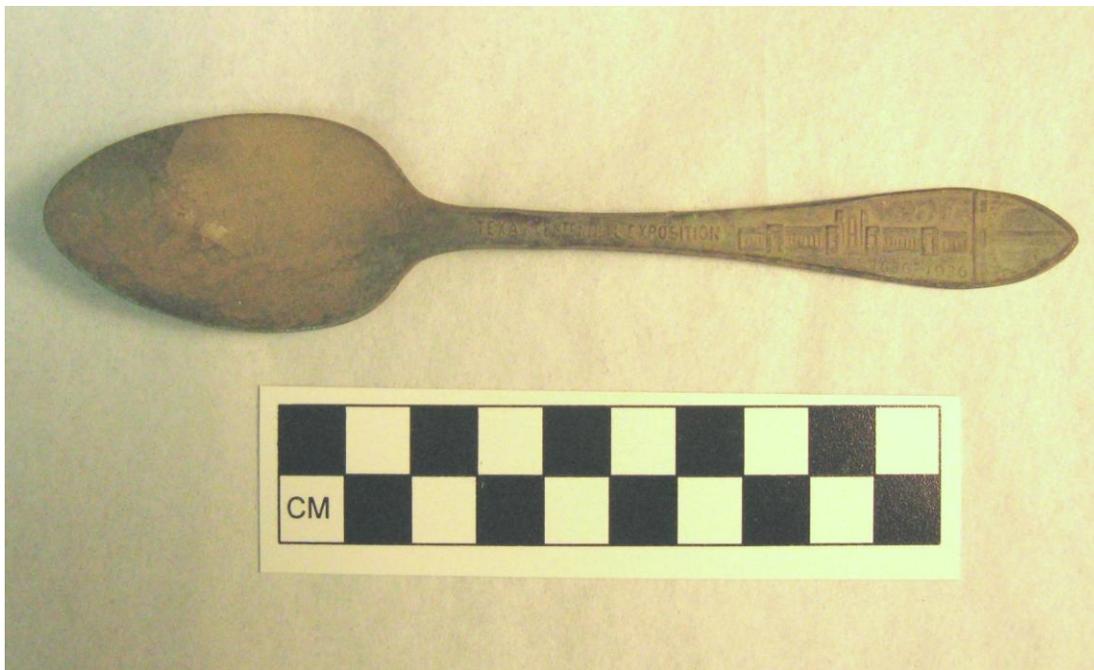
The Texas Centennial Exposition 1836-1936 spoon (FS-2) dates to 1936 (Figure 4). The Texas Centennial Exposition was a World's Fair held at Fair Park in Dallas, Texas to celebrate the 100th anniversary of Texas's independence from Mexico in 1836. The fair ran from June 6, 1936 to November 29, 1936 and was attended by over 10 million visitors (http://en.wikipedia.org/wiki/Texas_Centennial_Exposition). Perhaps one of the farm family members or relatives/friends attended the fair. The Owens-Illinois clear glass bottle fragment (Figure 3) can be dated from ca. 1929-1957. This item and the spoon were found adjacent to the metal granary.

Figure 4. Spoon (FS-2) embossed with "Texas Centennial Exposition 1836-1936" found adjacent to the northeast corner of metal granary.

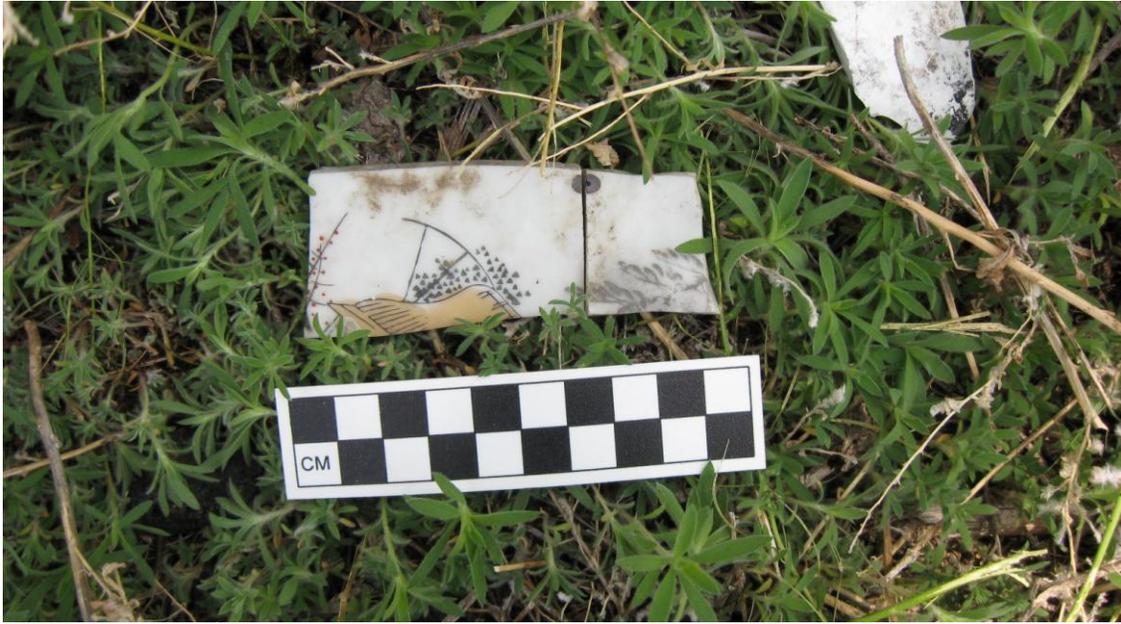
FS-4 and 5 are Japanese decorated plate fragments (Figures 5, 6 and 11) and appear to date to the Koizuma-Hishinuma post-WWII occupation. The "MADE IN JAPAN" trademark on FS-4 dates to ca. post-1941 (http://www.gotheborg.org/marks/index_jap_marks.htm). The mark "...PAN" on FS-5 is also suggestive of a "JAPAN" or "MADE IN JAPAN" trademark and can be roughly date to post-1921, and may date to the same time period as FS-4.

Figure 5. Japanese design on plate fragments (FS-4) found north of the concrete silo.

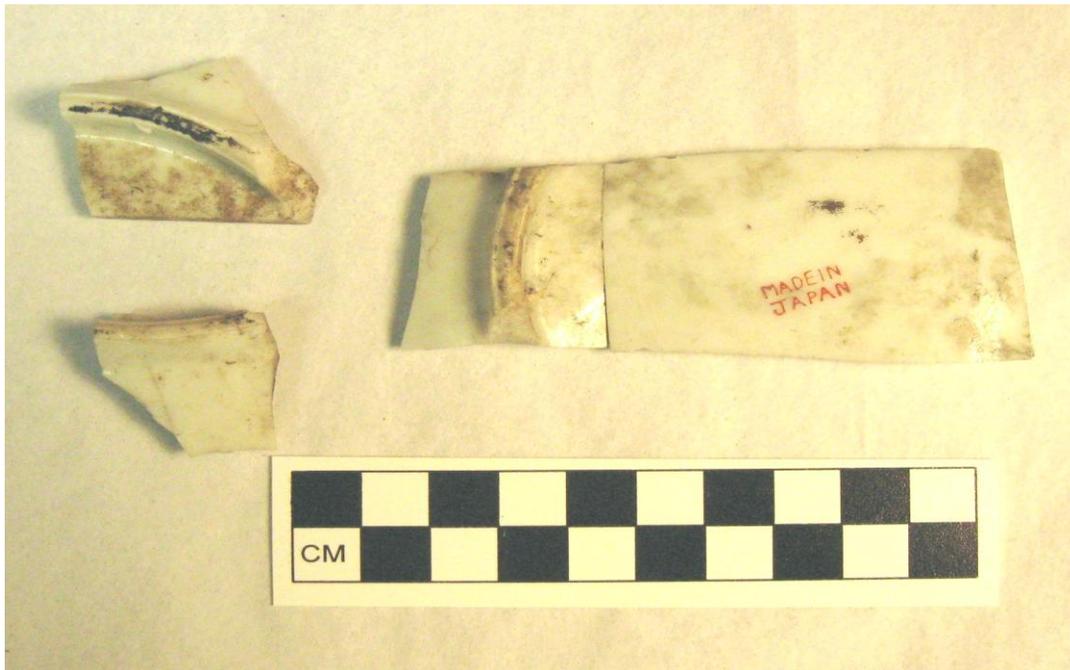
Figure 6. Back of plate fragments (FS-4) showing “MADE IN JAPAN” trademark (ca. post-1941), http://www.gotheborg.org/marks/index_jap_marks.htm

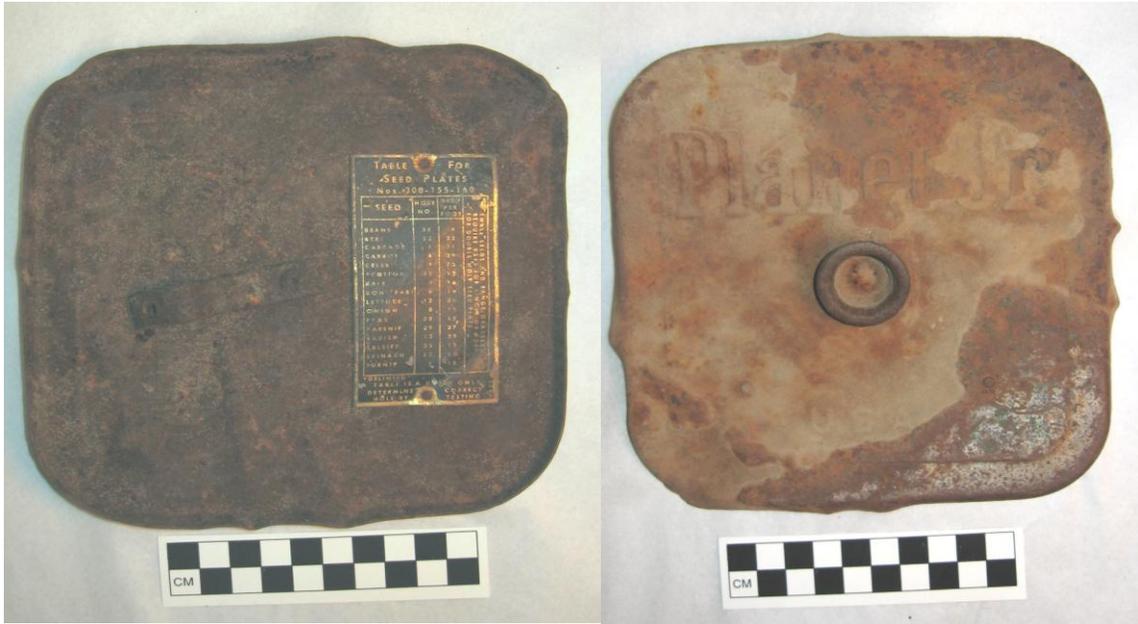
Figure 7. Front and back view of metal seed plate (FS-3) “Planet Jr. USA” found south of concrete silo.

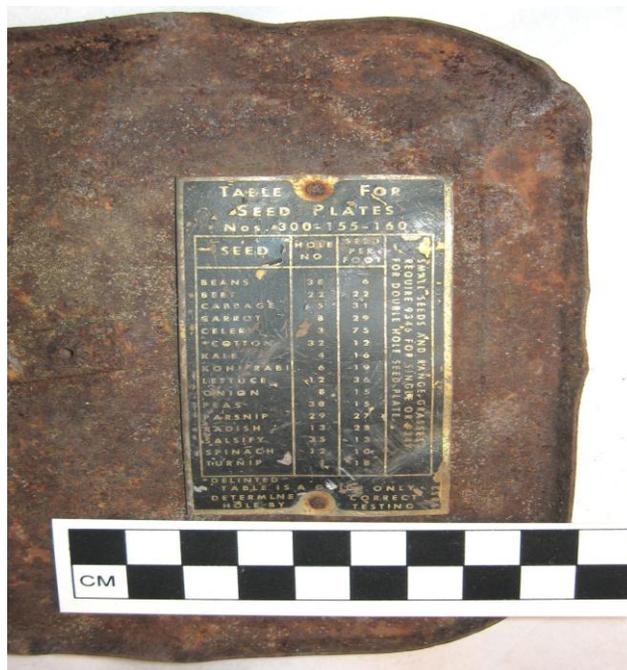
Figure 8. Close-up view of table for seed plates (FS-3)

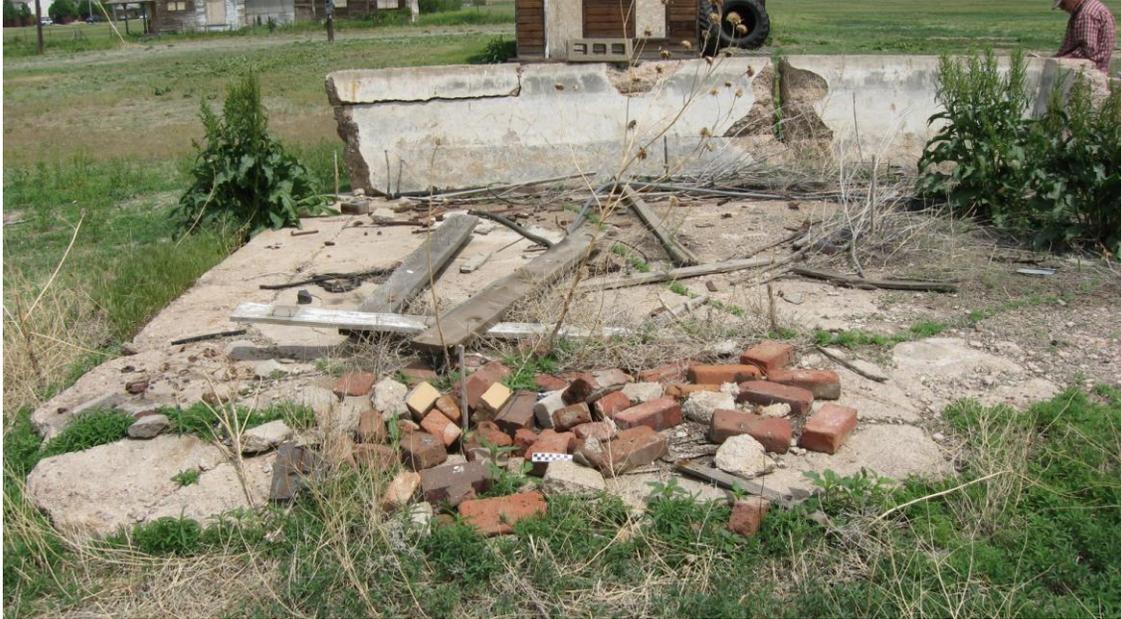
Figure 9. Brick, miscellaneous wood and metal artifacts located west of the milk trough.

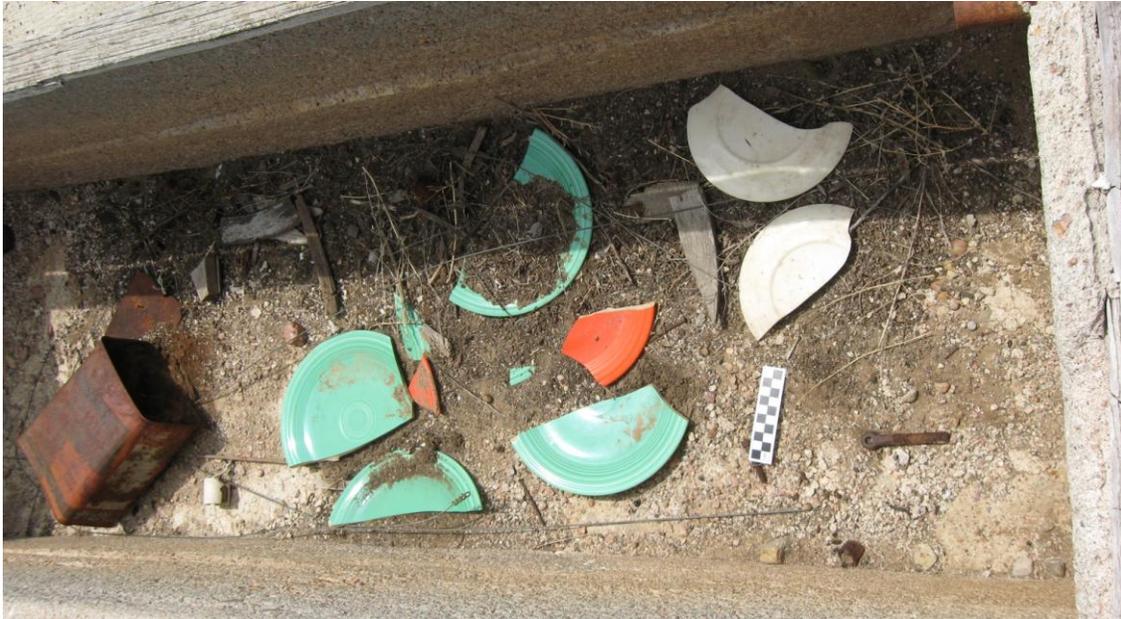
Figure 10. Fiestaware and other artifacts located inside of the milk trough.
