Bromley Farm

Master Plan

Historic Structures Assessment

Prepared by:
Avenue L Architects
March 18, 2010

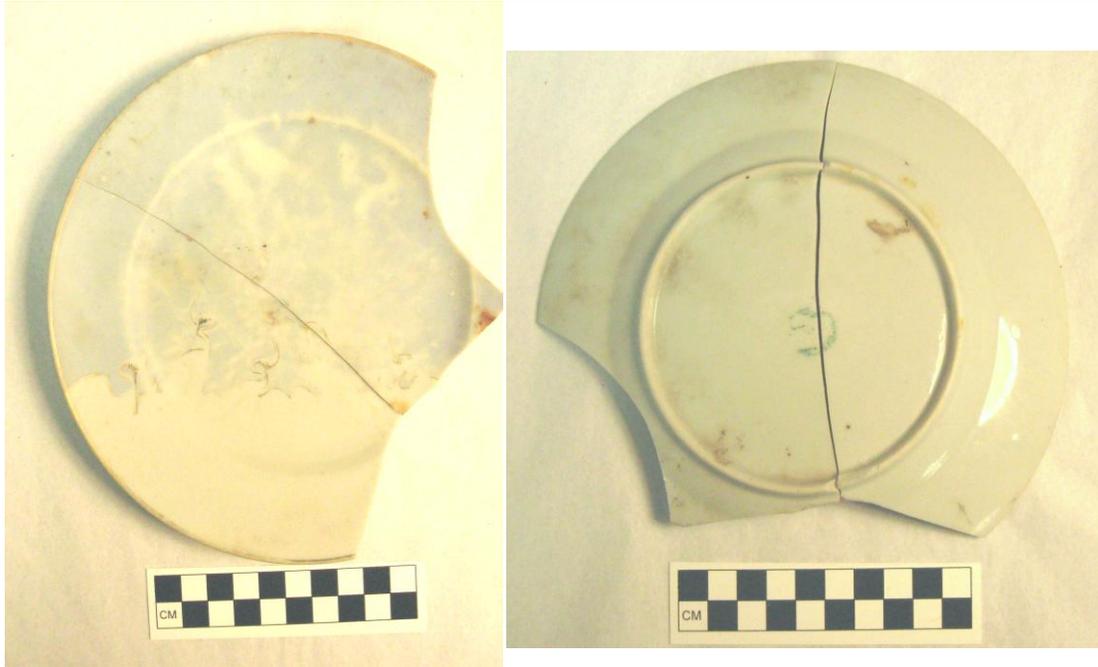
Figure 11. Plate (FS-5) with Japanese design found inside of milk trough (on left). Trademark with "...PAN" on back (on right).

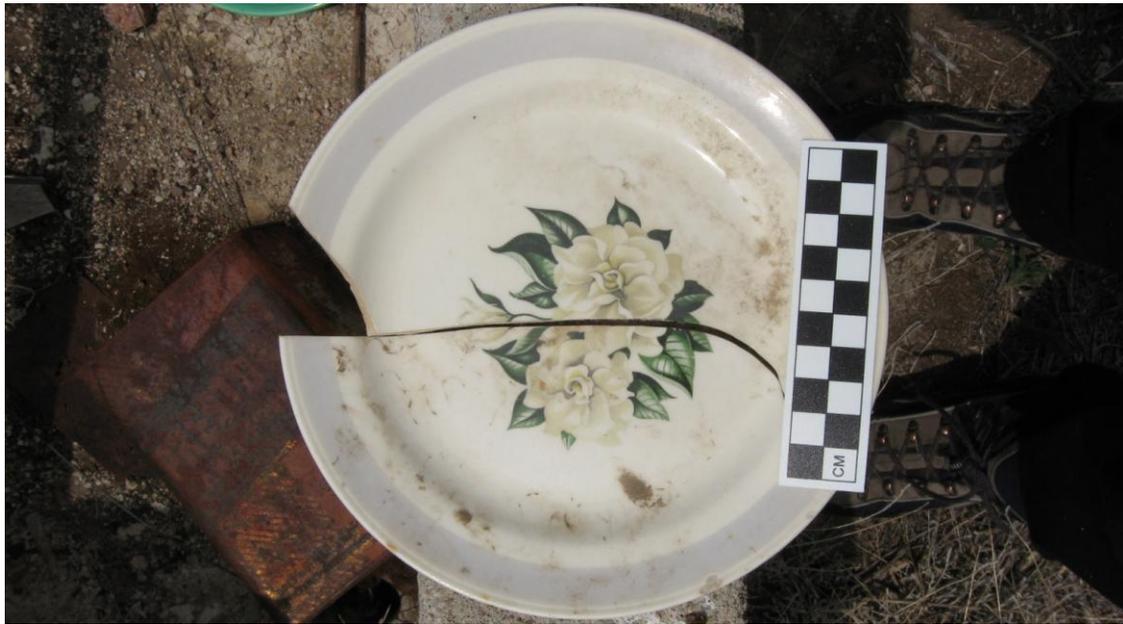
The Homer Laughlin China (Eggshell Nautilus, Nassau pattern) plate found in the milk trough dates from the period 1937-1950s (Figure 12). This pattern of white roses and green leaves is Eggshell Nautilus, Nassau made by Homer Laughlin China, ca. 1937-

Figure 12. Plate found in milk trough. Pattern is Eggshell Nautilus, Nassau made by Homer Laughlin China, ca. 1937-1950s; made for and sold by Montgomery Ward (<http://www.robbsnest.com/eggshell-nautilus/nassau.html>).

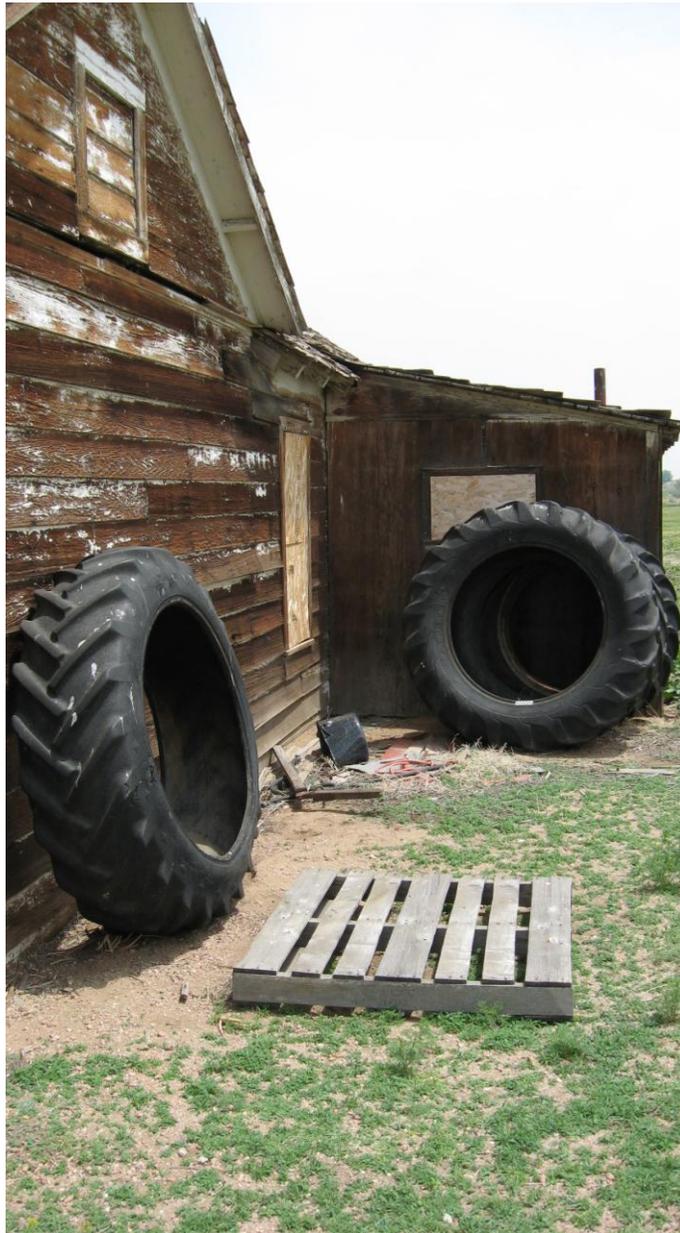
Figure 13. Trash and artifacts south of migrant worker's house.

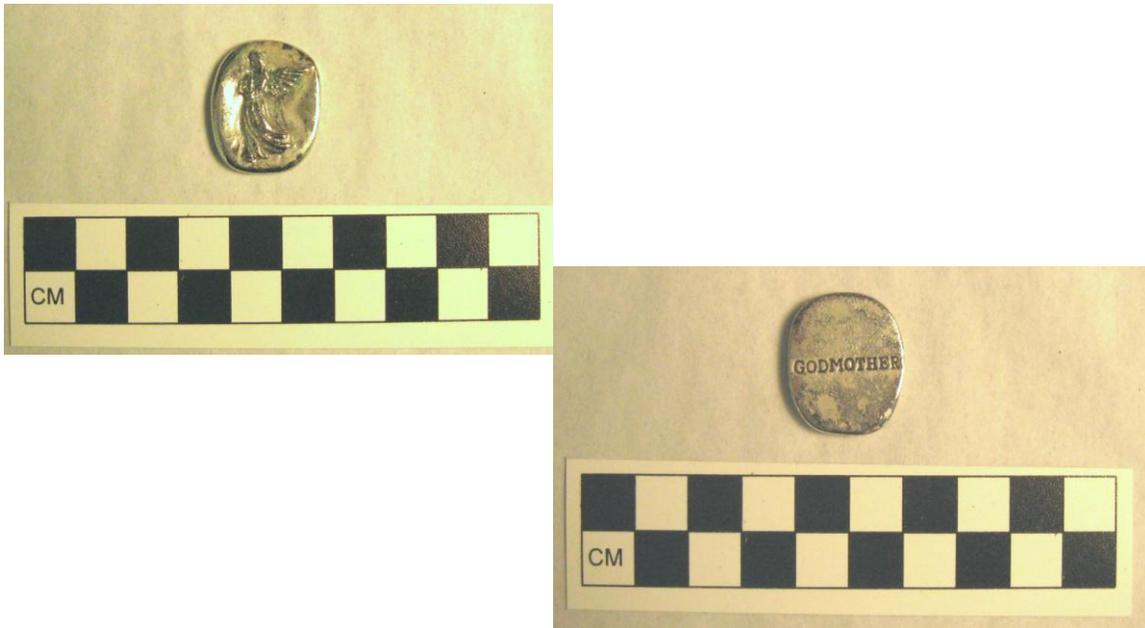
The date of the Godmother charm (FS-1) is not known, and it could be related to more recent use of the site (Figure 14). It was found behind the migrant worker's house. The date of FS-3, the metal seed plate, is not known but also may date to one of the later occupations of the site (Figures 7-8). The Fiestaware plates found in the milk trough (Figure 10) likely date to ca. 1936-1951 or later (<http://www.madeintheusadinnerware.com/colors.htm>).

Figure 14. Godmother charm, front and back. Found behind the migrant worker's house.
